RUTHERFORD + CHEKENE

DATE: 2019-06-28

UC Santa Cruz building seismic ratings
Field House Addition

CAAN #7119.1

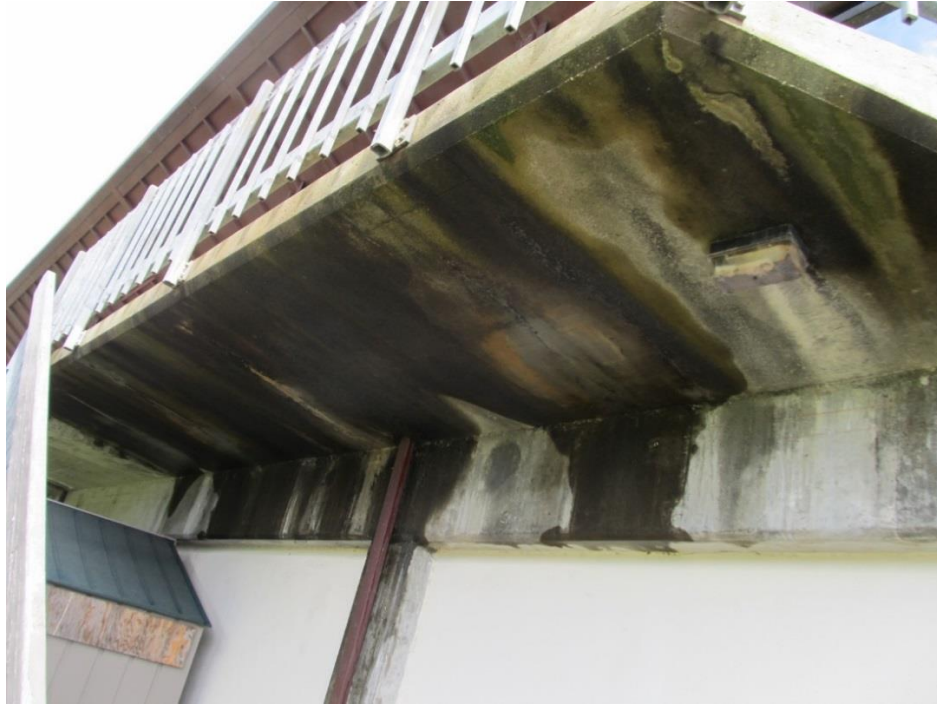
Building condition: in general, the building is in good structural condition. No significant damage in the structural system was identified during the site visit. However, the bottom face of the exterior concrete slab use as hallway for the exterior stair was wet during the visit. Water marks, brown stains, and efflorescence were evident in the same area (see pictures in Appendix A). The columns along Gridlines 8 and 11 are rusted because they are exposed to the weather (see picture).

Water Marks on the Exterior Stairs Hallway (South)

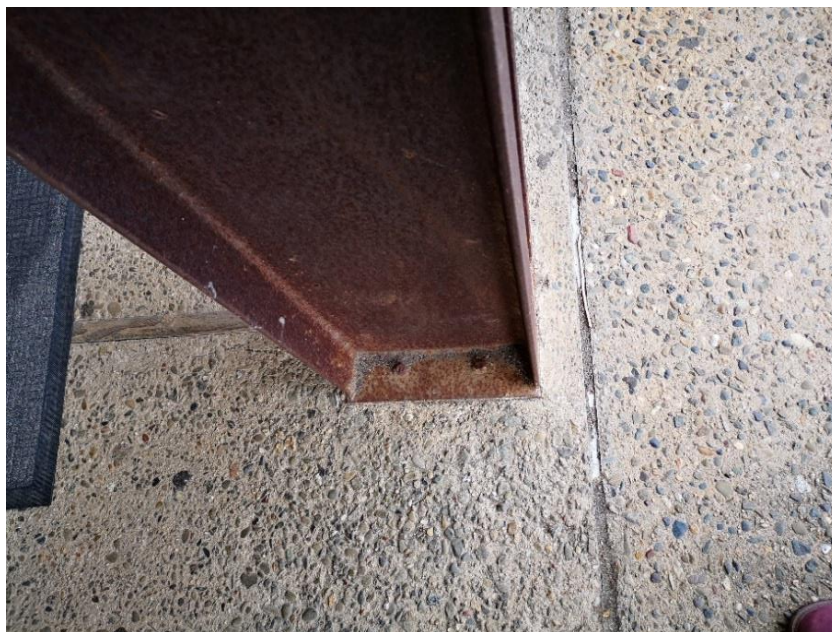
Rusted columns on Gridlines 8 and 11.
