UC Santa Cruz building seismic ratings Stevenson College House 1

CAAN #7135

University of California, Santa Cruz
ASCE 41-17 Tier 1 Seismic Evaluation
7135 - Stevenson College House 1

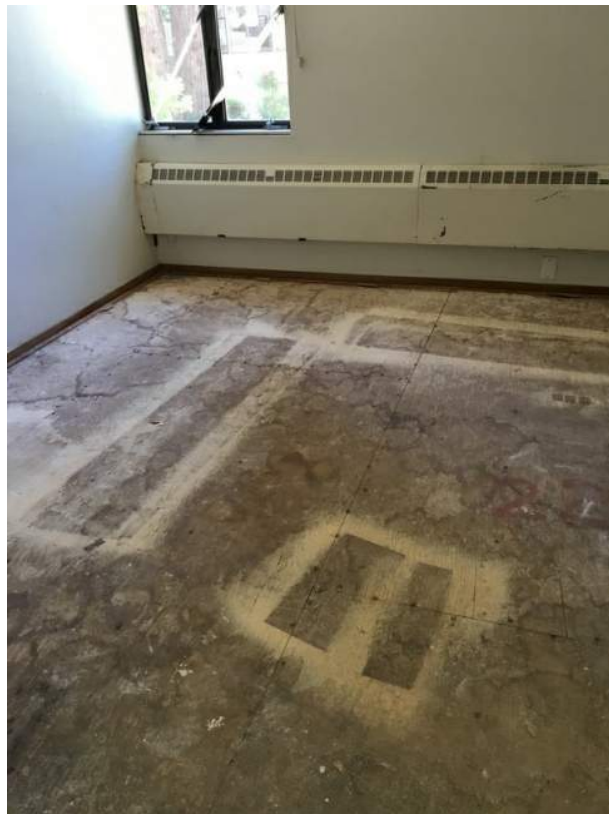
Typical plywood sheathing on building floors
