UC Santa Cruz building seismic ratings

Stevenson College House 2

CAAN #7136

University of California, Santa Cruz
ASCE 41-17 Tier 1 Seismic Evaluation
7136 - Stevenson College House 2

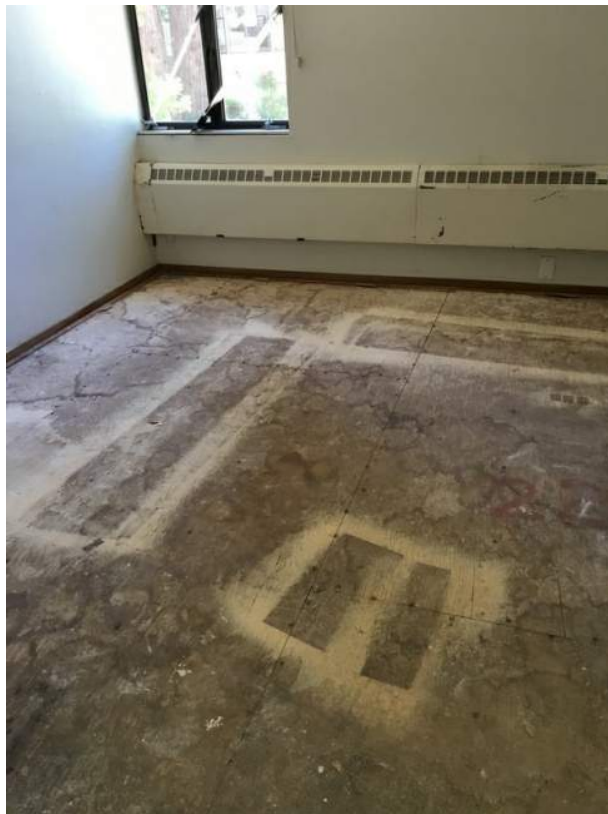
Typical plywood sheathing on building floors
