## UC Santa Cruz building seismic ratings Stevenson College House 3

CAAN #7137

University of California, Santa Cruz  
ASCE 41-17 Tier 1 Seismic Evaluation  
7137 - Stevenson College House 3

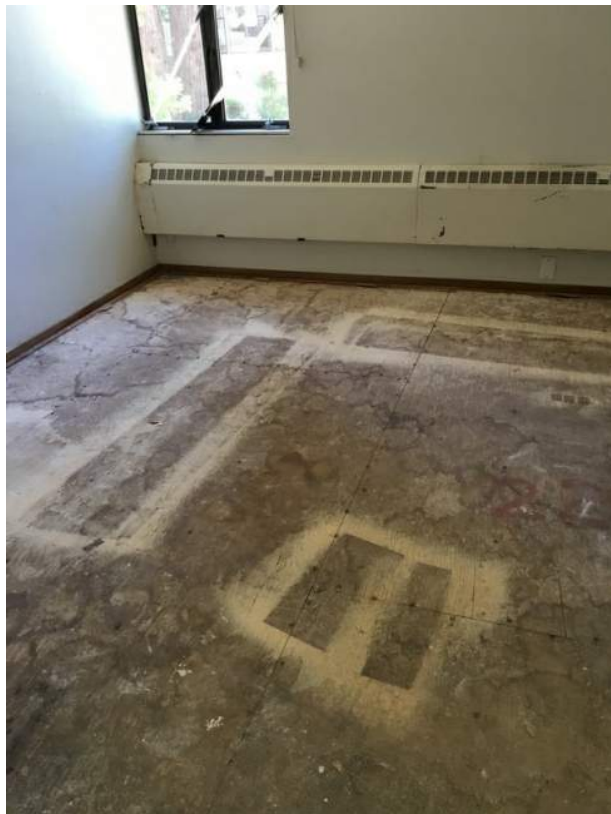
Typical plywood sheathing on building floors

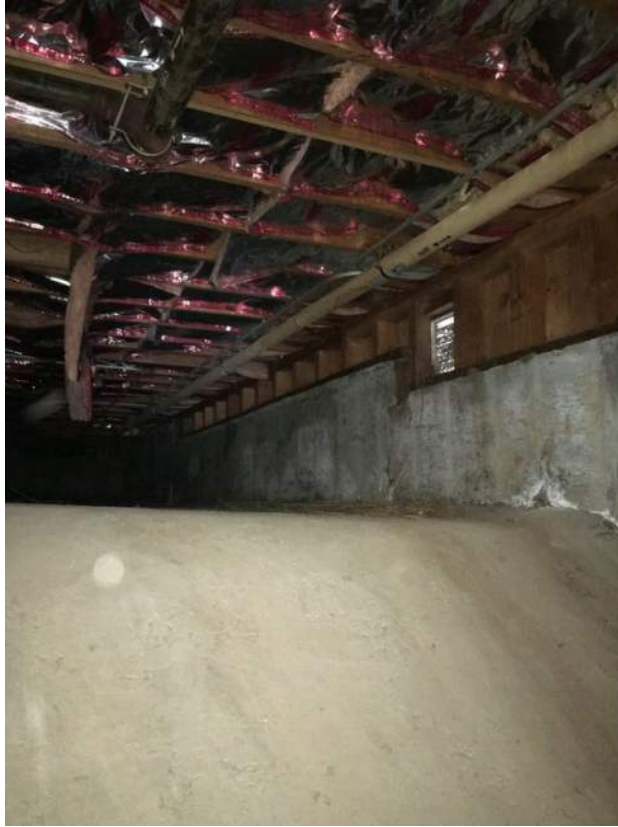
Framing in crawl spaced supported on perimeter retaining walls.

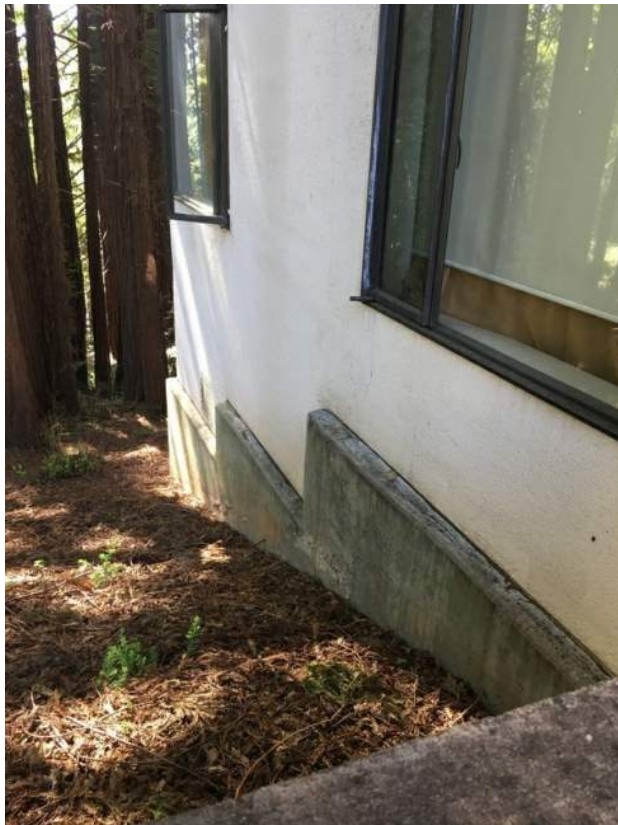
Stepped footing at crawl space
