## UC Santa Cruz building seismic ratings Stevenson College House 5

CAAN #7139

University of California, Santa Cruz  
ASCE 41-17 Tier 1 Seismic Evaluation  
7139 - Stevenson College House 5

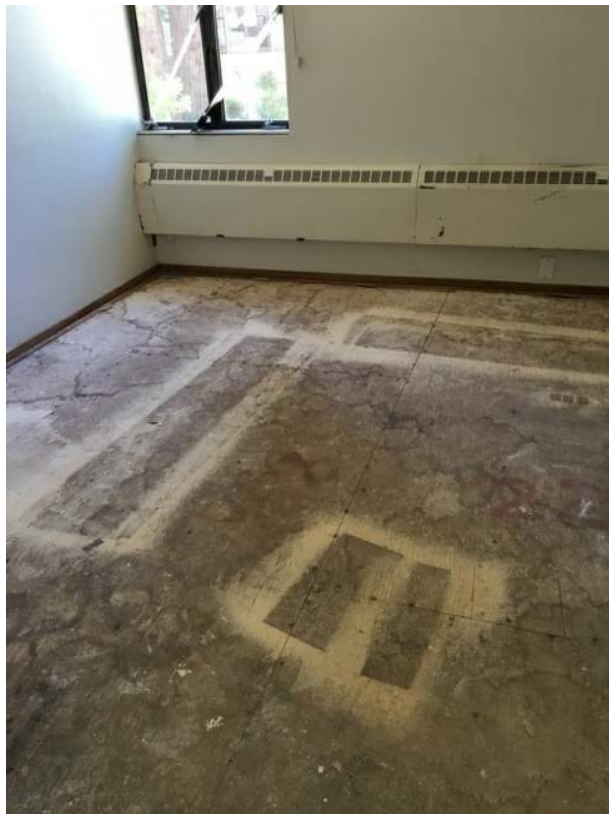
Typical plywood sheathing on building floors
