UC Santa Cruz building seismic ratings Stevenson College House 7

CAAN #7141

University of California, Santa Cruz
ASCE 41-17 Tier 1 Seismic Evaluation
7140 - Stevenson College House 7

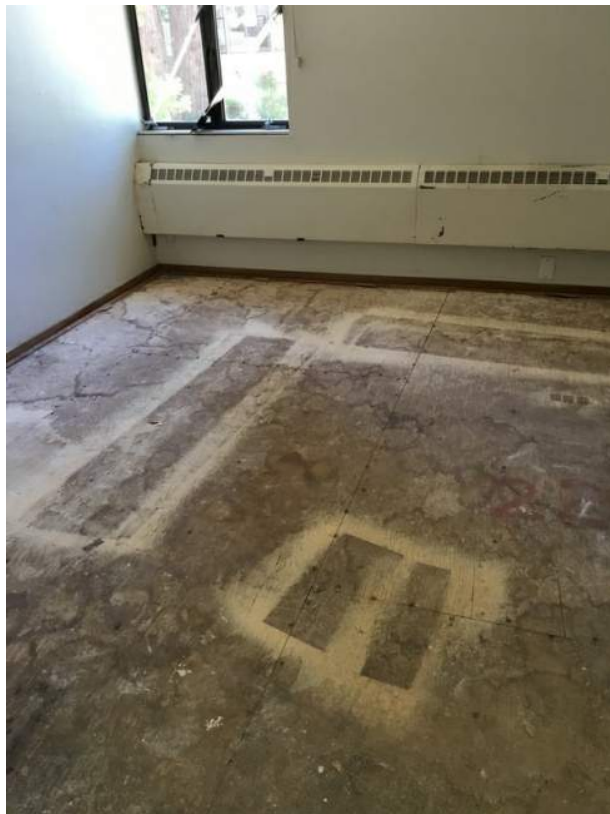
Typical plywood sheathing on building floors

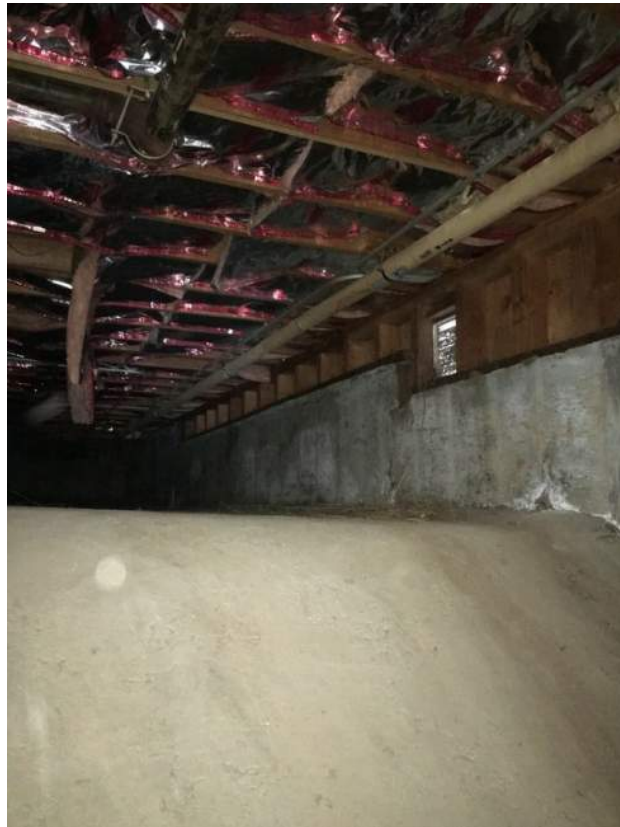
Framing in crawl spaced supported on perimeter retaining walls.

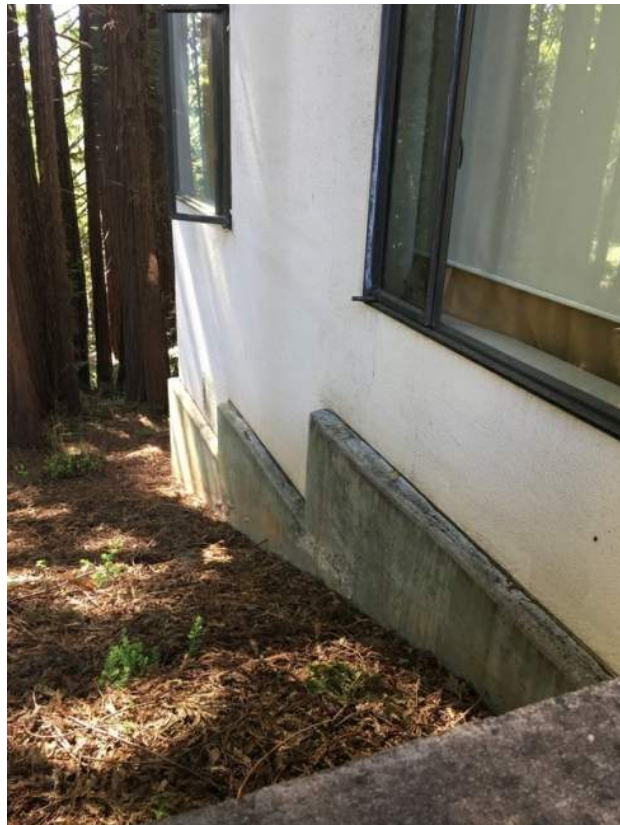
Stepped footing at crawl space
