Date: 07/28/2019

UC Santa Cruz Building Seismic Ratings
Crown College Commons

CAAN #7157

630 Crown Road, Santa Cruz, CA 95064

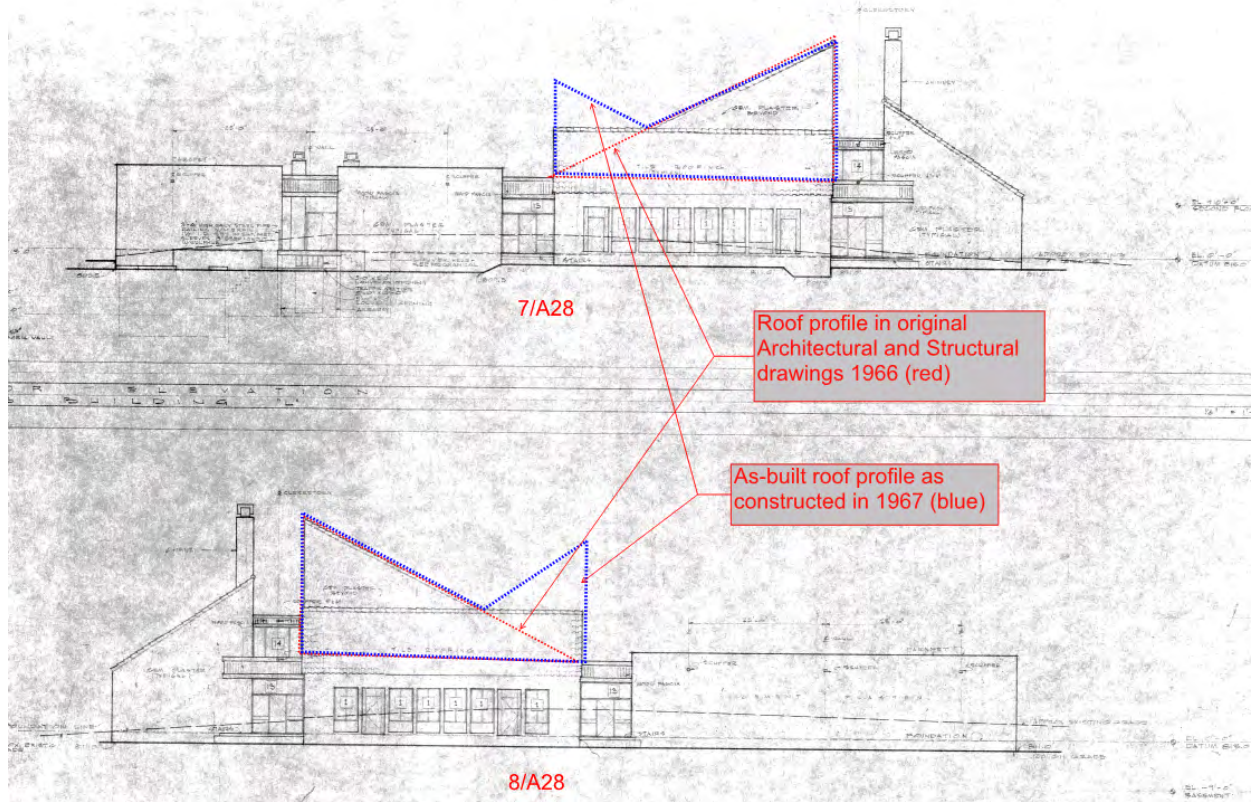
- The roof diaphragms are discontinuous, and connections between all the adjacent roof areas unclear, particularly since Dining Hall roof was not built as shown in 1966 drawings.

Original 1967 Architectural Elevations Showing Dining Hall Roof Profile (Red) and As-Built Roof Profile (Blue)

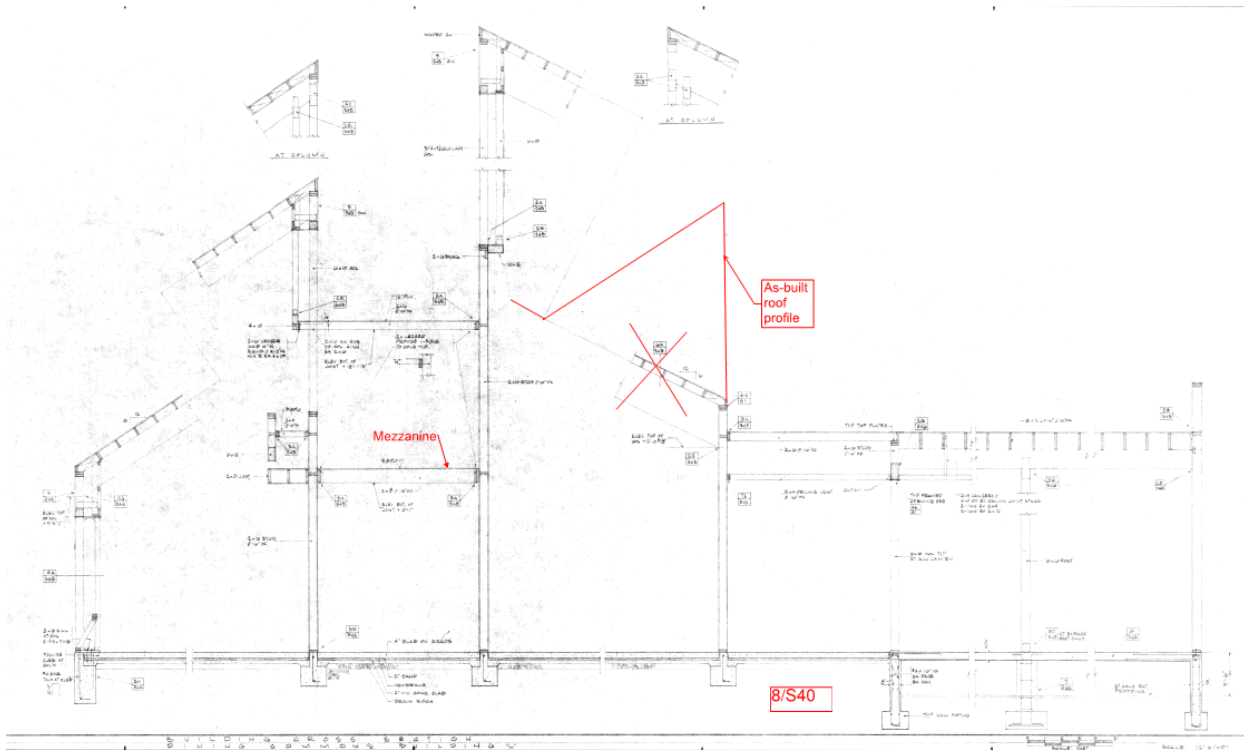
Original 1967 E-W Partial Section (Looking North, Kitchen at Right) with As-Built Roof Profile Marked in Red

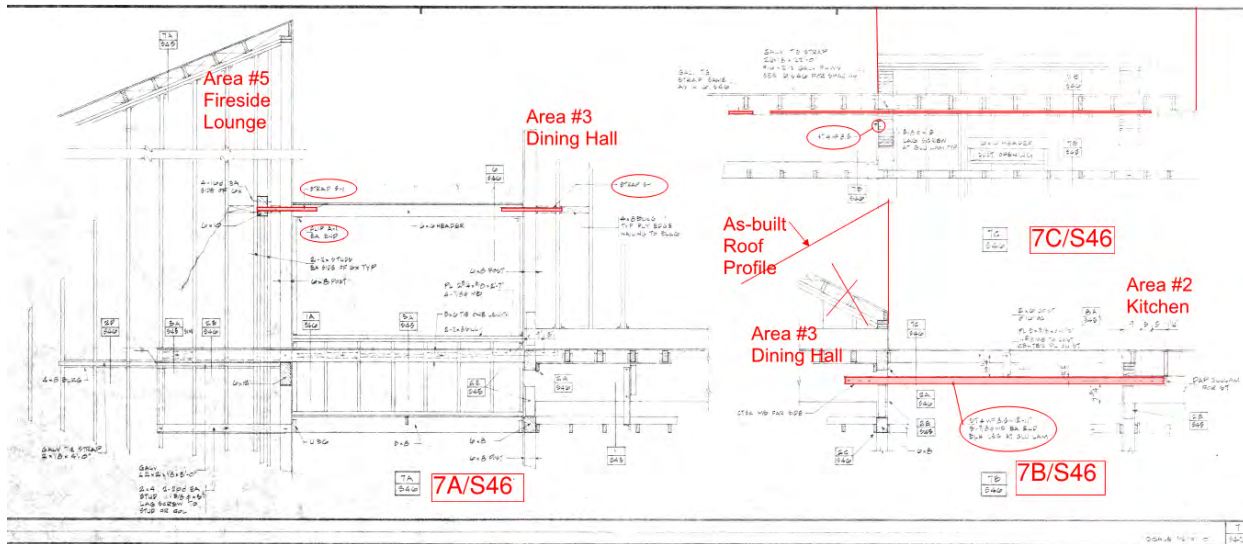
- The original building had vertical discontinuities in the E-W direction and lacked a clear load path for E-W loads from the glulam girders at the Dining Hall roof. The original connection details shown in the 1966 drawings may not have been installed as shown, since the as-built roof profile differs from the drawings. A three-phase retrofit in 2000-2001 may have addressed these issues, but the load path remains unclear. A detailed Tier 2 review of the retrofitted building is needed to see if the various narrow wall segments, nailing, straps, and hold downs are adequate to resist the shears and overturning moments from the high roof area. As there were no foundations at the north and south edges of the Dining Hall, these loads are still being dragged into other sections of the building; the adequacy of all the details of this load path should be reviewed.

Straps from High Roof in Original 1967 Drawings (As-Built Profile and Straps in Red)

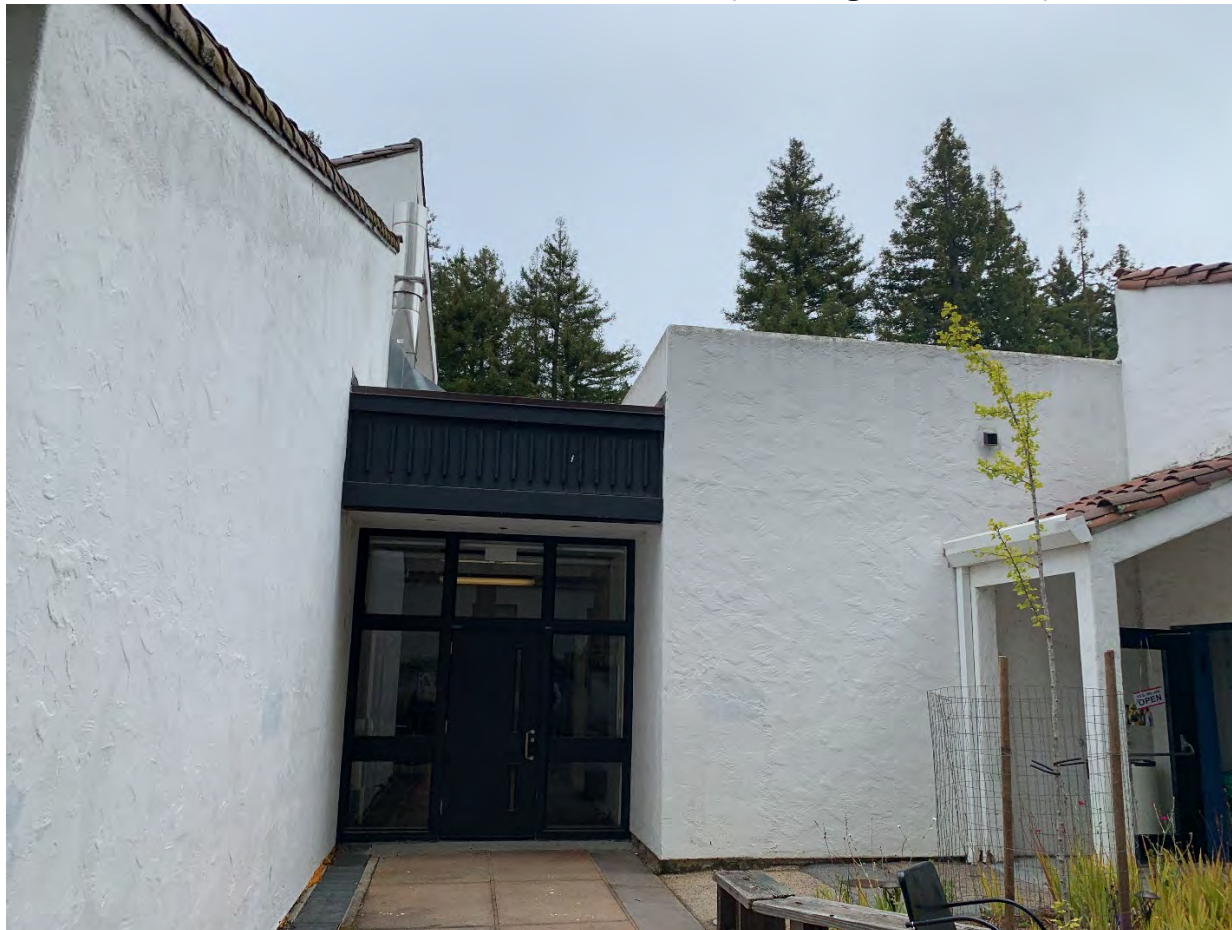
- Two separate wings of Merrill College were built adjacent to the Kitchen area without visible gaps. We have not reviewed the Merrill College drawings and do not know if these buildings rely on the Crown College kitchen for lateral resistance or whether any seismic gaps are present.

Partial south elevation, Banana Joe's at left, glazed entry and kitchen with flat roof in middle, Merrill College Student Life Wing at right with no visible gap (looking north)

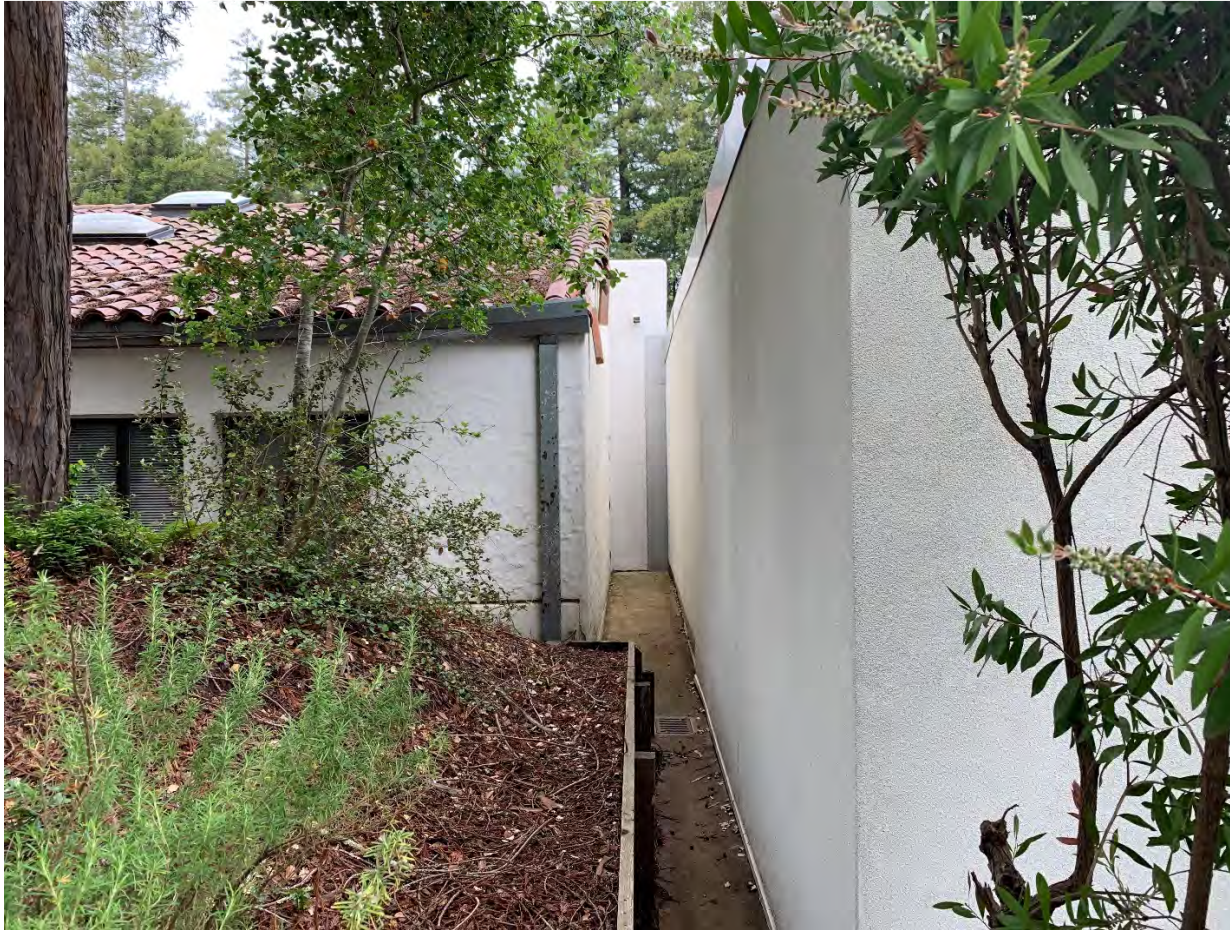
Partial south elevation showing southeast corner at rear of kitchen in center with portions of Merrill College at left and right with no visible gaps (looking north)

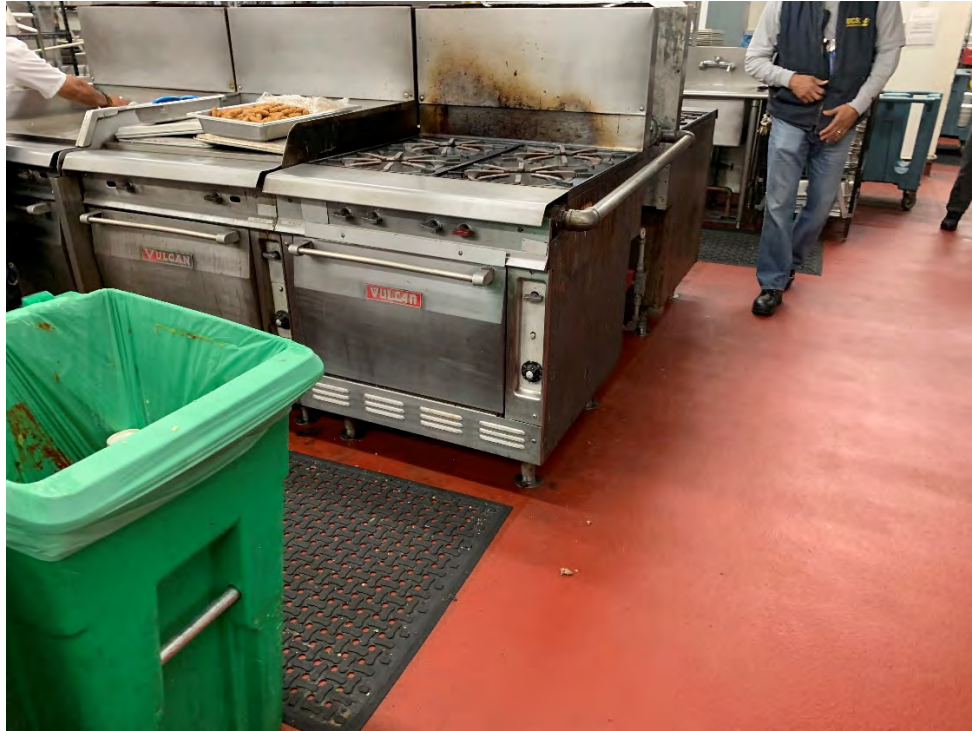
We observed gas-fired appliances in the kitchen that all appeared to have one anchor bolt in a base plate at each leg. None of the refrigerators, freezers, or storage units appeared anchored. Mechanical equipment and piping in the basement area appeared to be braced and anchored. There are clerestory windows in the high roof area above the Dining Hall and glazing above and around all the entries. We recommend verifying that the glazing consist of tempered glass or the like. This building has what appears to be unrestrained Spanish tiles, including some adjacent to entries and over adjacent areas with foot traffic. We recommend nailing tiles adjacent to stairs and walkways to preclude a life-safety concern.

Gas-fired stoves anchored in Kitchen

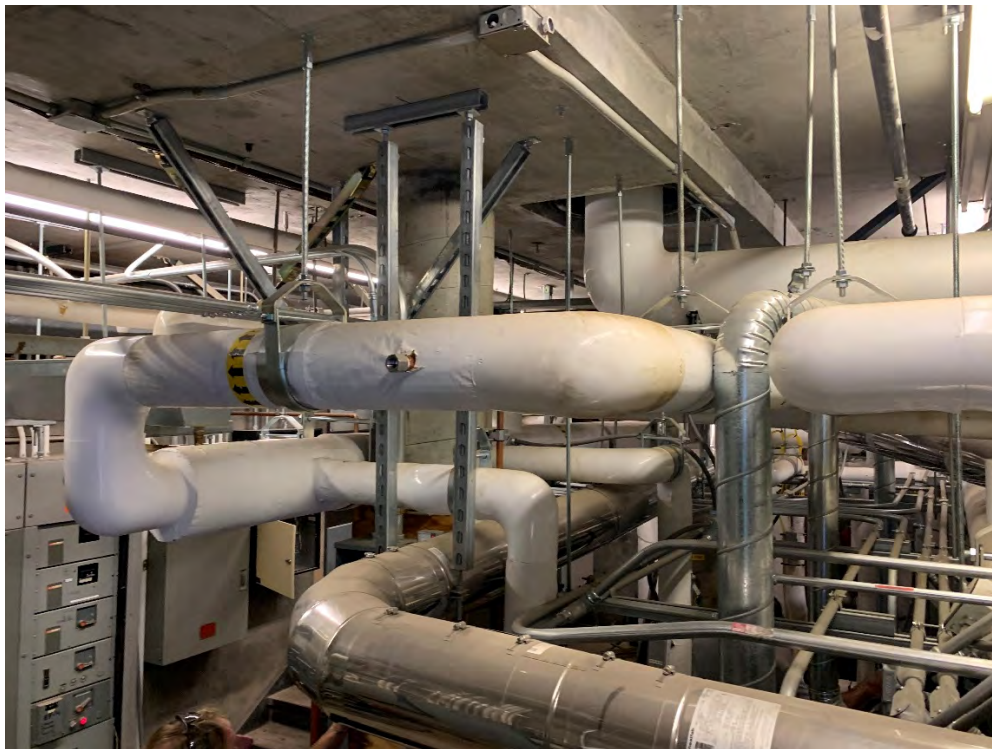
Braced piping in mechanical room at basement level below Kitchen

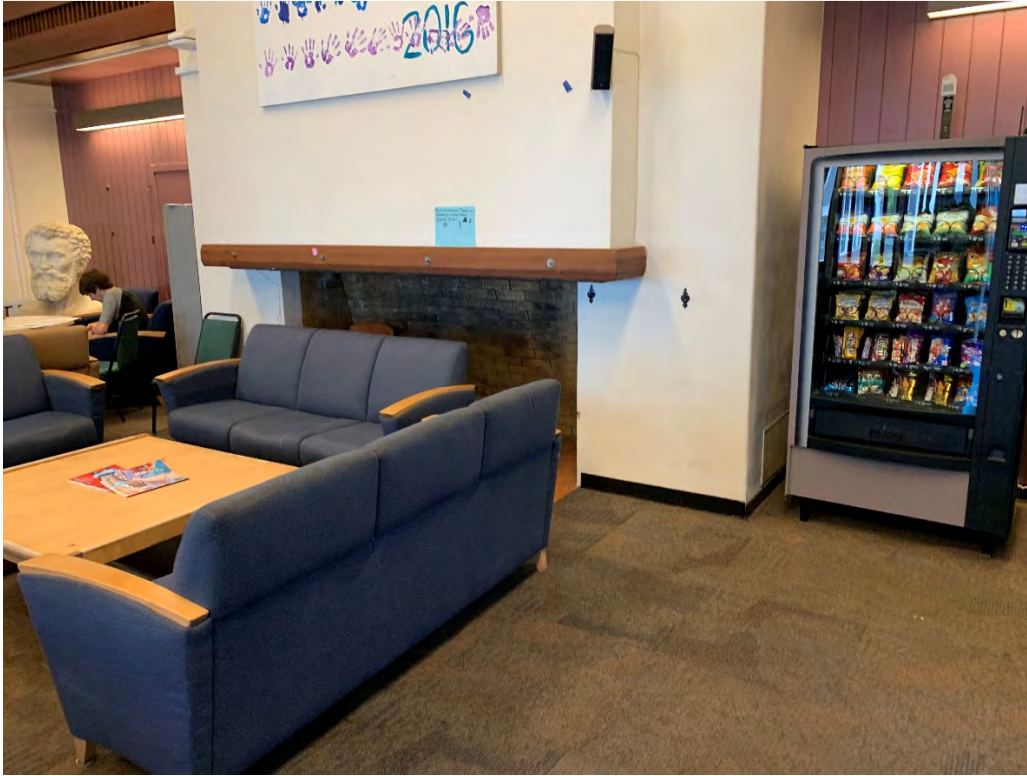
- The reinforced concrete chimney is stiffer than adjoining wood framed elements; as a result, the influence of this concrete element and the connections to the adjacent framing should be reviewed in a more detailed fashion.

Base of reinforced concrete chimney in Fireside Lounge
