Rating form completed by:

UC Santa Cruz Building Seismic Ratings
Crown Library Study Building

CAAN #7162

680 Crown Service Road, Santa Cruz, CA 95064

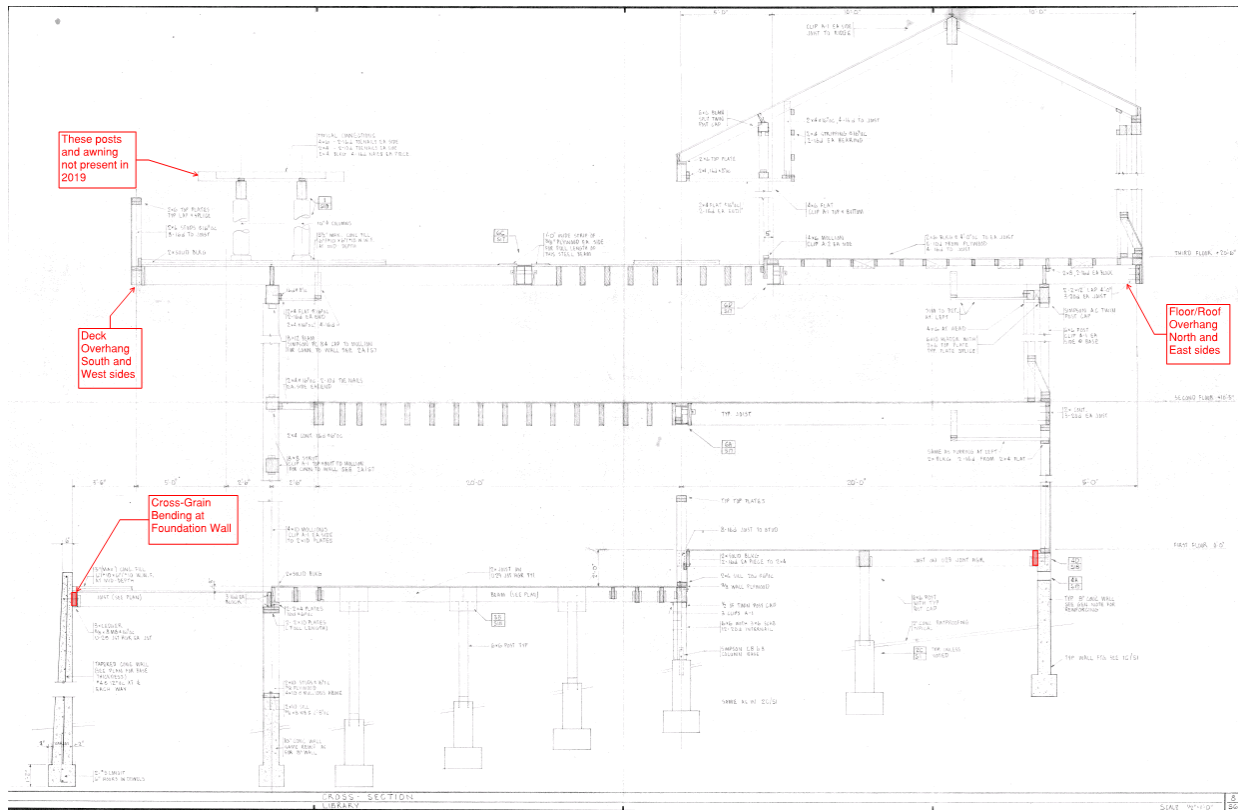
Interior Transverse (E-W) Building Structural Section 8/S6 (Looking North Showing Overhangs, Vertical Offsets, and Cross-Grain Bending at Connections to Foundation Walls)

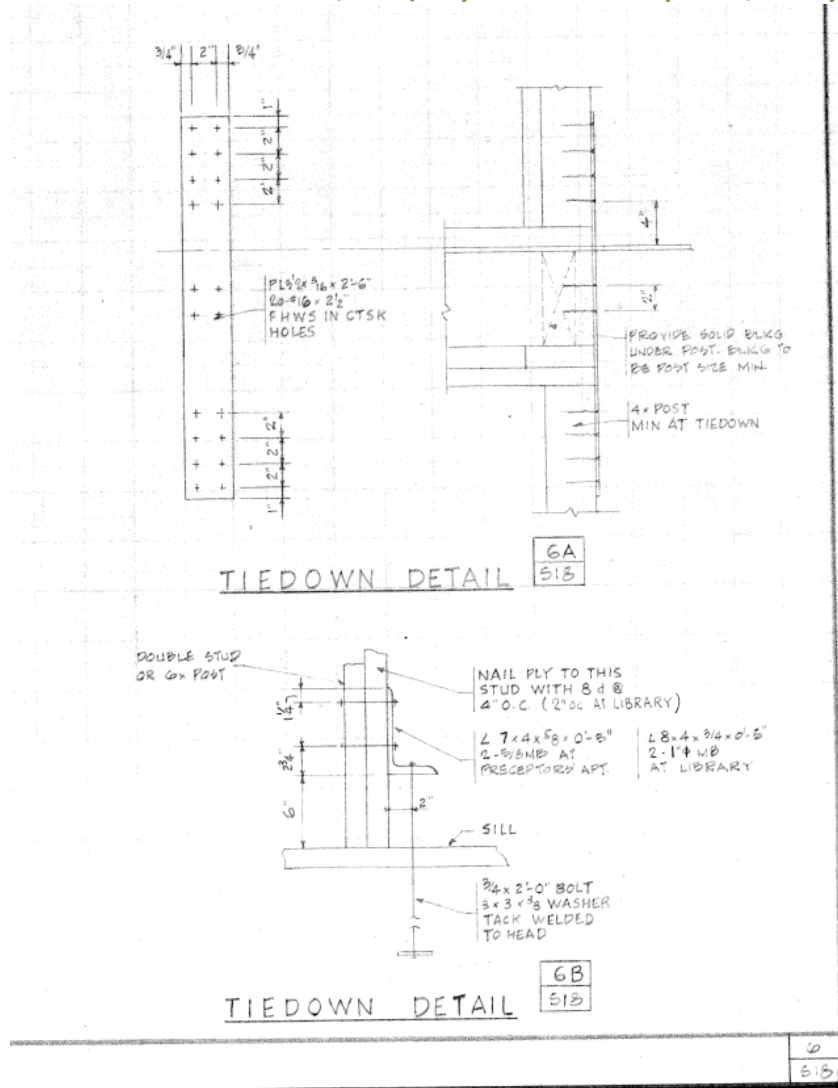
"Tiedown Detail" 6A&6B/S18 (only used at a few places, not typical at all wall ends)

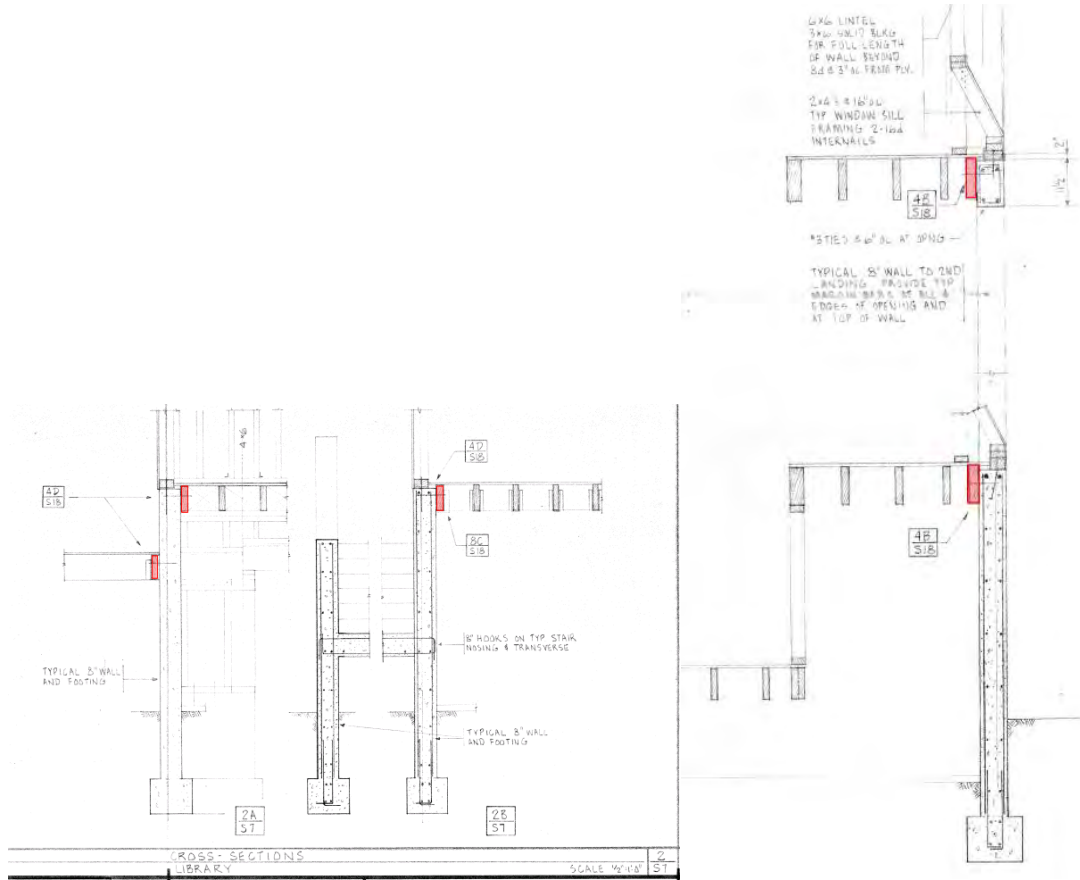
Cross-Grain Bending at Ledger Present in Typical Details 2/S7 and 8/S7

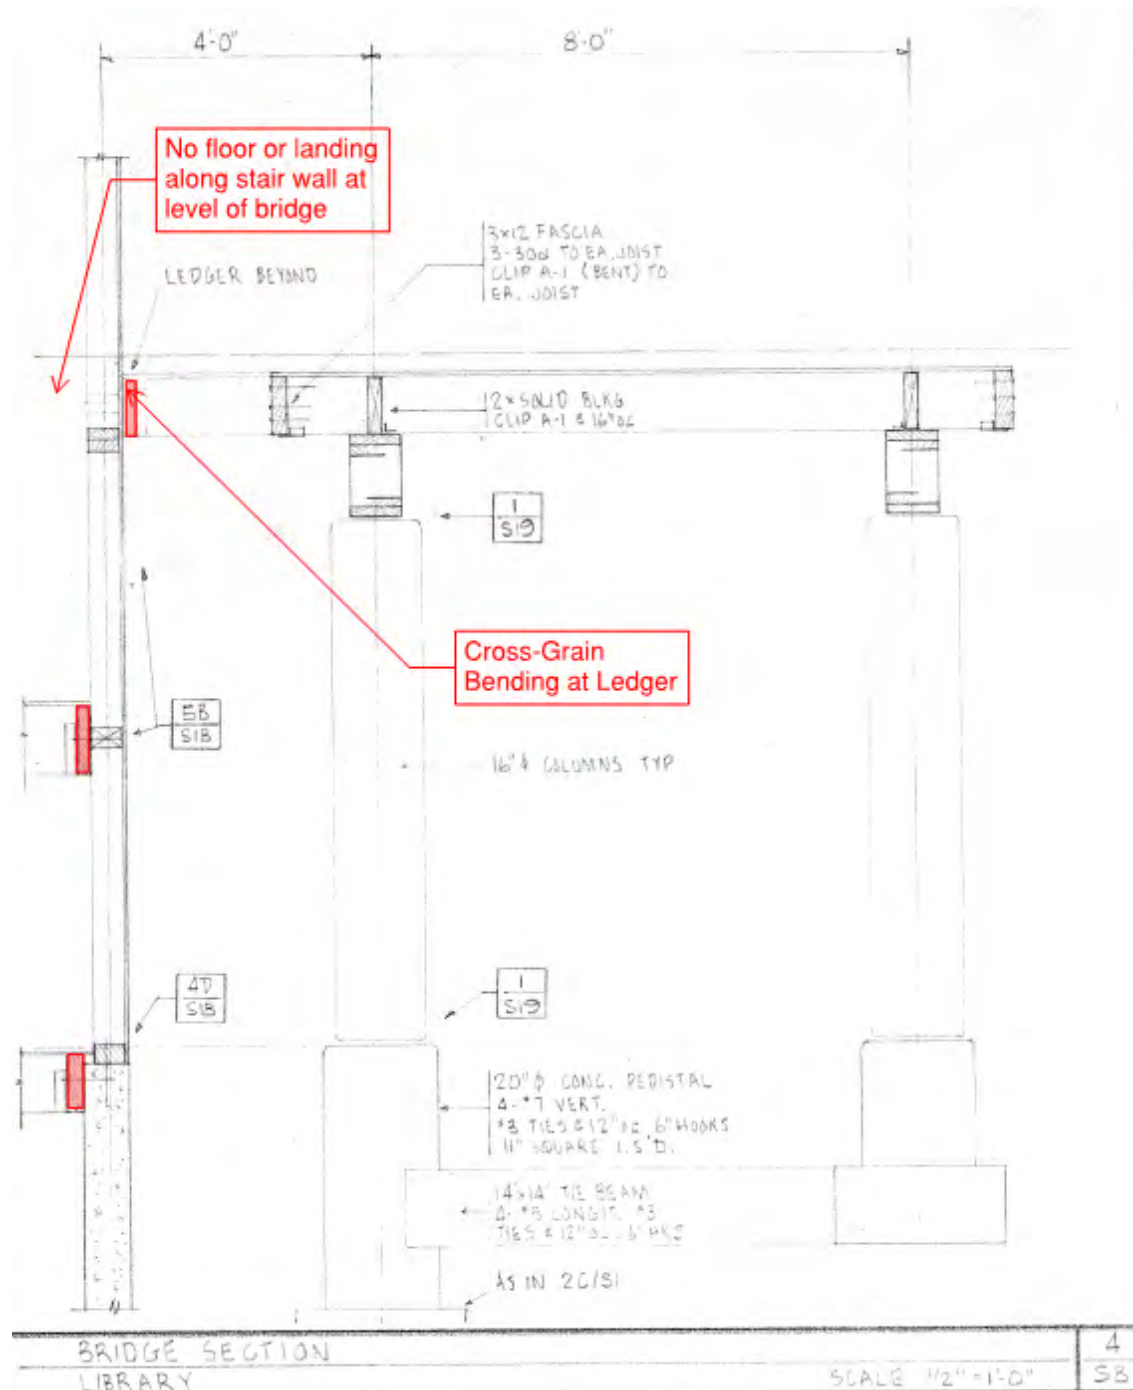
Detail 4/S8 of Adjoining Bridge Structure Anchored to Library and Connecting to Classroom and Faculty Wing at Second Floor Level (No Floor Aligned with Bridge at this Section and Cross-Grain Bending at Connection Details)

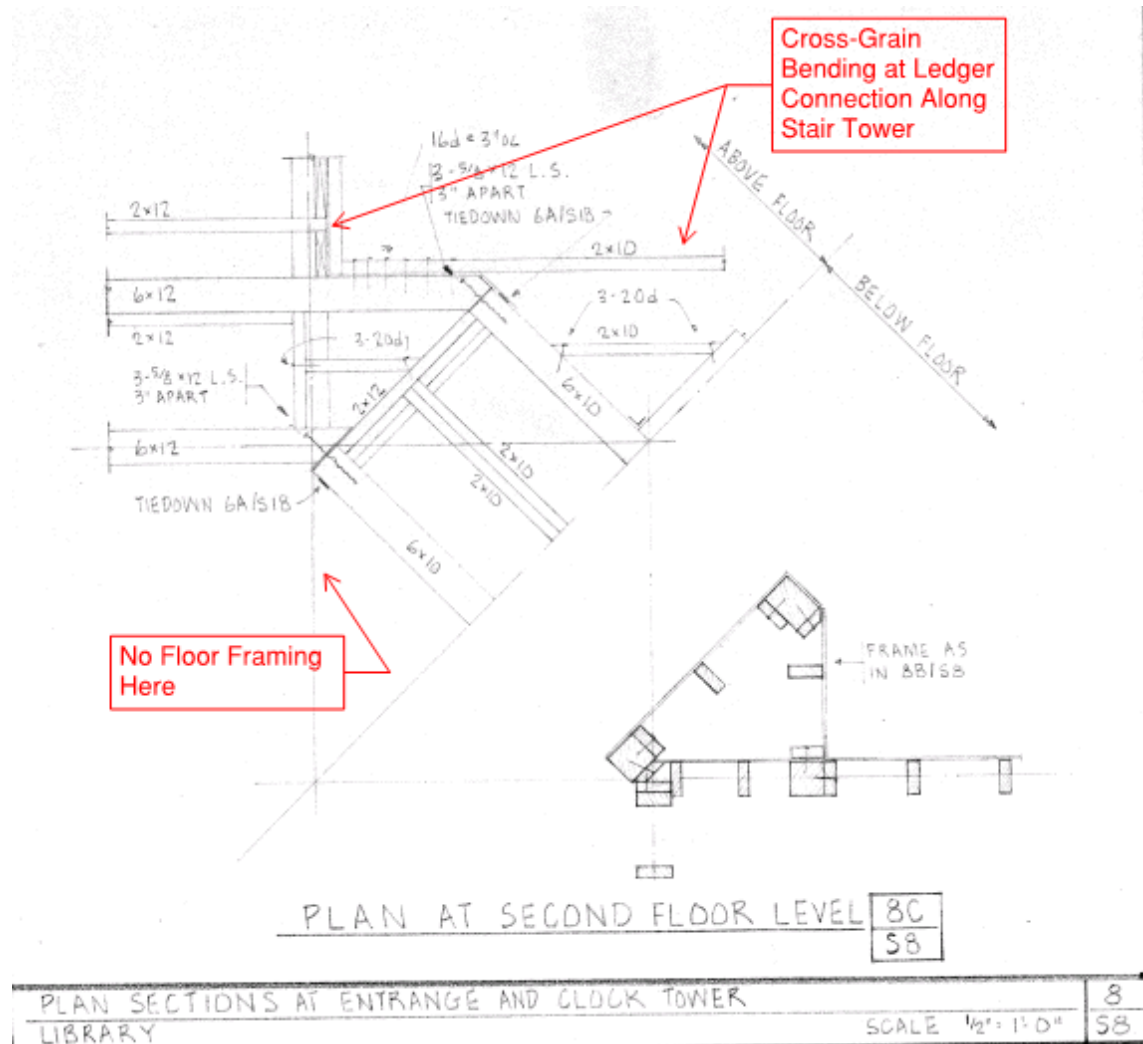
Details of Bridge Anchorage to Library Building at Entrance to Clock Tower (Note Floor Opening Adjacent to 6x10)
