UC Santa Cruz building seismic ratings

Stevenson Preceptor House

CAAN 7174

DATE: 2020-10-31

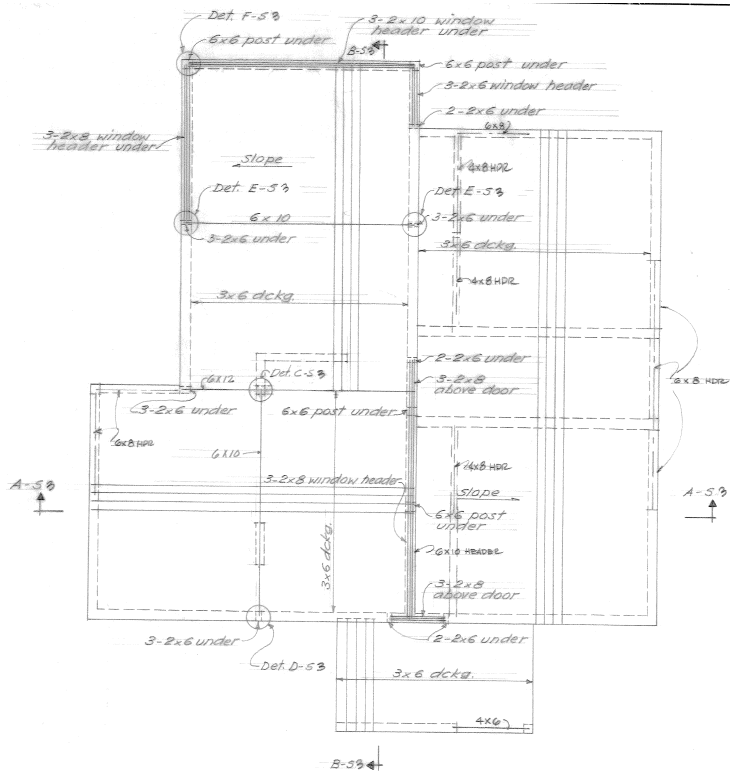
ROOF FRAMING PLAN
Scale 4" = 1'-0"

Structural feature or potential deficiency	Finding
Load Path	A disruption in load path occurs at the two discontinuous shear walls located at the floor cantilevers.
Vertical Irregularities	Two shear walls are discontinuous and terminate at the first floor level rather than continue to the foundation.
Wall Openings	There are large wall openings in shear walls that are not supported by plywood panels on both sides and no special detailing has been provided around the openings (such as straps) for adequate load transfer.
Diaphragm Continuity	The roof profile has a 4 ft (approx.) step at the midspan of the roof diaphragm that is not supported by a shear wall, and the detailing does not seem to show that lateral load can be adequately transferred across this step in elevation to shear walls on the other side of the building.
Diaphragm Span	The roof diaphragm is composed of 3x6 wood decking that spans about 30 ft and violates the span limitation (24 ft) of straight sheathing.

It is recommended to investigate the central long interior wall of the building, that aligns with the step in roof profile, if it is sheathed with plywood. Accordingly, the building should be reevaluated to see if it needs a retrofit.

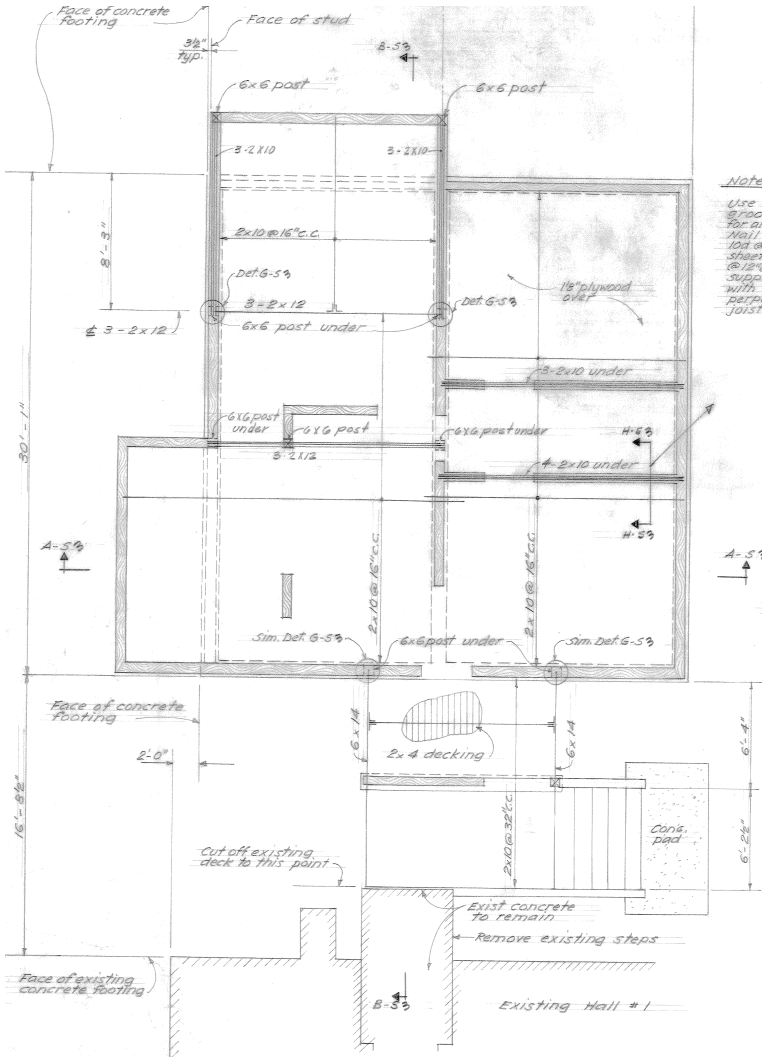
FOUNDATION AND FLOOR FRAMING PLAN
Scale 4" = 1'-0"

Nonlinear behavior is expected to occur in the roof diaphragm at the vertical offsets and in the floor diaphragm where it supports the discontinuous shear walls.
