**MAFFEI STRUCTURAL ENGINEERING**  
maffei-structure.com

**UC Santa Cruz building seismic ratings**  
**Communication Building**

CAAN #7175  
620 Baskin Circle, Santa Cruz, 95064  
UCSC Campus: **Main Campus**

DATE: 2019-06-30

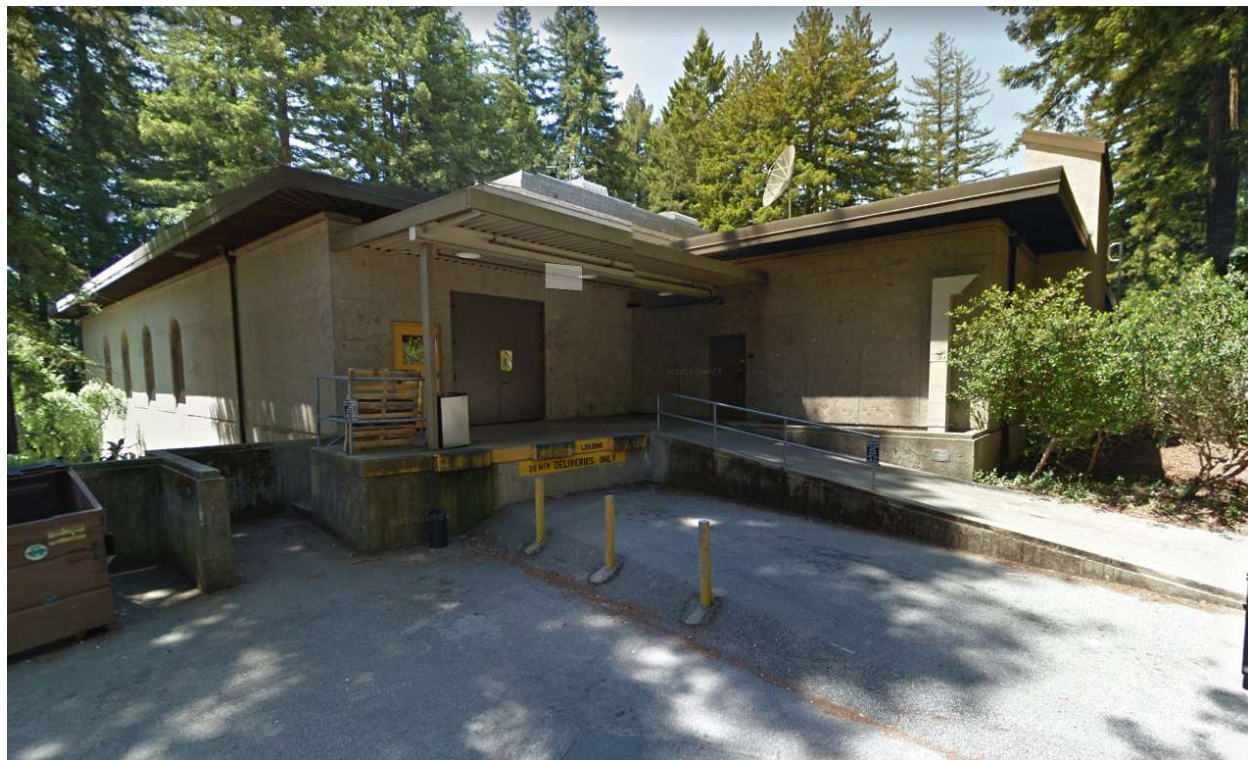
**Loading dock on northeast side of building**

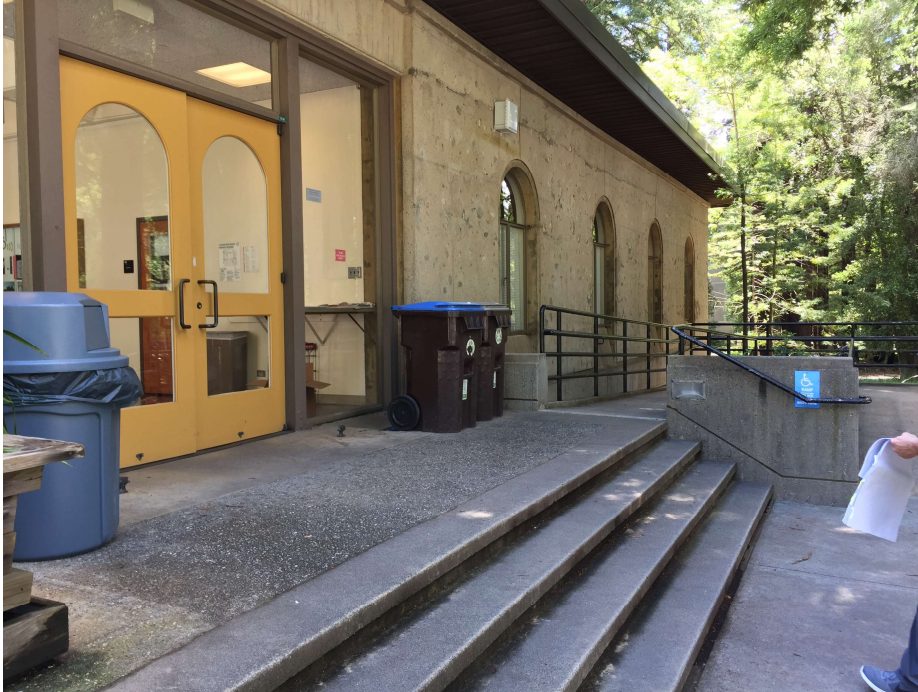
**Entry at west side of building**

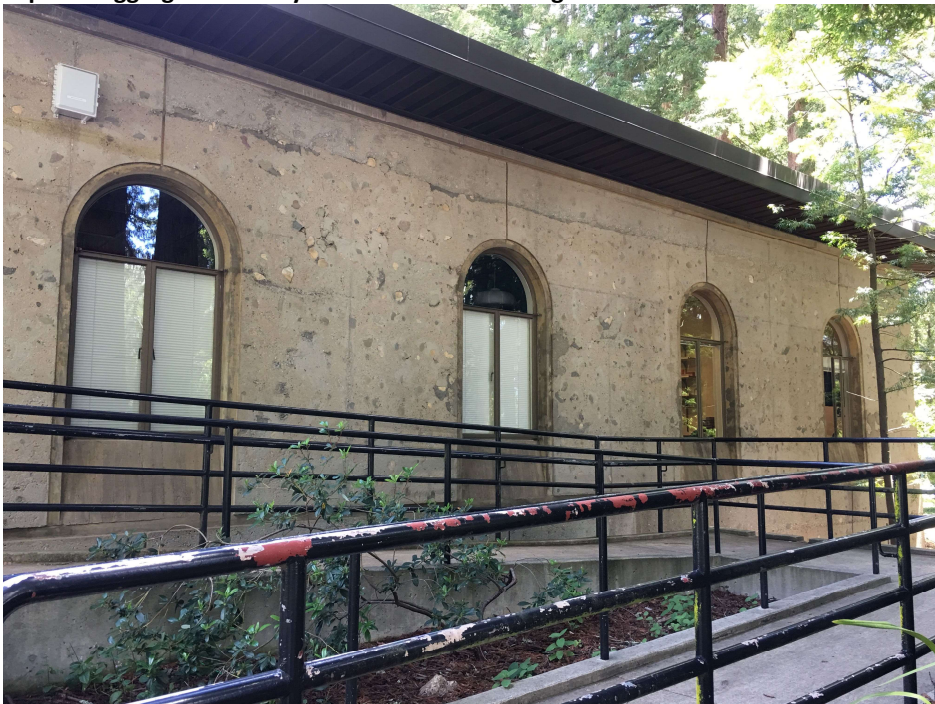
- There are embedded river rocks, minimum 3" diameter, at the exterior face of perimeter concrete walls as an architectural feature. Although this feature occurs at the wall on the entry side of the building, we do not expect this to be a significant life safety falling hazard which would warrant a V(Poor) seismic performance rating.

**Exposed aggregate at entry at west side of building**

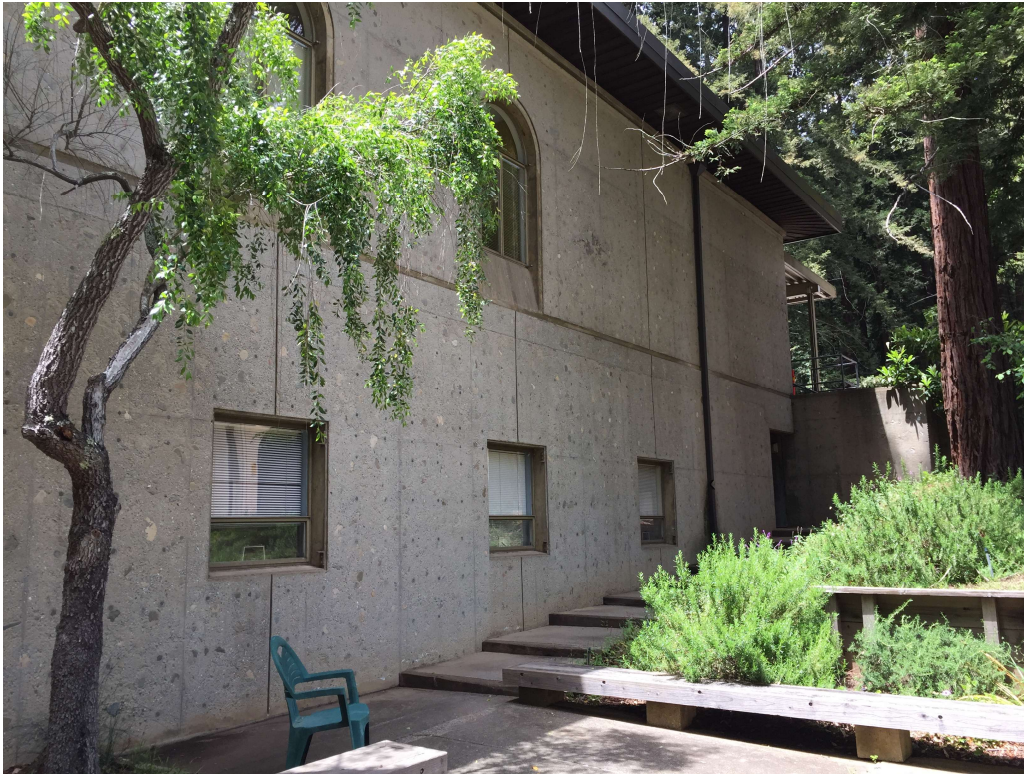
**East side of building**
