Rating form  
completed by:
**MAFFEI STRUCTURAL ENGINEERING**  
 maffei-structure.com  
 Karl Telleen, Joe Maffei
Text in *green* is to be part of UC Santa Cruz building database and may be part of UCOP database
**UC Santa Cruz building seismic ratings**  
**Natural Sciences Building 2, University of California Santa Cruz**

CAAN #7179  
 560 Red Hill Road, Santa Cruz, CA 95064  
 UCSC Campus: **Main Campus**

DATE: 2018-12-31

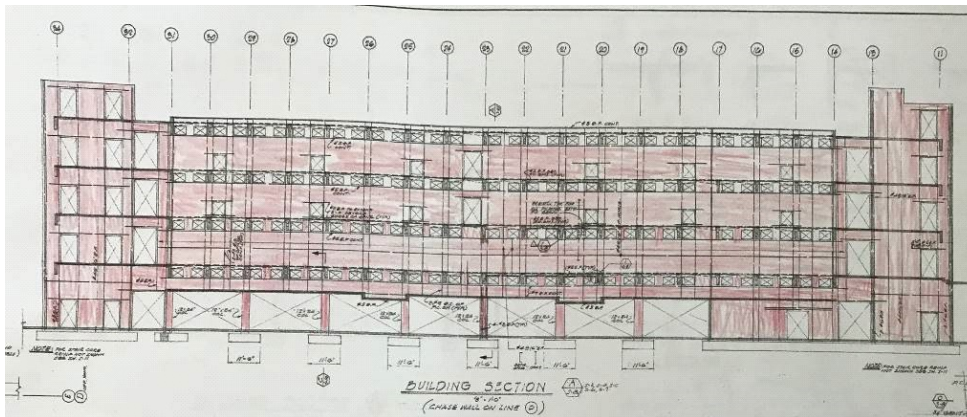
- Numerous openings in longitudinal concrete walls on Lines D and E just below each floor level. (See wall elevations Sheet S-8.) These openings are expected to reduce shear strength of the walls and cause shear damage to the short piers between the openings.

Wall elevation Line D (looking south).

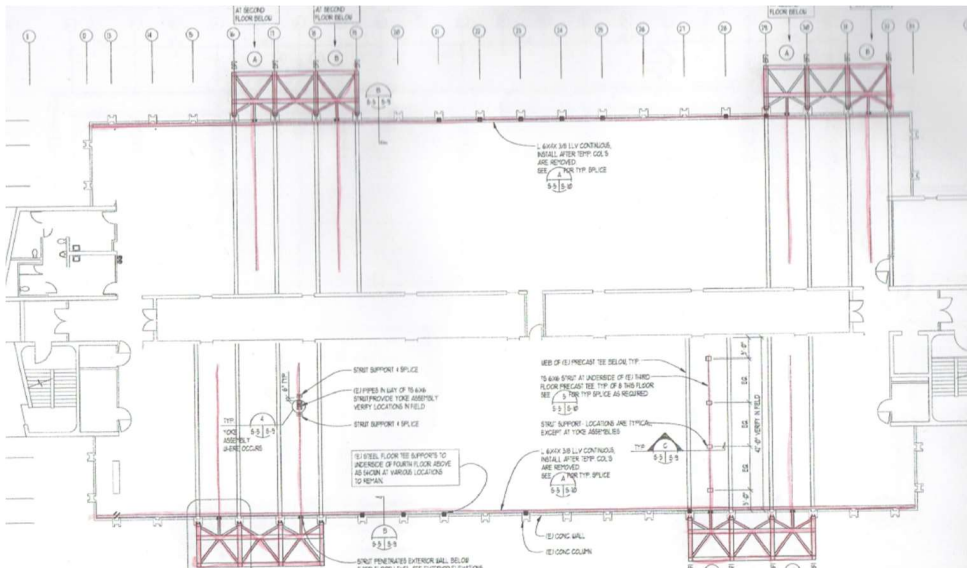
Seismic retrofitting constructed in the late 1990s includes exterior steel braced frame buttresses added on the north and south sides of the building to provide seismic resistance in the north-south direction. The braced frame buttresses consist of welded steel rectangular tube sections, and they are founded on concrete drilled piers. Steel collectors (rectangular tube sections) extend from the buttresses into the building, connected to the underside of T-beam flanges. On the north side, the braced frame buttresses exist at the 2<sup>nd</sup> and 3<sup>rd</sup> Stories (because the 1<sup>st</sup> Story is below-grade on the north side of the building); on the south side, the braced frames exist at the 1<sup>st</sup>, 2<sup>nd</sup>, and 3<sup>rd</sup> Stories, and they include east-west braces at the 1<sup>st</sup> Story. At the 4<sup>th</sup> Story, retrofitting includes interior X-braces in the north-south direction constructed from steel WT shapes. Steel angles (L6x4x3/8) are added at the north and south edges of the 2<sup>nd</sup>, 3<sup>rd</sup>, and 4<sup>th</sup> Floor diaphragms as chord reinforcement.

1998 retrofit. (3<sup>rd</sup> floor shown.) Red indicates exterior steel braced frame buttresses (rectangular tube sections), steel collectors extending into the building (rectangular tube sections), and steel chord reinforcement (angle sections) added along the north and south edges of the diaphragm.
