UC Santa Cruz building seismic ratings

Natural Science Building Unit 2 Annex

CAAN #7180

DATE: 2019-06-30

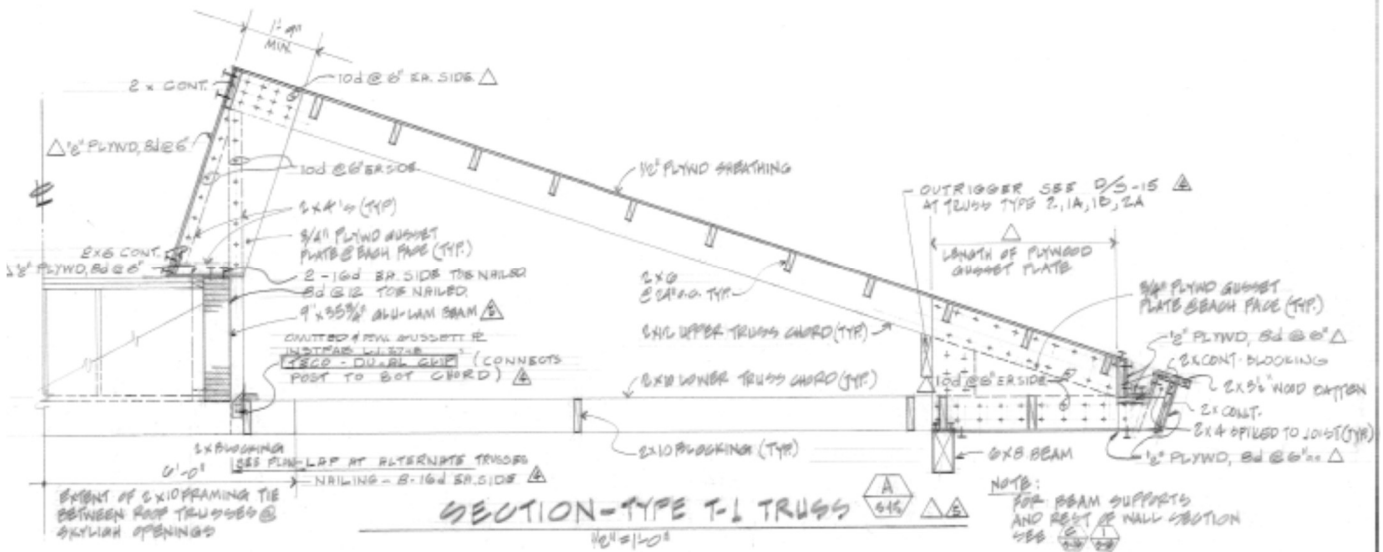
Typical roof truss (original construction)

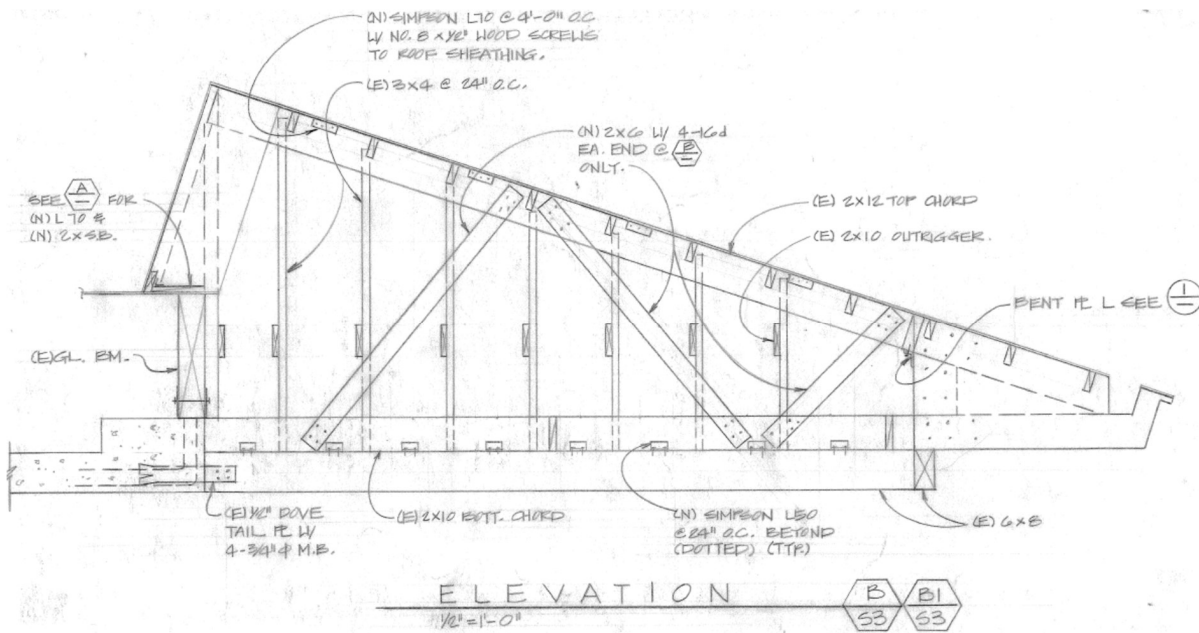
Roof truss at east-west walls with added diagonals to improve connection to precast piers (1988 seismic strengthening)

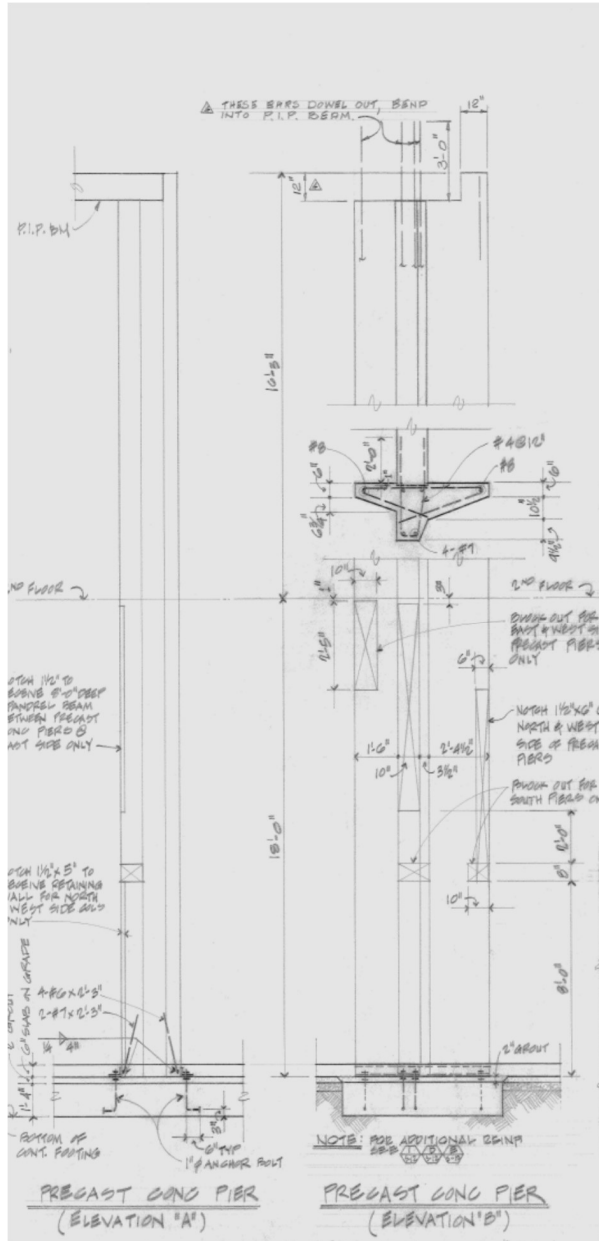
Precast pier elevation

- Nonductile force path from roof to walls, with weak point being lightly reinforcement precast pier in shear.

We recommend a Tier 2 evaluation of connection of the roof diaphragm to the concrete walls, and of the adequacy of the precast concrete piers.

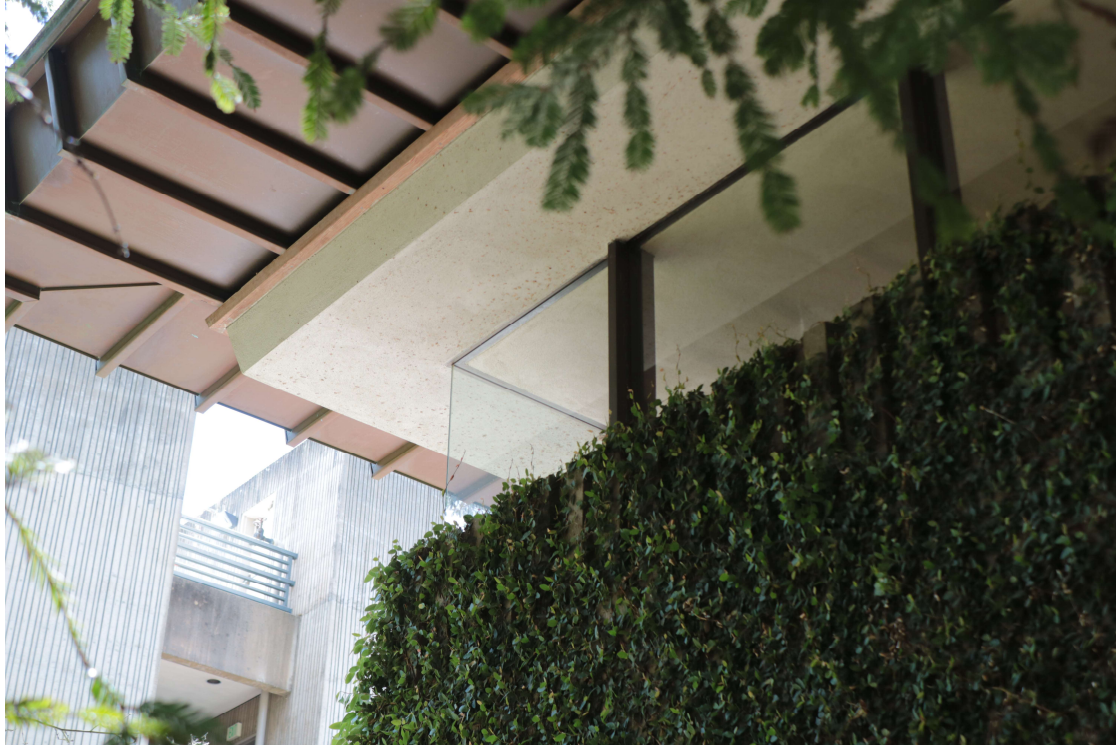
Roof – clerestory window with steel tubes supporting a perimeter 6x8 wood beam that supports the roof

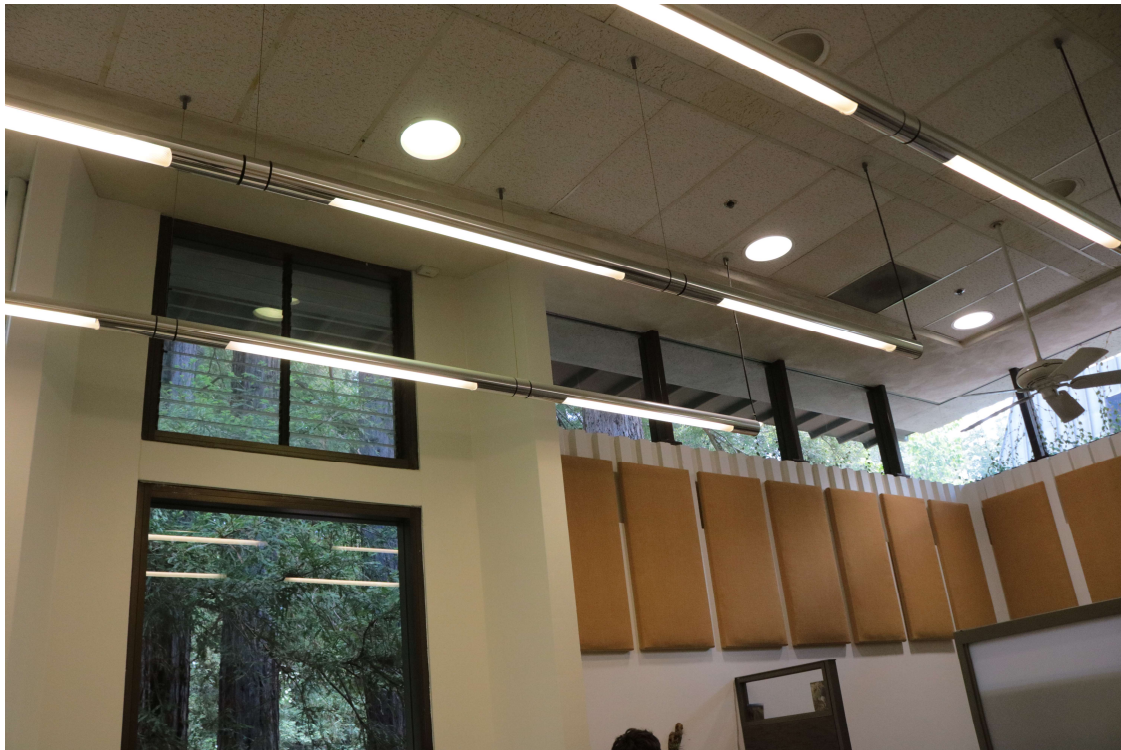
Building interior – precast piers and clerestory windows

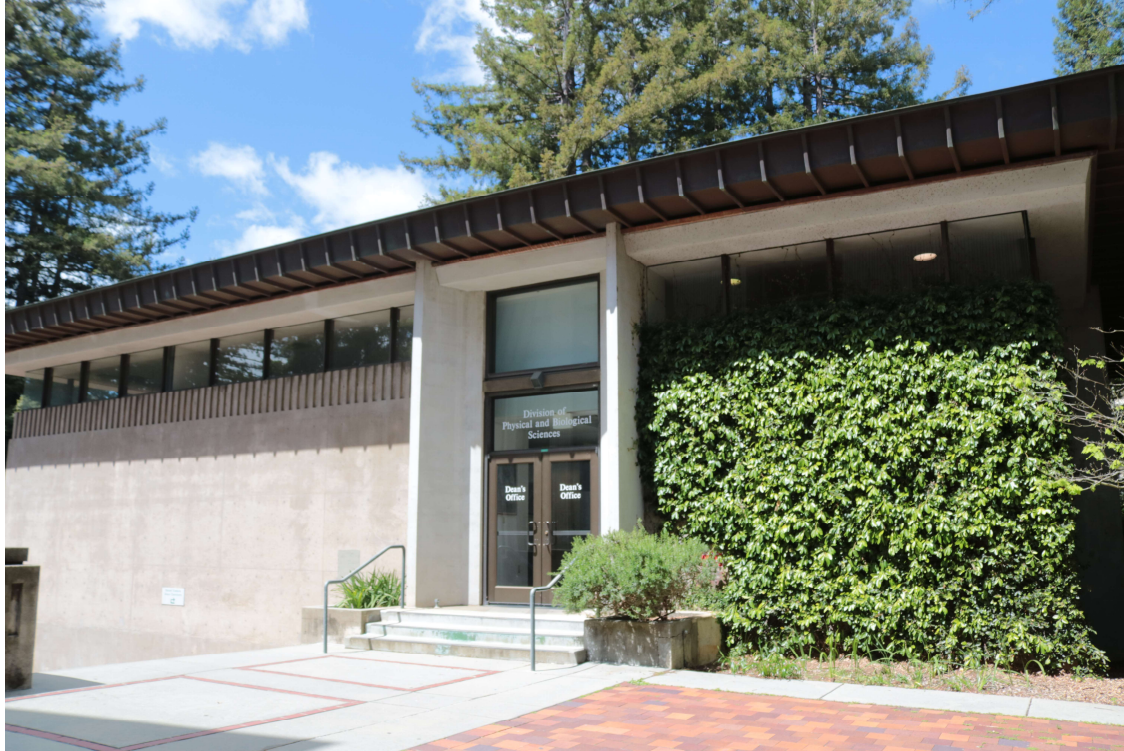
Main entry at Level 2, looking west

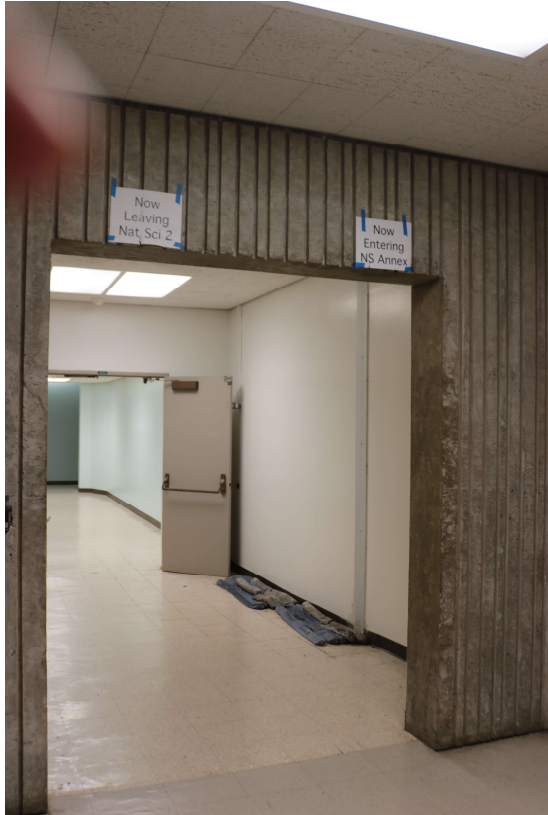
Below-grade tunnel from Natural Science Building to Natural Science Annex, looking west
