Rating form  
completed by:**RUTHERFORD + CHEKENE**  
ruthchek.com

DATE: 2019-07-29

**UC Santa Cruz building seismic ratings**  
**MT Hamilton Dorm #1**

CAAN #7213

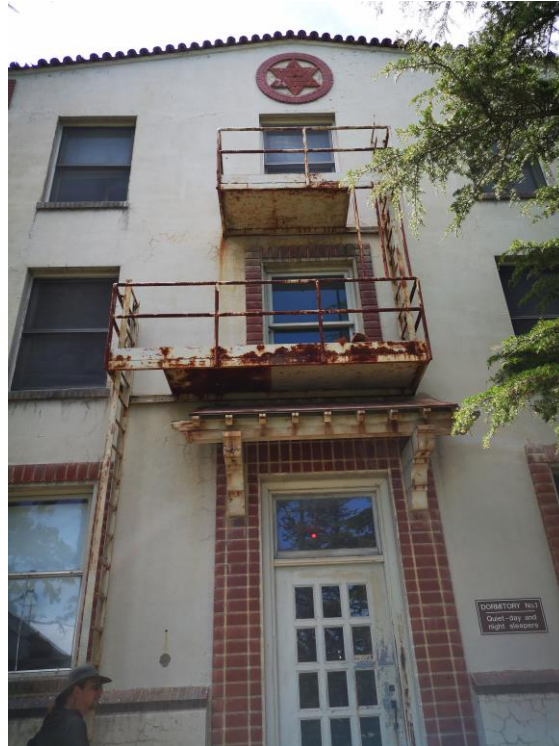
The structural integrity of the exit structure and its connection to the structure and the retaining walls are not clear. Since it connects to the third floor which is still in use as students' dorm rooms, it may become an exit route during an extreme event. The deteriorated second floor balcony landings are a significant falling hazard. Loose tiles on the roof are a falling hazard especially when over the exit routes. In addition, the fire escape on the east side is heavily corroded.

Partial East Elevation (Looking West).  
Note Corrosion on the East Fire Escape

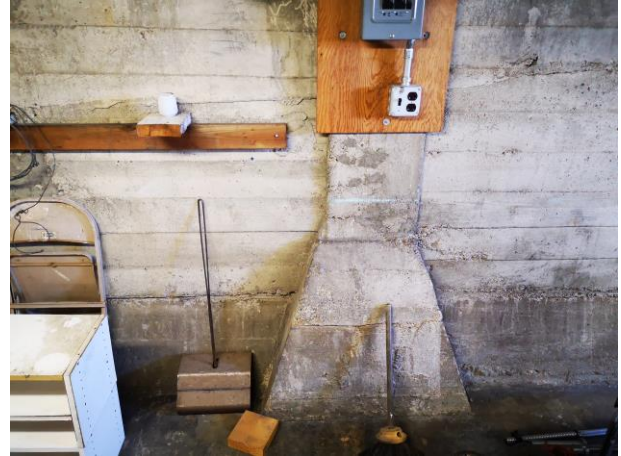
Tapered Column End in Basement

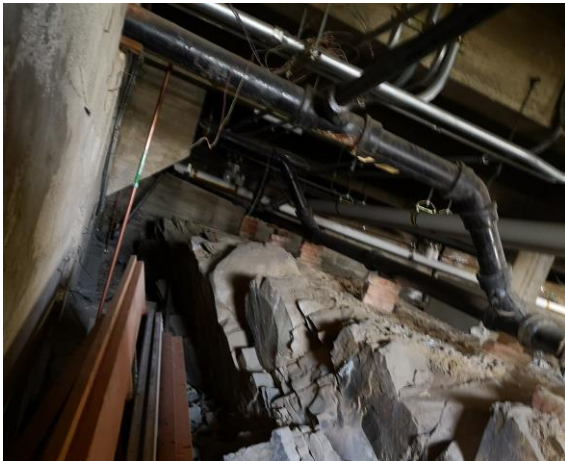
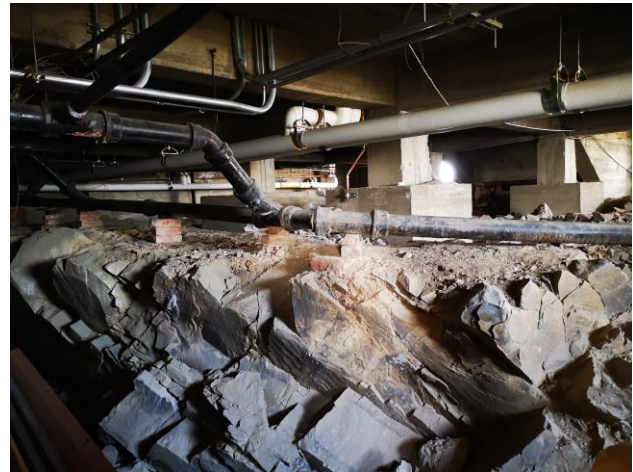
Crawl Space

Left Image: Basement Wall on the Left;  
Right: Spread Footings under Columns Founded on Native Fractured Rock

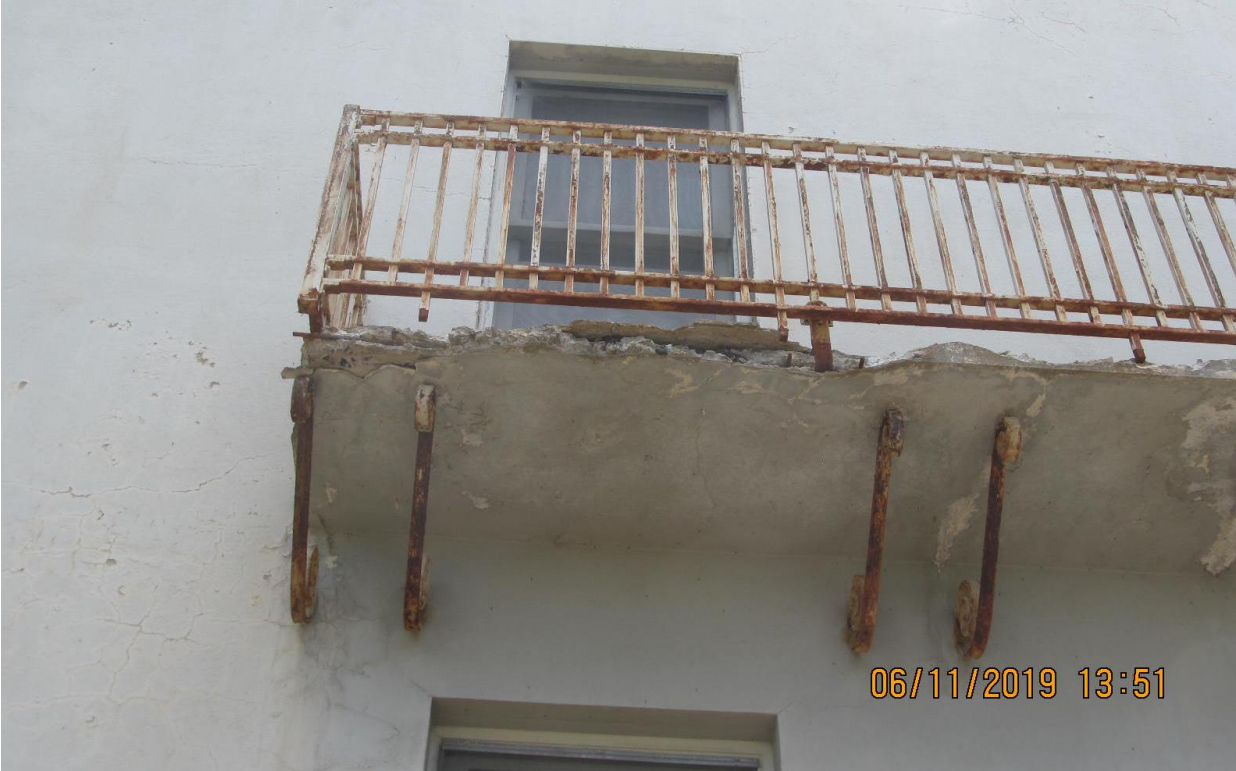
**Building condition:** Exterior walls are covered in stucco. Paint is peeling, and there is some limited, mostly hairline cracking. However, two concrete balconies at the second floor are severely deteriorated with rusted railings, spalled concrete landings, and exposed, rusted rebar in the landings. The third floor is used as the dorm rooms for students; the second floor is abandoned; the first floor is occupied by the university staff; the basement is used as storage room. Stairs in the building are accessible to all levels. Fire exit stairs outside the east elevation of the building show signs of substantial corrosion. The plaster decorations on the exterior wall and the brick ornament around the windows appears stable, but how they are anchored back to the building is unknown. Loose roof tiles were seen at the roof perimeter; the facility coordinator for the site indicated that the tiles contain wire ties to the roof, but the wires are corroding.

- Badly deteriorated balconies are falling hazard for passerby and potentially unsafe for use. Even though the second floor, where the balconies are located, is abandoned, the stairs inside the building can access all levels including the second floor.

Spalling and Corrosion at North Balcony

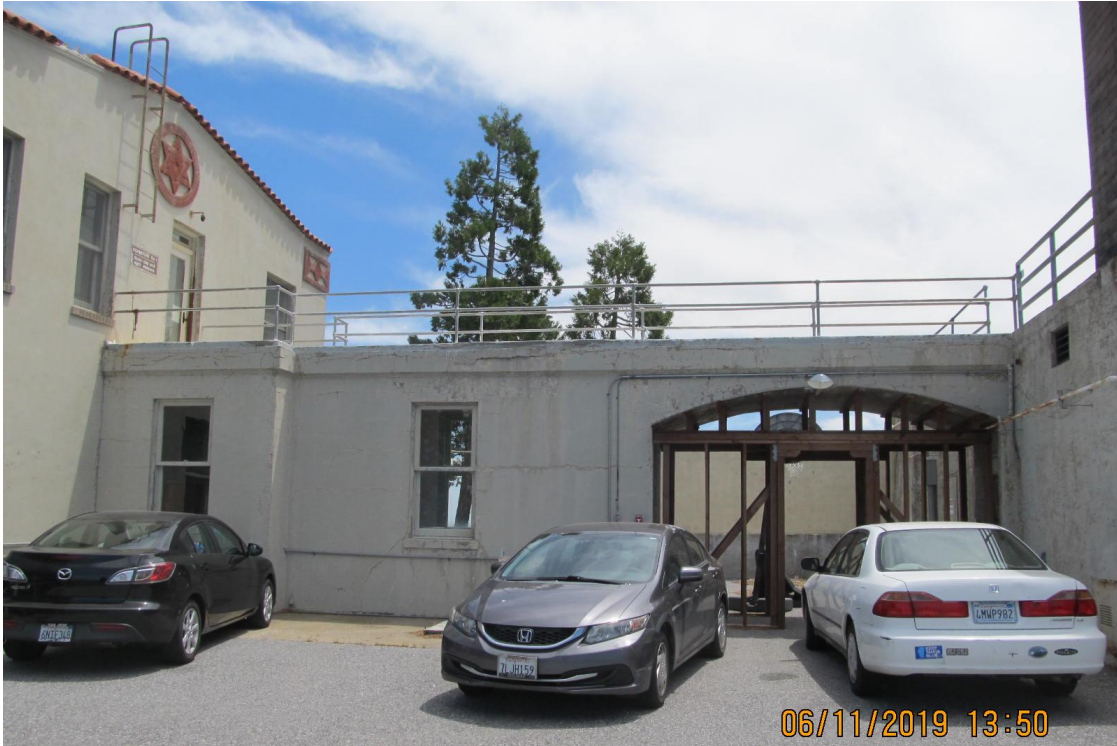
- There is no seismic separation at the exit structure to the retaining wall on the west side. When the dormitory and connected exit structure moves away from the retaining wall as the exit structure, the west end of the arched opening may lose vertical support from the retaining wall. Wood shoring has been installed as a backup vertical load-carrying support path.

Exit Structure North Elevation (Looking South)

- We recommend that the campus perform a Tier 2 evaluation to review the adequacy of the connection of the concrete diaphragm to the concrete shear wall and the exit structure, including selective field investigation to determine reinforcing details at the diaphragm-to-wall interface.
- We recommend the second floor balconies to be removed or repaired in the near future to limit continued spalling and propagation of corrosion into the main structure. The corrosion at the east fire escape should be reviewed to determine if the escape is safe to use.
- The wood shoring at the west end of exit structure should remain in place until an adequate seismic separation and independent vertical load-carrying support system is installed.

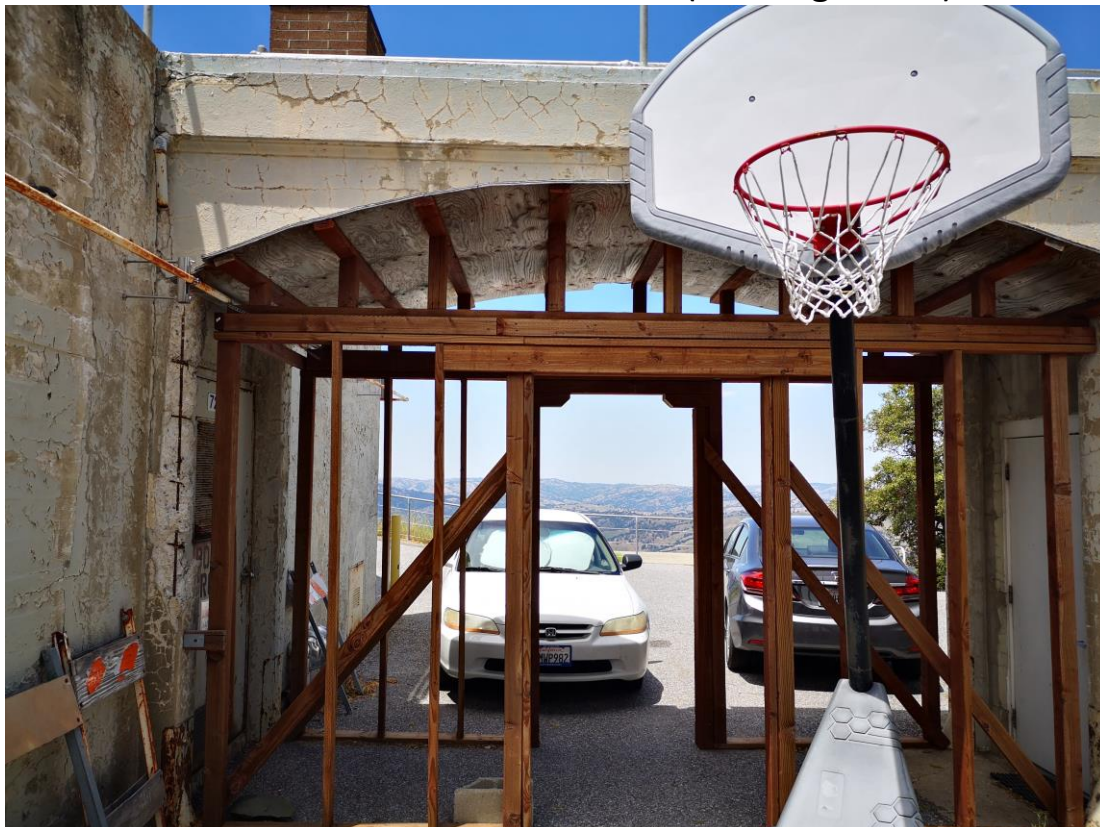
Exit Structure South Elevation (Looking North)
