UC Santa Cruz building seismic ratings
Mt. Hamilton Garage – Res #6

CAAN #7232

7281 Mt. Hamilton Road, Santa Cruz, CA 95140

UCSC Campus: Mt. Hamilton

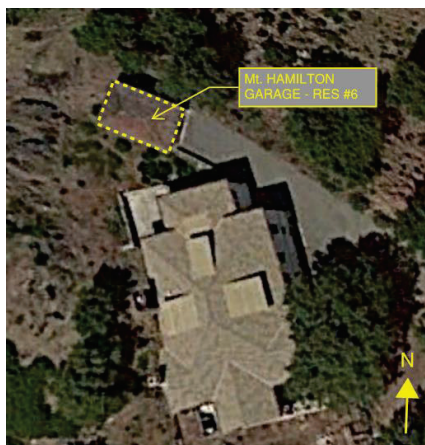
Plan

The structure utilizes the exterior sheathed walls as the primary lateral force-resisting system. A large garage door opening located on one exterior wall creates a "C"-shaped lateral system. As such, the building is torsionally irregular.

- The Mt. Hamilton Garage is torsionally irregular. It contains solid exterior walls on three sides; however, a large door opening is located on the east elevation which creates a "C"-shaped lateral force-resisting system.

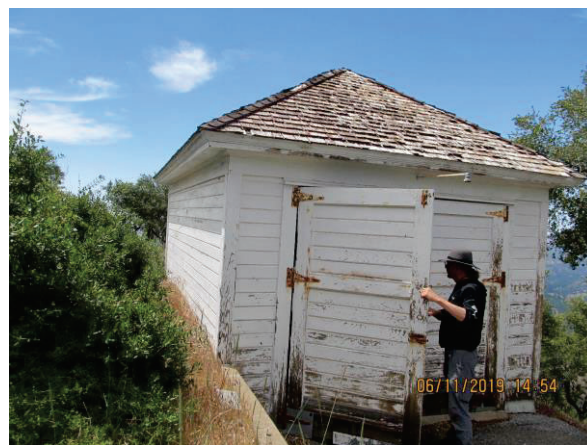
East Elevation (Looking Northwest)

The roof diaphragm is comprised of wood shingles over straight wood sheathing. The walls are horizontal wood siding over building paper and diagonal sheathing with two full-height let-in braces on the inside of each of the walls. The shingles are moderately deteriorated, and the siding paint is peeling. From the interior, the rafters and the studs appear to be in good condition.

No further analysis is required.

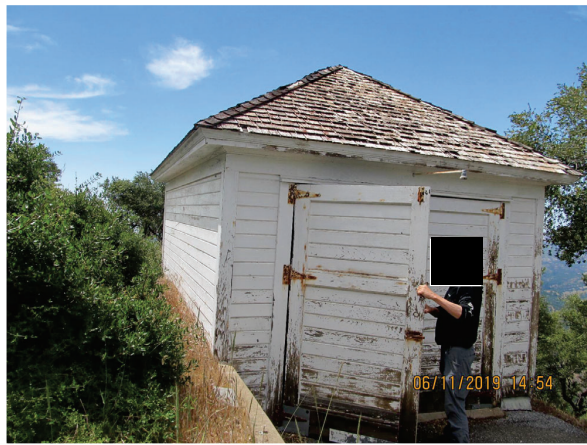
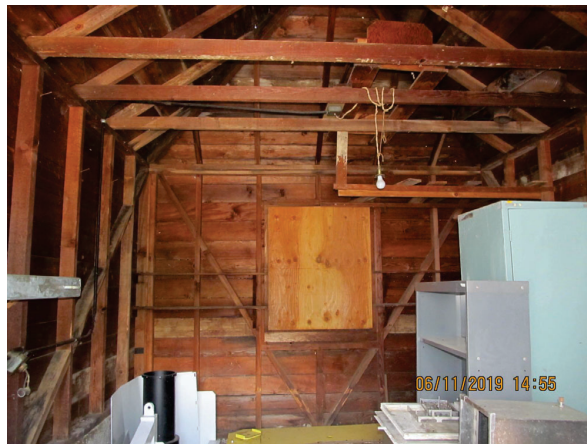
1. Roof diaphragm is wood shingles over straight sheathing. Walls are horizontal wood siding over building paper over horizontal sheathing with two full height let-in braces on inside of each of the walls except the garage opening on the east side. Shingles are moderately deteriorated and siding paint is peeling, but interior rafters and studs are in good condition.
