DATE: 2019-06-28

**UC Santa Cruz building seismic ratings****MT Hamilton Main Building**

CAAN #7240

UCSC Campus: **Mt Hamilton Campus**

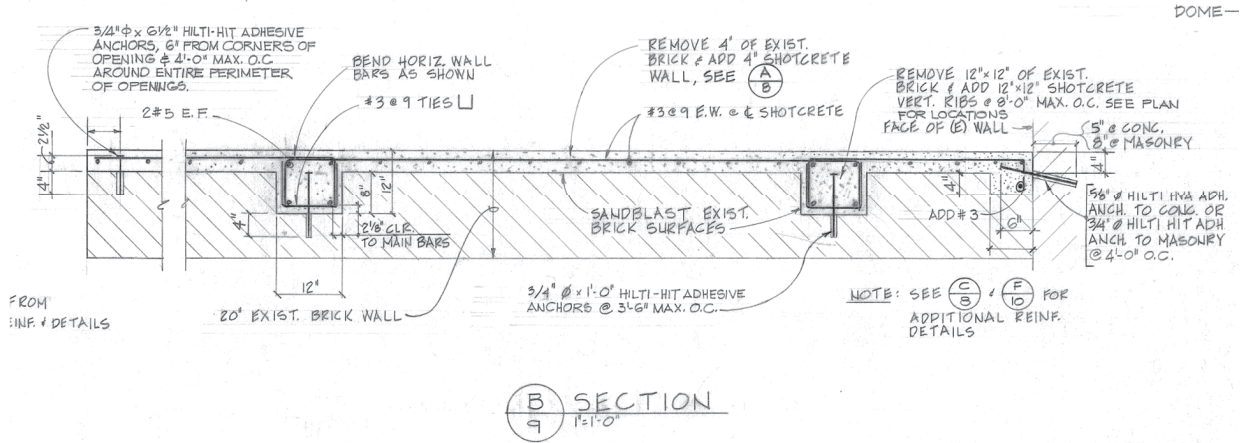
### Typical Shotcrete Strengthening and North and South Halls

- The unretrofitted URM walls in the halls have insufficient in-plane shear capacity. Per the Quick Check evaluation, they have a peak D/C ratio of nearly 3.

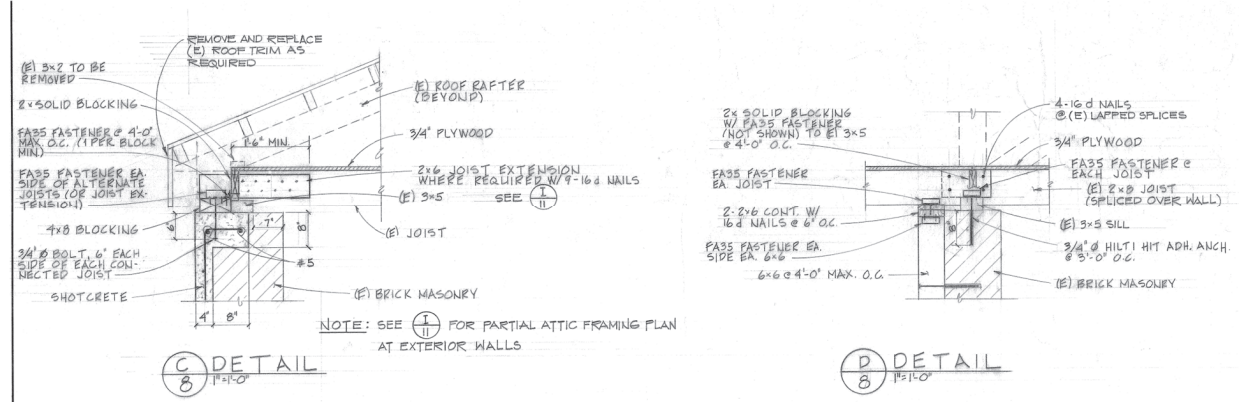
### Typical Attic Floor to Wall Connections (Left: Exterior Walls; Right: Interior Walls)

- The connection between the perimeter walls and attic joists has insufficient capacity for out-of-plane loads.
- The anchors between the shotcrete and brick at the exterior walls have only 4" embedment into the brick, so the ability of the shotcrete to serve effectively as resistance for out-of-plane bracing or compositely for in-plane loading is potentially limited. Similarly, the anchor between the wood strong backs and interior brick walls has 8" embedment, so it does not reach the far wythe in the 13" thick three-wythe walls.

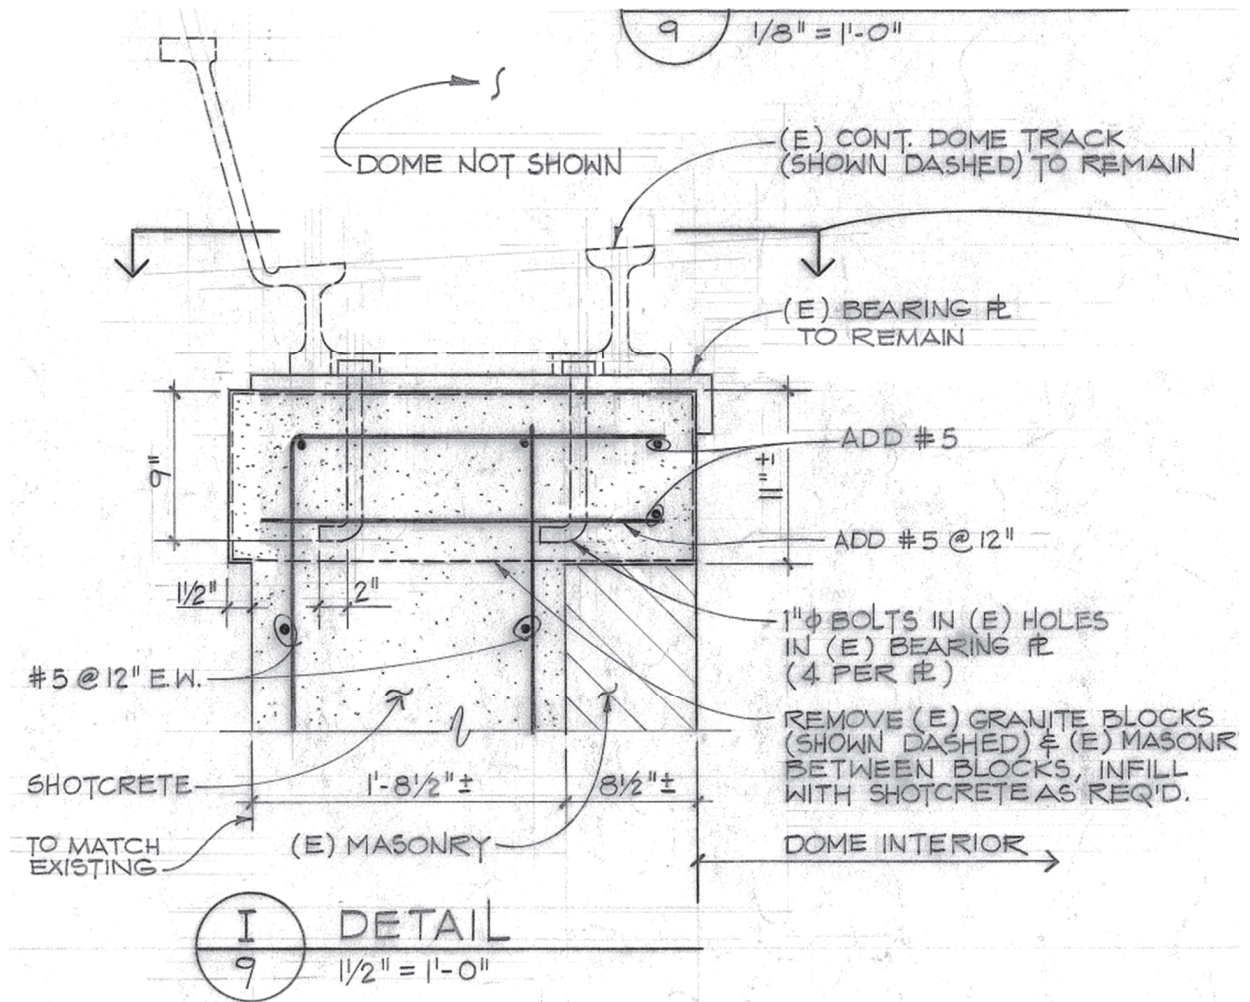
### Bond Beam at Top of the South Dome Retrofit Supporting Track for Roller Trucks)

- The top of the South Dome was capped with an 11" deep bond beam running across the full 29" width of the wall, but it does not have ties confining it, so it cannot act reliably as a beam to resist out-of-plane loads at the top of the wall including those imparted by the dome. At the North Dome, no bond beam was installed; the 4" shotcrete simply continues up to the top of the wall.

A Seismic Performance Level rating of V is assigned to the building. While the 1989 seismic retrofit was comprehensive, the Tier 1 evaluation found that the connections between walls and diaphragms in the central portion of the building do not have adequate capacity to resist out-of-plane wall demands, the central unreinforced N-S longitudinal URM wall line is overstressed for in-plane loads, the unreinforced transverse E-W URM walls are significantly overstressed for in-plane loads, anchorage of the drilled dowels between the shotcrete and brick is relatively shallow and may not be fully effective in helping brace the brick walls for out-of-plane action or work compositely to resist in-plane loads, and the top of circular wall supporting the domes may have limited ability to resist out-of-plane loading due to a lack of a significant tension ring or bond beam.

We recommend a Tier 3 linear evaluation of the building. In-plane tests of the existing brick mortar and a closer examination of the current collar joint condition should be performed to determine the URM capacity in order to have a more refined and less conservative estimate of the in-plane capacity of the walls, diaphragm capacity, out-of-plane capacity of the URM wall strengthening, and the ability of the circular walls to support out-of-plane loading.

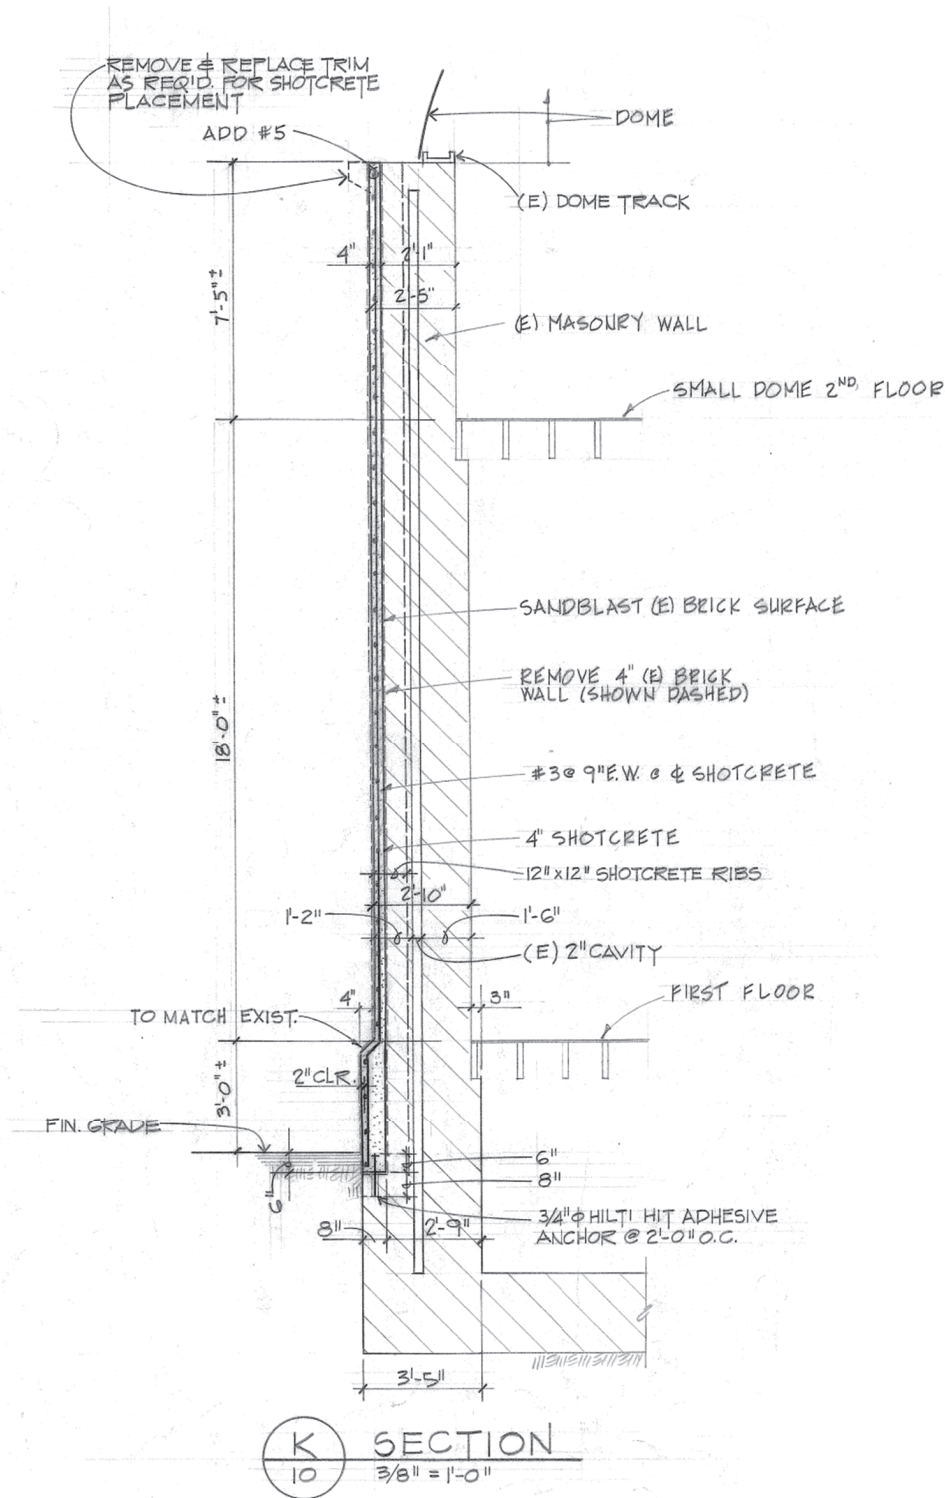
### North Dome

- The ability of the steel dome to act as a diaphragm at the top of the circular walls is questionable.
- There is a 2" cavity shown inside the North Dome URM wall between the inner and the outer wythes. The retrofit provided anchors only every 8'0" o.c. at ribs to cross this joint. Height-to-thickness ratios are high, and because of the cavity, even though the outer wythes are reinforced with shotcrete, the inner wythes may act independently and be damaged or fall from out-of-plane and in-plane forces.

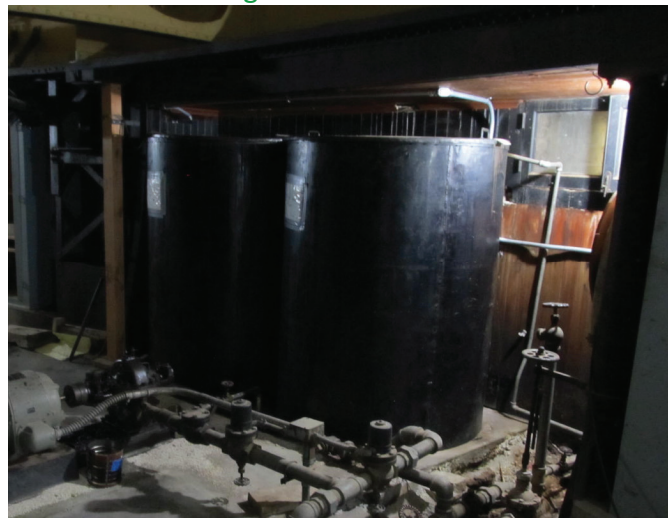
The south dome is movable and is controlled by hydraulic pressure. The container for the liquid used in this hydraulic system were found not braced.

Oil Container Not Braced in the South Dome
