DATE: 2019-06-28

UC Santa Cruz Building Seismic Ratings
The 120-inch Telescope

CAAN #7276
7281 Mt Hamilton Rd, Mt Hamilton, CA 95140
UCSC Campus: Mt. Hamilton

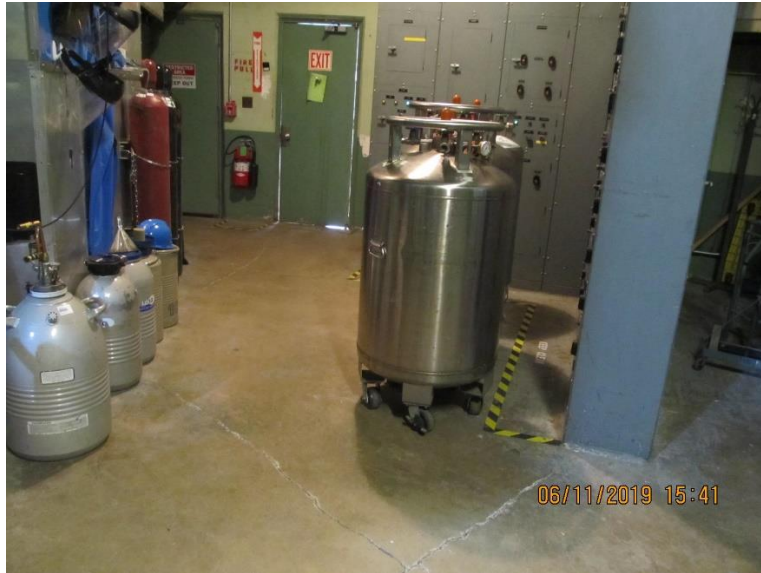
We did not observe any falling hazards that pose a life-safety concern. Review of the telescope assembly is outside the scope of the Tier 1 assessment. Generally, chemical tanks in the first floor service area were restrained, but we did observe liquid nitrogen tanks that are unrestrained. Any hazardous materials should be properly restrained.

Unbraced liquid Nitrogen tanks in service area at first floor

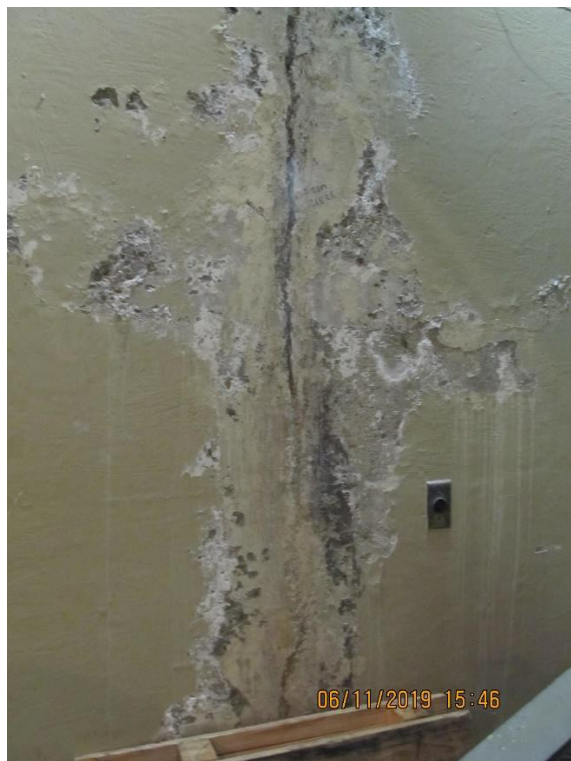
Building condition: Structure is in relatively good condition. There is peeling paint and rust on the outside of the dome. Efflorescence and cracking were observed in the interior of the lowest story walls.

Crack and efflorescence located in light tunnel

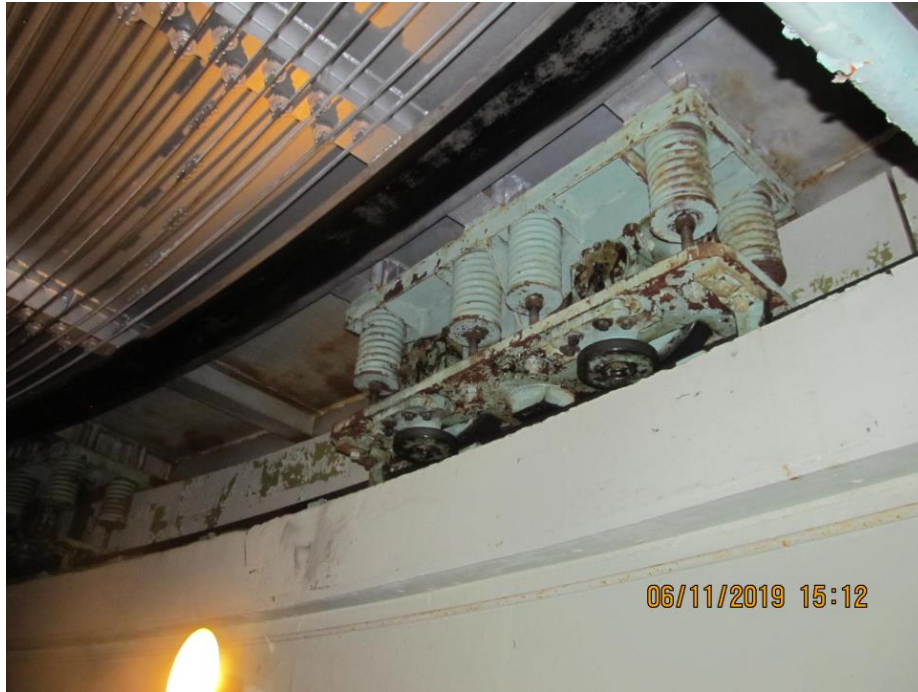
We assign a Seismic Performance Level rating of IV to this building because no major seismic deficiencies were identified in the ASCE 41-17 Tier 1 evaluation process, and we judge the structure to have adequate capacity to resist in-plane loads. If there is out-of-plane separation at the dome-to-wall interface, loss of vertical support appears unlikely due to the geometry of the base of the dome.

Roller trucks supporting the dome
