UC Santa Cruz building seismic ratings
Theater Arts E Classroom

CAAN #7315
 459 Kerr Road, Santa Cruz, CA 95064
 UCSC Campus: Main Campus

DATE: 2019-06-30

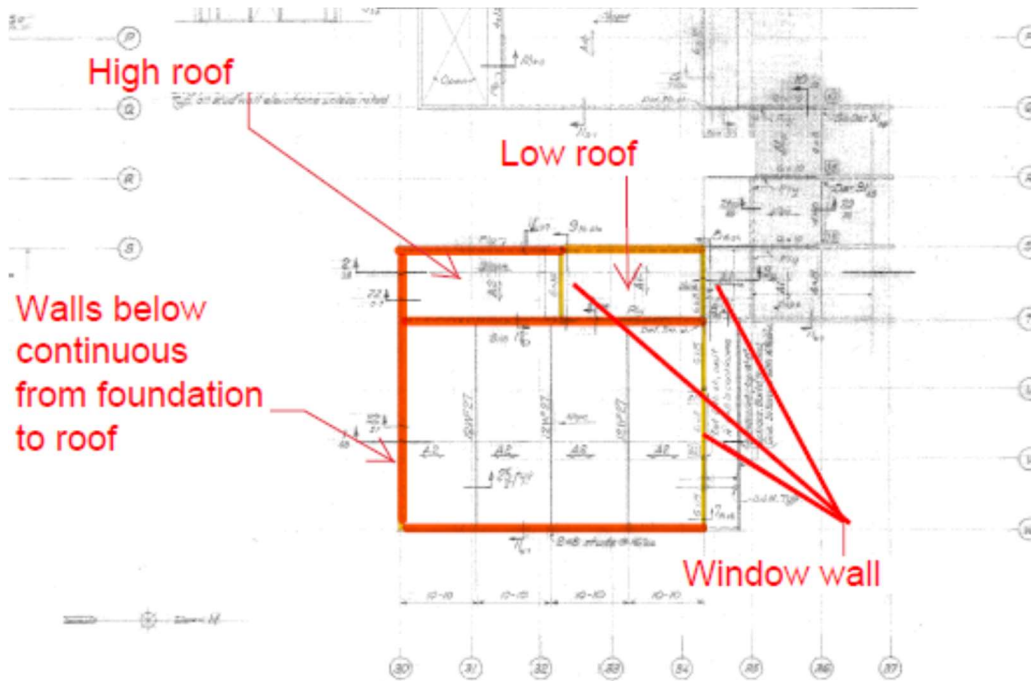
Annotated plan (roof shown)

- The roof has only one line of shear walls in the east-west (transverse) direction. This results in plan torsion at the roof, but the roof diaphragm is a flexible diaphragm and cannot accommodate torsion.

The rating of V (Poor) is because of the potential life safety hazard of the heavy exterior walkway, as well as the lack of a seismic-force path at the high roof.

We recommend that the Campus perform a more detailed review of the 3-sided support at the roof. This should be investigated further in a Tier 2 analysis. The campus should also check the condition of the exterior walkway and provide separation joints between buildings. We put the building on Priority Category A, because the walkway modifications should be done as soon as possible.

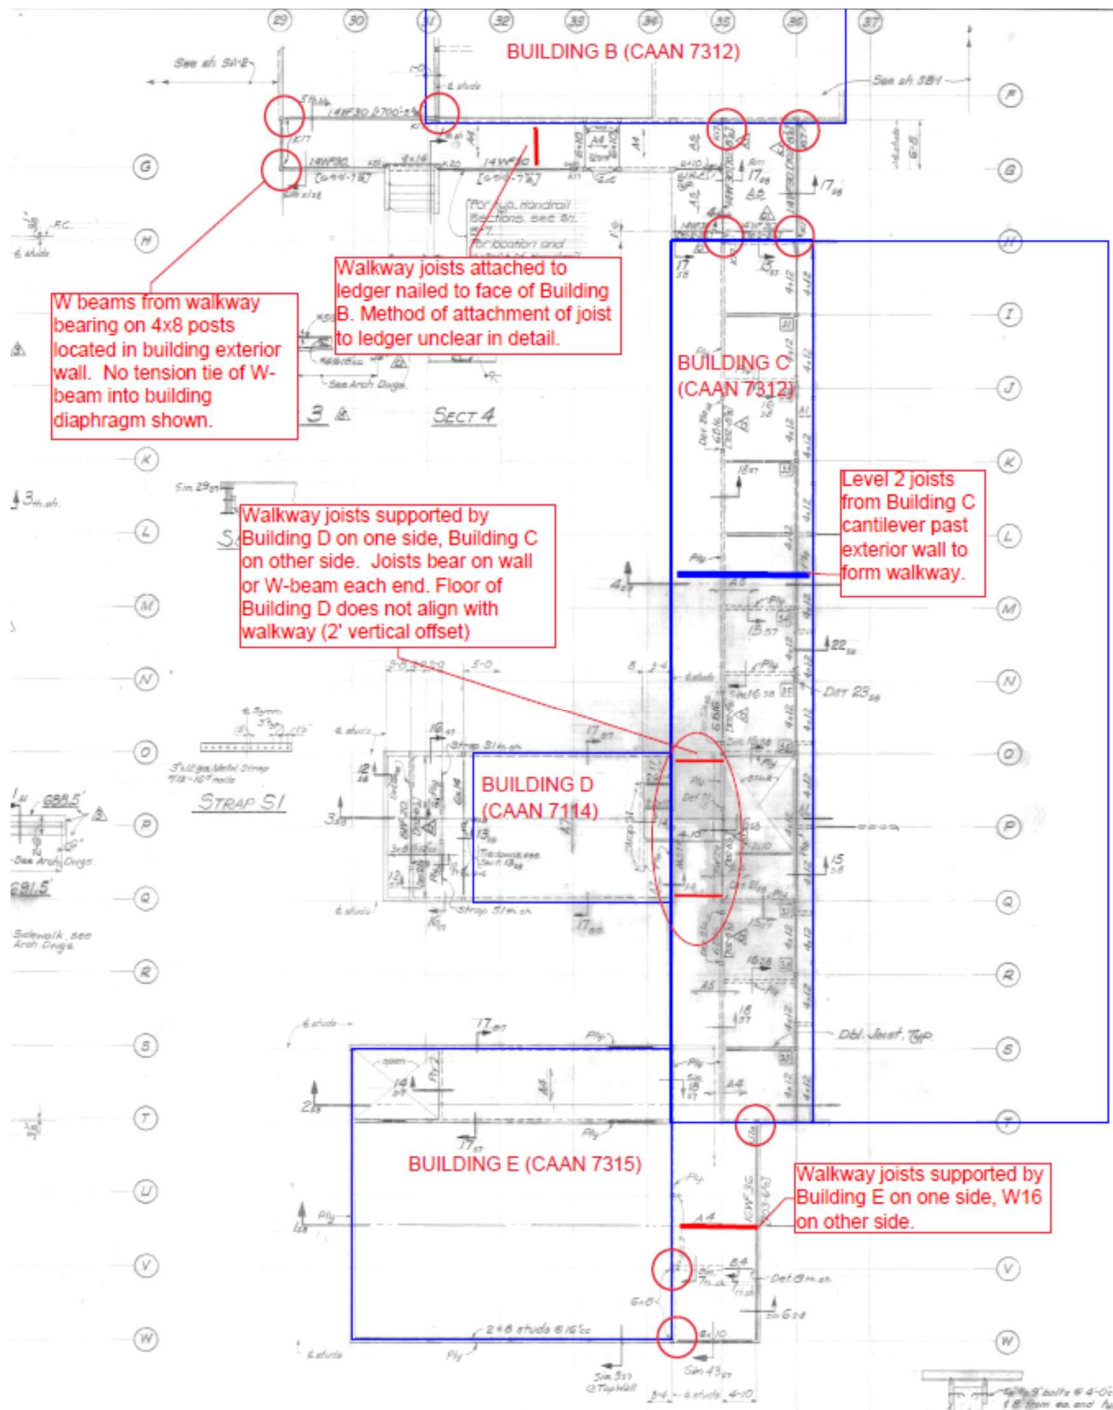
Plan at walkway:

- At this building, the walkway joists are supported at one end on a ledger attached to the exterior wall of the building, and at the other end by steel W-beams that are supported by a post located in the wall of Building D (CAAN 7314). Differential movements between Building D and this building could cause the walkway joists to lose their support.

- Locations where walkway W-beams are supported on posts located within building exterior walls shown:

- Locations where walkway joists are attached to ledger nailed to face of building exterior wall shown:

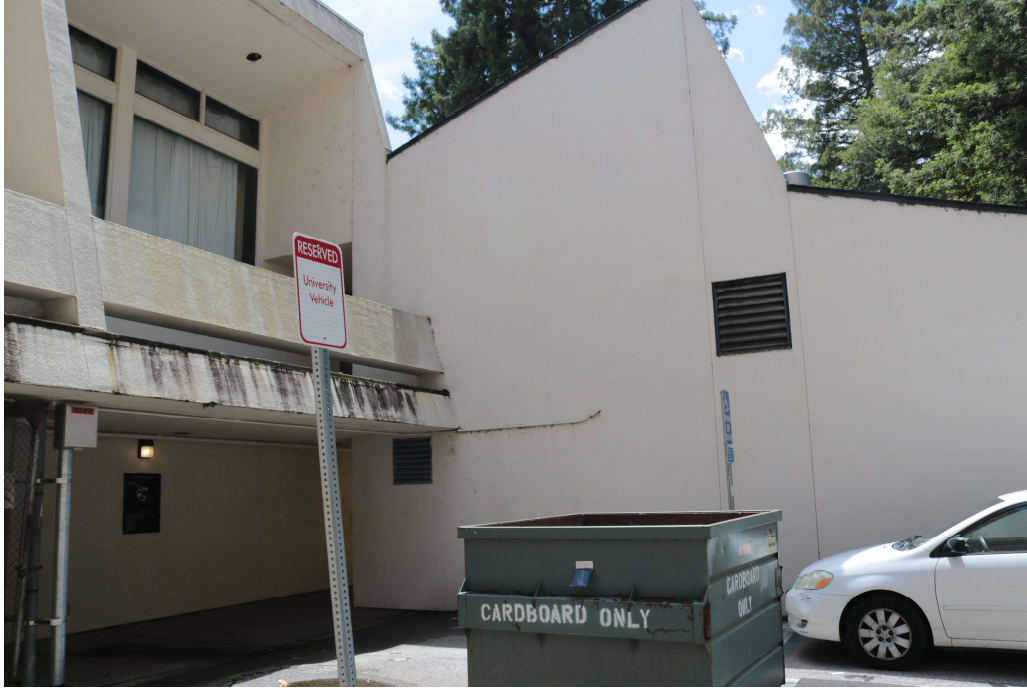
- The Level 2 exterior walkway connects five buildings – CAAN 7311, 7312, 7313, 7314, and 7315. There are no seismic separations in the walkway between buildings, and differential movement between the buildings could cause damage in the walkway.

North elevation, showing walkway connection between Building D (CAAN 7314) and Building E (CAAN 7315)
