MAFFEI STRUCTURAL ENGINEERING
 maffei-structure.com
 Noelle Yuen, Joe Maffei

UC Santa Cruz building seismic ratings
Theater Arts H 2nd Stage

CAAN #7318
 451 Kerr Road, Santa Cruz, CA 95064
 UCSC Campus: Main Campus

DATE: 2019-06-30

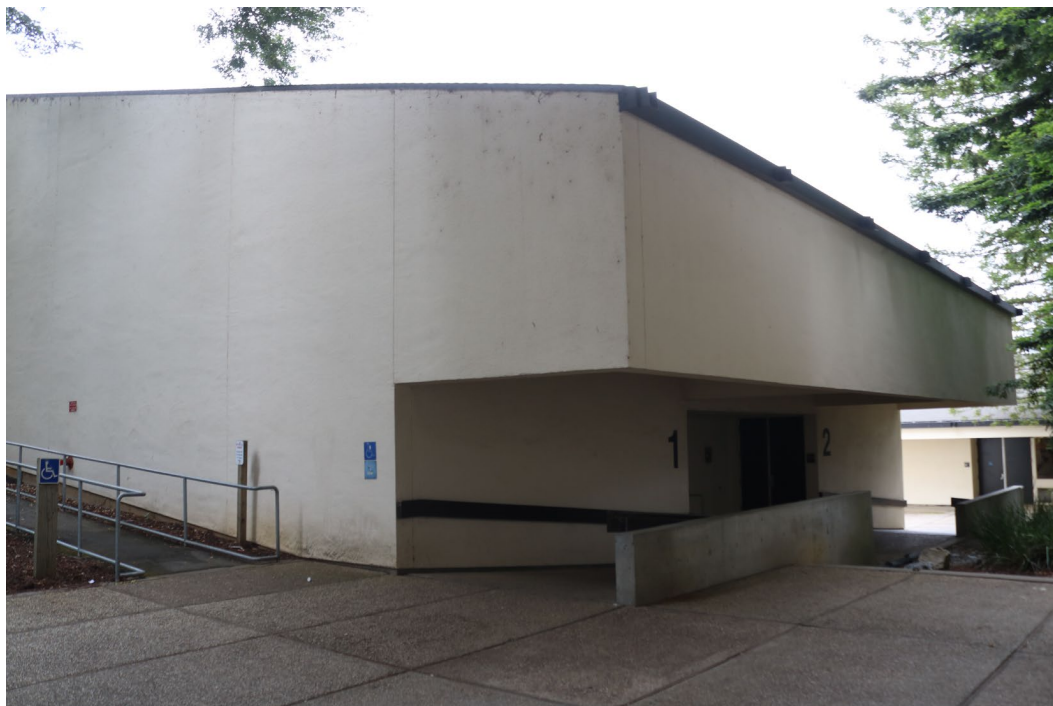
Entry looking south

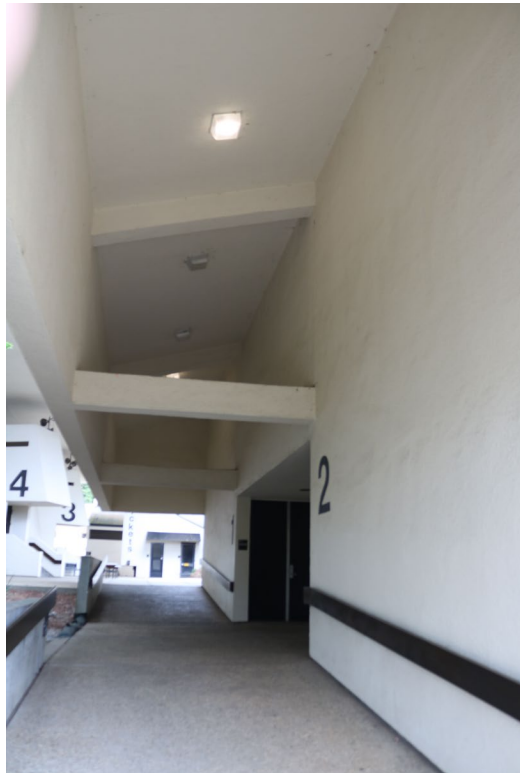
Entry looking north

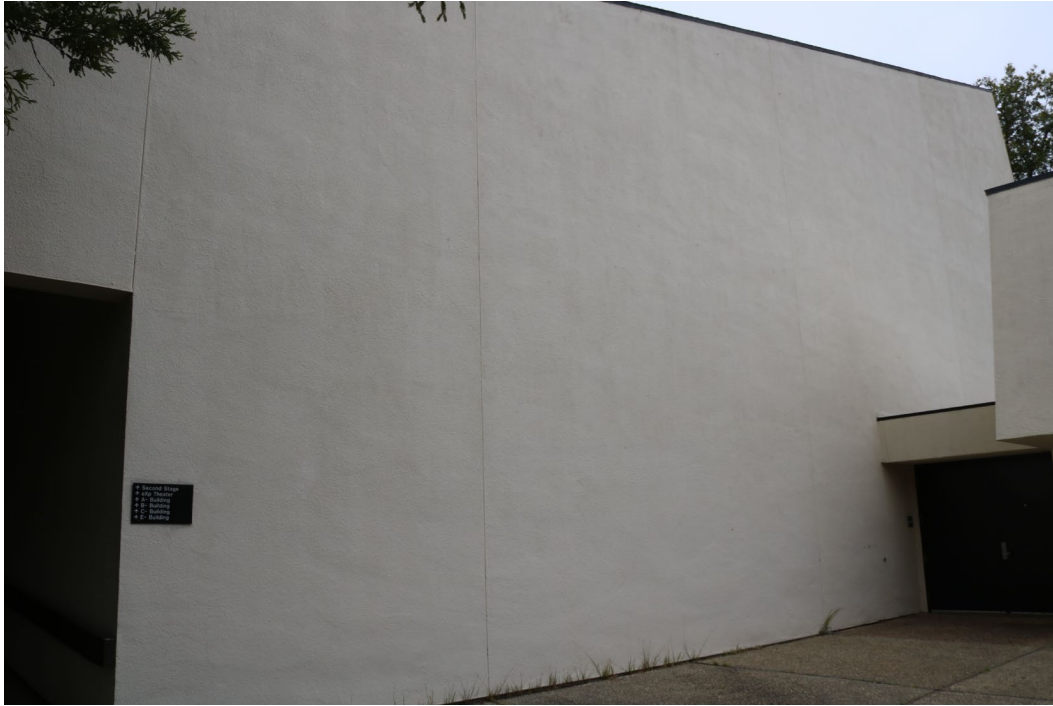
- A corridor structure is attached to the south side of this building and provides access to the 2nd Stage Annex building (CAAN 7319). The corridor structure is one-story tall. Roof joists in the corridor structure span north-south, connected at one end to the wall of the 2nd Stage building and at the other end to the wall of the 2nd Stage Annex building, with no seismic separation joints at either end. The elevation of the corridor roof does not line up with the elevation of the floor of the adjoining buildings. Differential movement of the 2nd Stage and 2nd Stage Annex building in the north-south direction may result in pulling the roof joists away from their supports, creating a falling hazard.

South elevation showing corridor

We recommend that the Campus perform a more detailed review of the connection of the corridor structure and consider providing separation joints in the corridor roof between buildings. A Tier 2 evaluation for the building should focus on the adequacy of the roof diaphragm at the overhang over the entry at the east side of the building and whether hold-downs are required at the transverse (north-south) walls at gridlines U and V at Level 2.

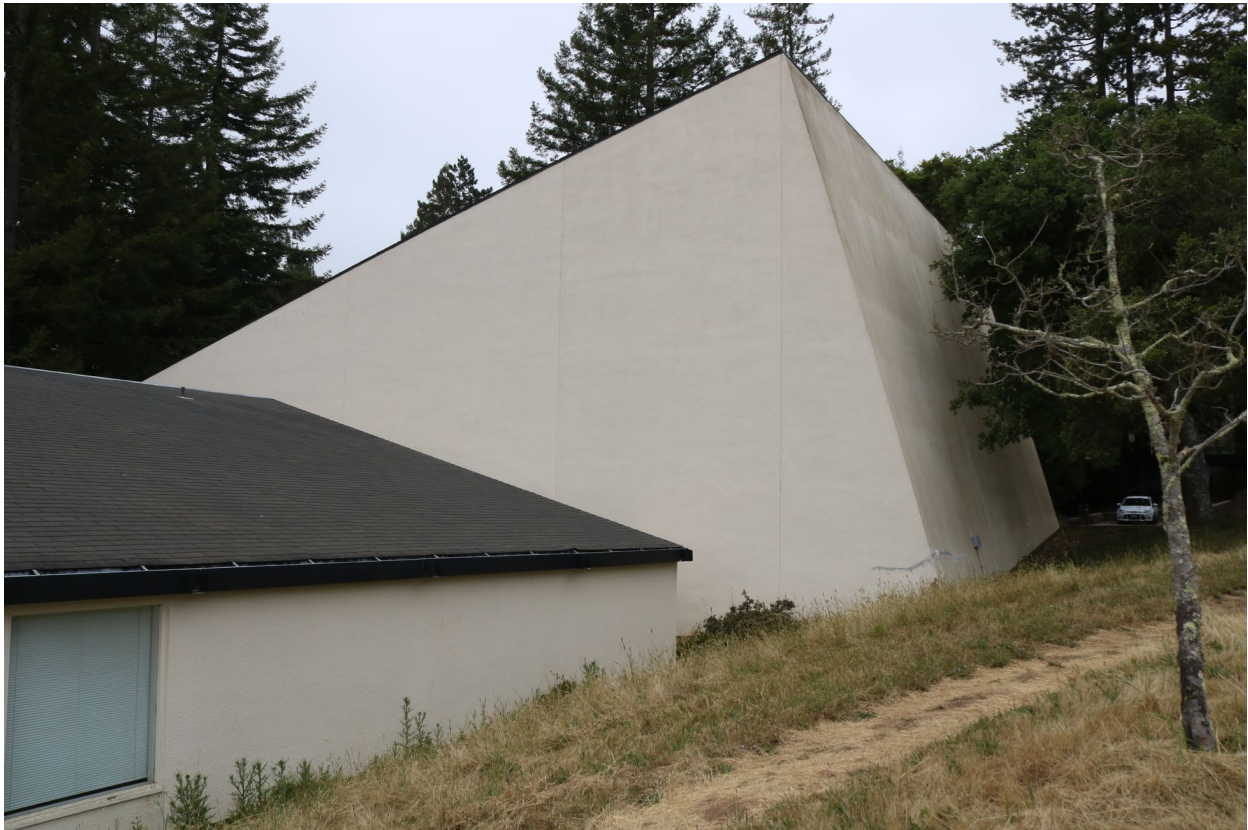
Back of building, looking north
