UC Santa Cruz building seismic ratings
Theater Arts J Offices Building

CAAN #7320
 445 Kerr Road, Santa Cruz, CA 95064
 UCSC Campus: Main Campus

DATE: 2019-06-30

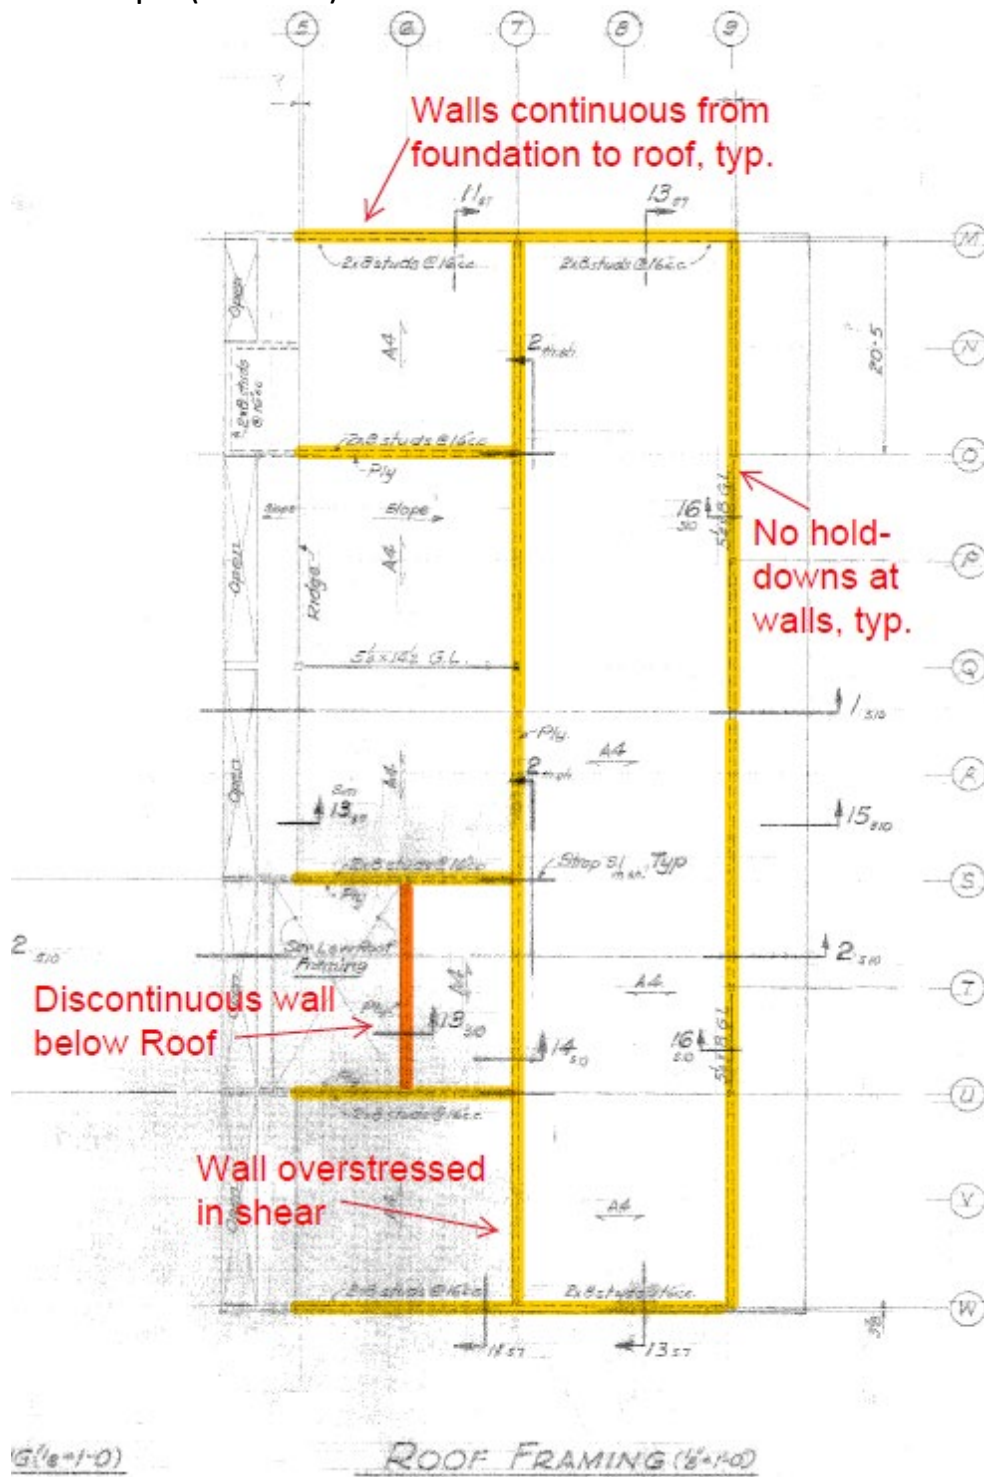
Annotated plan (Roof shown)

demand equally may not be valid. We did a spot check using flexible diaphragm assumptions, and found that the wall on gridline 7 has a DCR of $1.5 > 1.0$.

The rating of V (Poor) is due to the high shear demand on the center east-west wall at the gridline 7, which has no tie-downs.

We recommend that the Campus perform a more detailed review of the adequacy of the plywood sheathed walls for both shear capacity and hold-down connections. A Tier 2 evaluation may allow the rating to be raised to IV (Fair).
