Rating form  
completed by:
**MAFFEI STRUCTURAL ENGINEERING**  
 maffei-structure.com  
 Noelle Yuen, Joe Maffei
Text in **green** is to be part of UC Santa Cruz building database and may be part of UCOP database
**UC Santa Cruz building seismic ratings**  
**Theater Arts Foundry Building**

CAAN #7405

410 Foundry Road, Santa Cruz, CA 95064

DATE: 2019-06-30

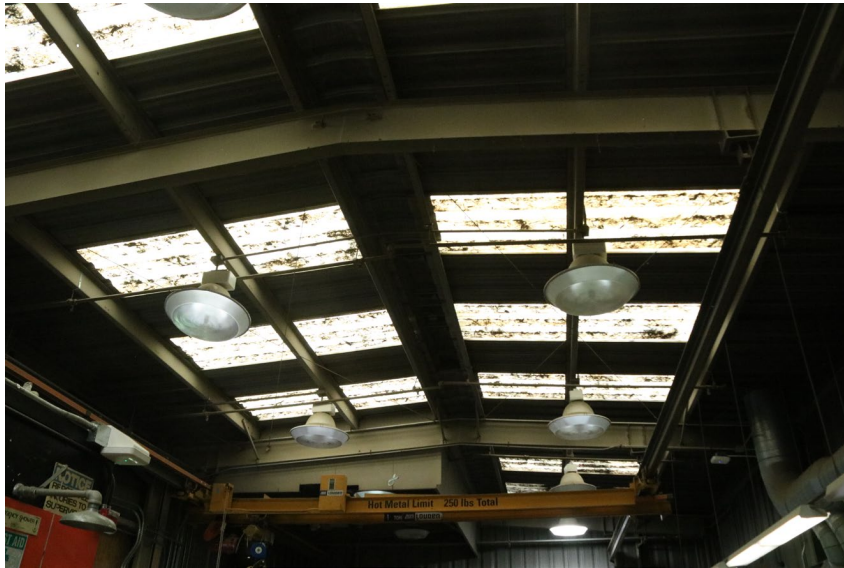
**Moment frame at roof**

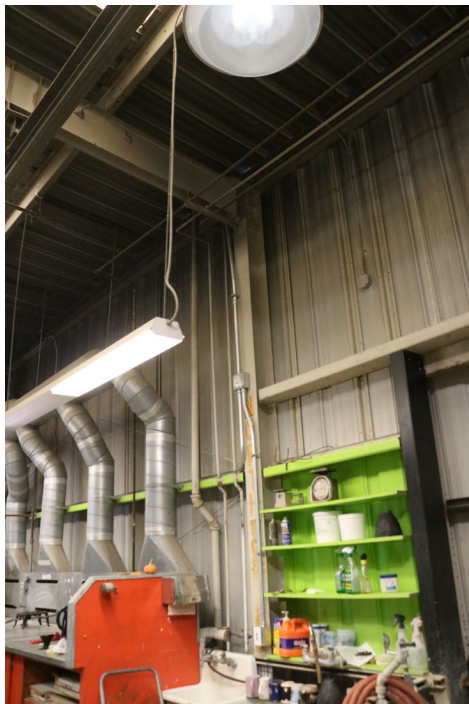
Structural system for lateral forces: The structure is a Butler Building with steel moment frames in the transverse direction and metal panels in the longitudinal direction. The moment frame column is a W8 shape, the moment frame beam appears to be a W10 or W12. The metal wall panels are attached to an edge beam at the roof, to horizontal girts at third points along the height of the wall, and to an angle at the bottom of the wall that is attached to the slab on grade. Fasteners are visible at joints in the metal panel at approximately 12" o.c. Our visual inspection found that the moment frames appeared in good condition but the metal wall panels were rusted and water-damaged.

**Moment frame beam-column joint, metal wall panels**

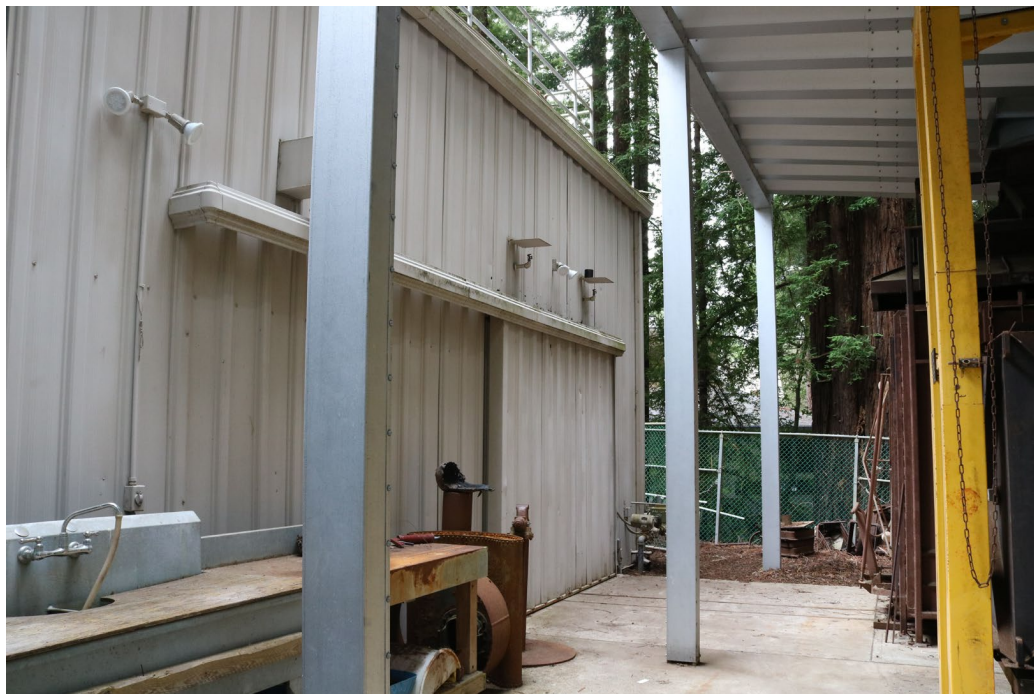
**West wall**

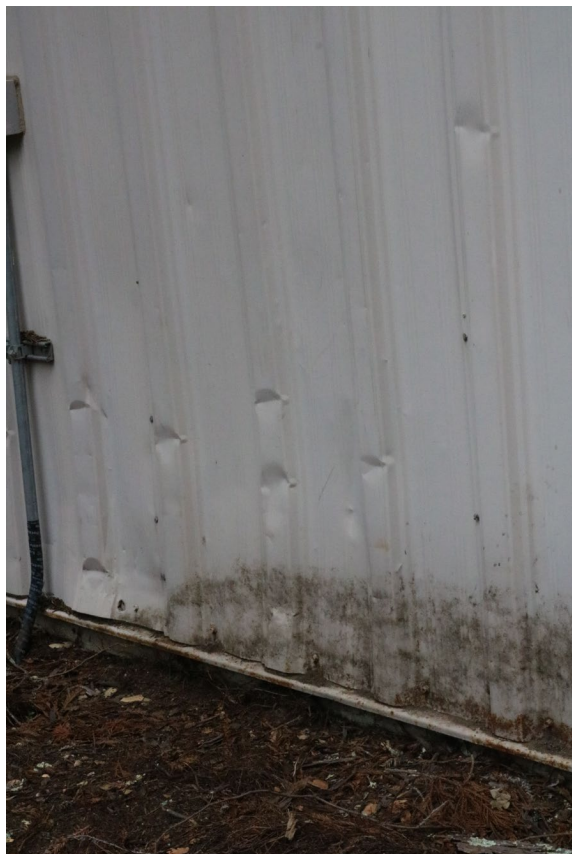
- The metal paneling on the exterior walls of the building is rusted and deteriorated at several locations, thus compromising the lateral load path to the foundation.

The rating of V (Poor) is due to the poor condition of the building, namely the rusted wall panel connections to the foundation. If further inspection of the walls finds the connection to the foundation to be mostly intact, or if the metal panels are replaced, the rating may be raised to IV (Fair).

**East wall, water damage visible**

We recommend that the Campus perform a more detailed inspection of the metal wall panels, and replace as needed to provide a connection to the foundation.

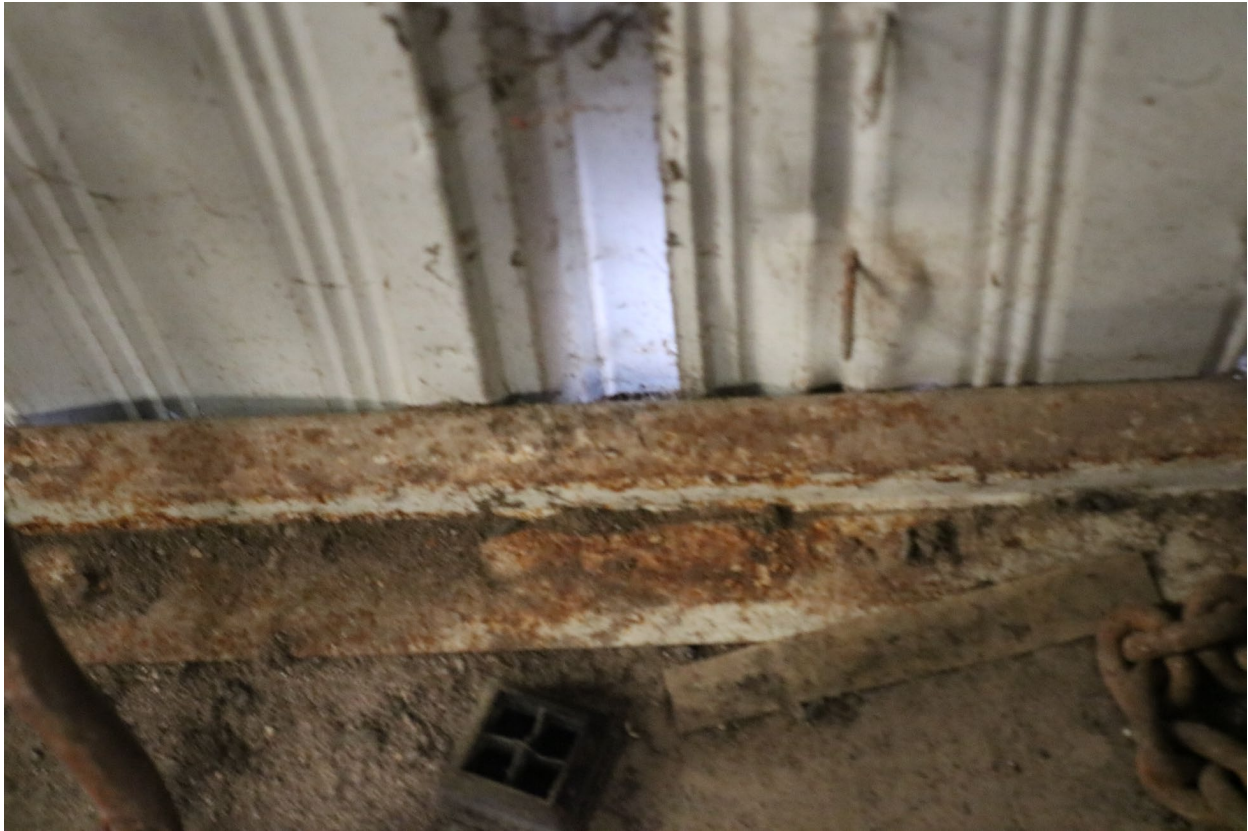
**West wall, water damage visible**
