**UC Santa Cruz building seismic ratings**  
**Oakes College Residence B11-15**

CAAN #7414  
 230 Oakes Road, Santa Cruz, CA 95064  
 UCSC Campus: Main Campus

DATE: 2019-06-30

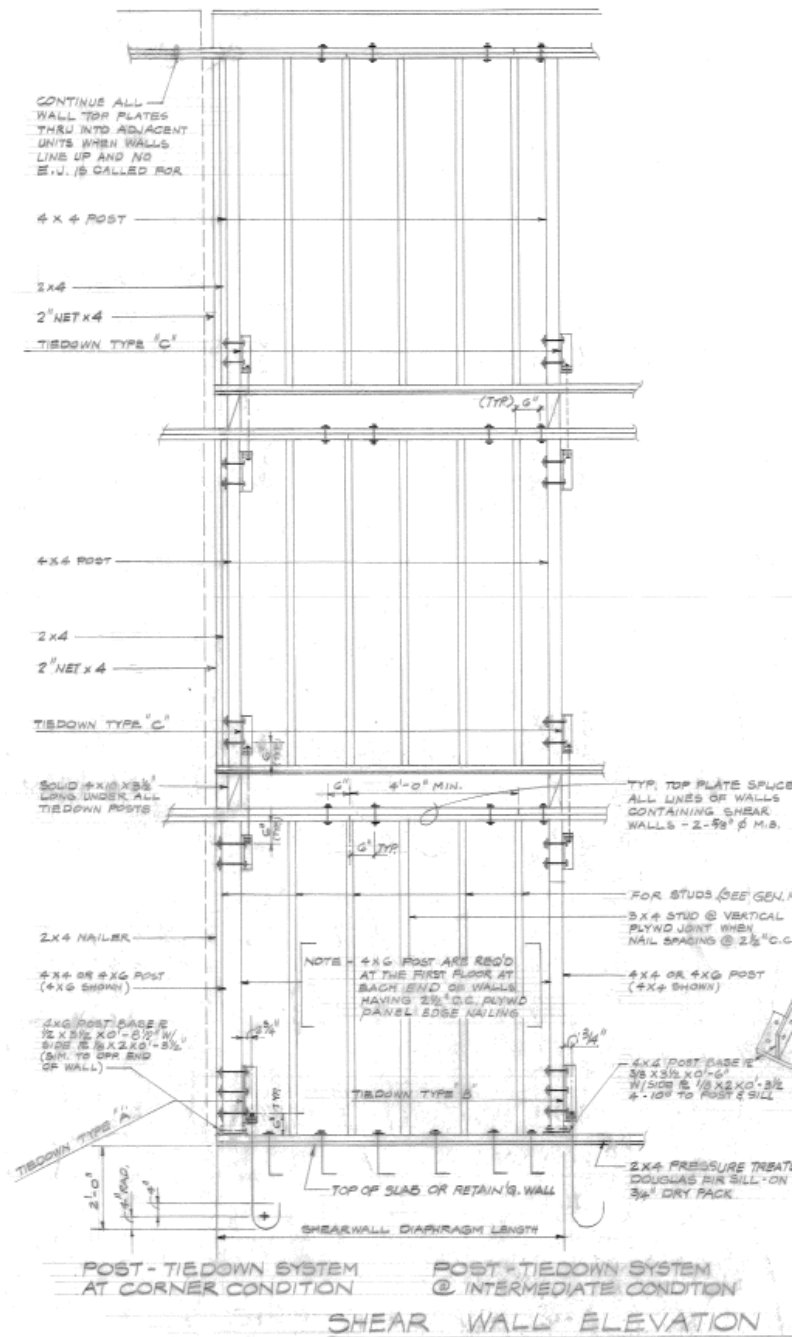
Shear wall typical detail

- The shear wall hold-downs do not have a shrinkage compensating device and additional deflections would be expected from slack connections.
- The shear wall aspect ratios do not meet the Tier 1 checklist requirements, but the stress check and structural detail of these walls appear adequate.
- The seismic gaps between the building units at the walkways are small and some pounding is expected in a seismic event.
- The stair connections do not have any deformation capability because of their rigid connection top and bottom. We expect that the walkway structure will experience damage/non-linear behavior in a seismic event because of this.

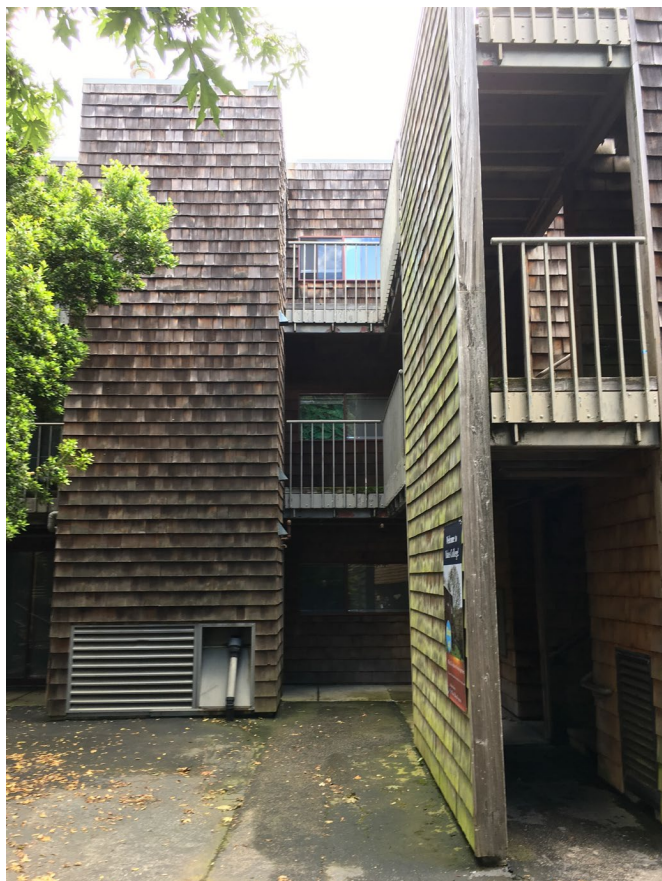
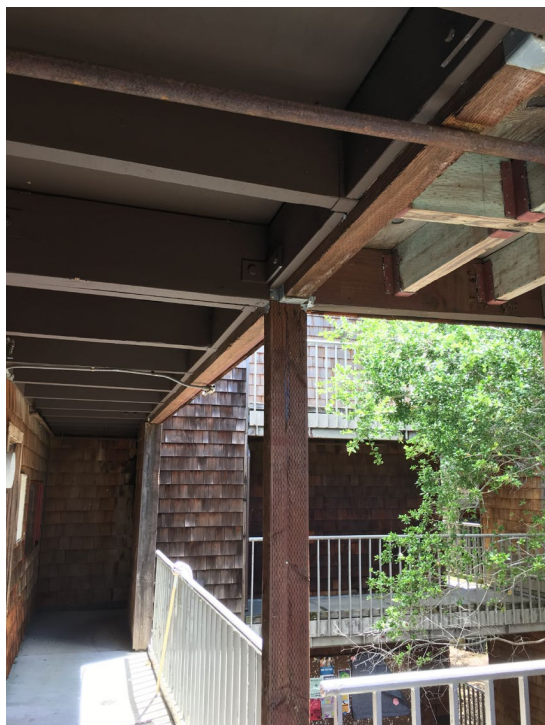
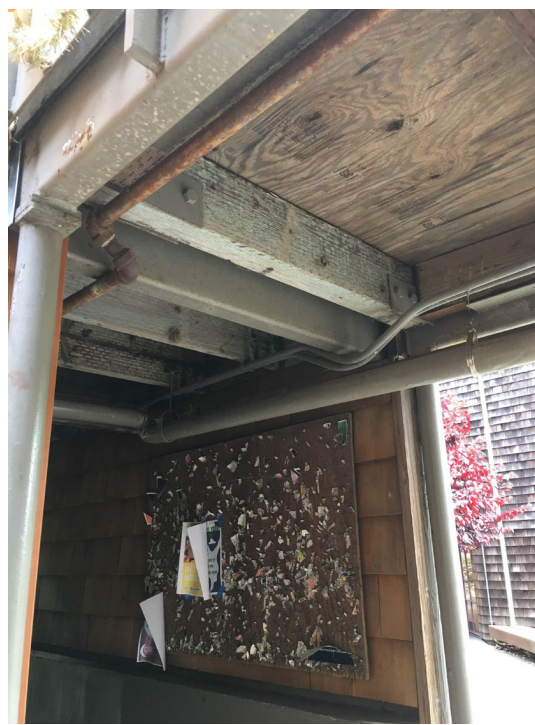
Photos of walkway and stairs

We observed no clear concerns. The stair connections at the exterior walkway is rigid at both ends and may present drift compatibility issues in a seismic event.

The building has a well-defined force path and is well-detailed, and we assign this building a rating of IV (Fair). This rating assumes that the exterior stairs are connected to the structure in a reasonably adequate way, such that they are not a collapse risk in the BSE-2E earthquake level.

Although we rate the building as IV (Fair), we recommend that the Campus perform a more detailed review of stair connections, for both a condition assessment and adequacy of the connections for a seismic event. We put the building on Priority Category B, as the above items should be done if there are any plans for modifying the building.
