UC Santa Cruz building seismic ratings
Oakes College Residence D14-16

CAAN #7423

243 Oakes Field Service Road, Santa Cruz, CA 95064

DATE: 2019-06-30

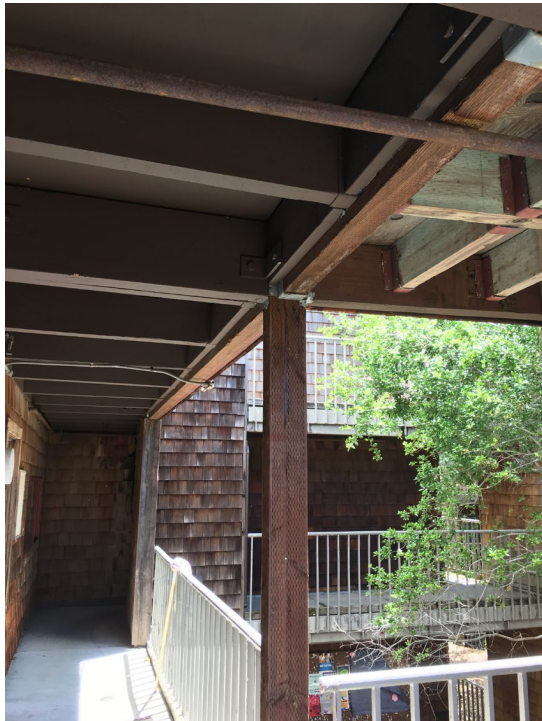
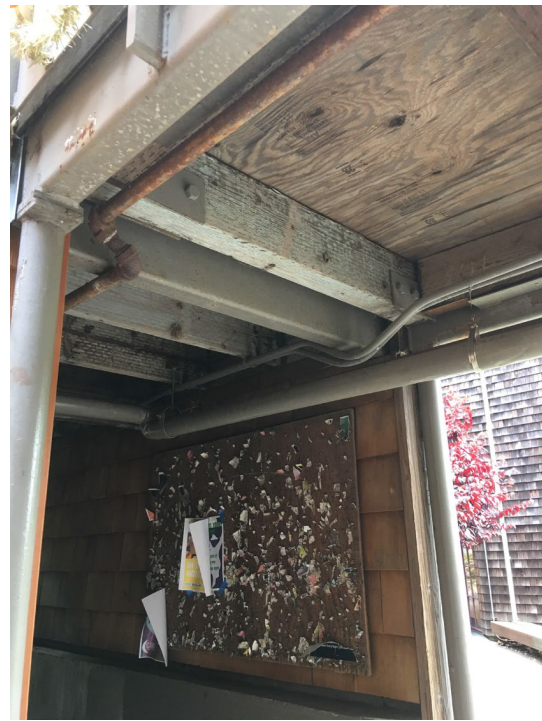
Photos of walkway and stairs

We observed no clear concerns. The stair connections at the exterior walkway is rigid at both ends and may present drift compatibility issues in a seismic event.

The building has a well-defined force path and is well-detailed, thus we assign this building a rating of IV (Fair). This rating assumes that the exterior stairs are connected to the structure in a reasonably adequate way, such that they are not a collapse risk in the BSE-C earthquake level.

Although we rate the building as IV (Fair), we recommend that the Campus perform a more detailed review of stair connections, for both a condition assessment and adequacy of the connections for a seismic event. We put the building on Priority Category B, as the above items should be done if there are any plans for modifying the building.
