UC Santa Cruz building seismic ratings

LML William T. Doyle Research Building

CAAN #7438

University of California, Santa Cruz
ASCE 41-17 Tier 1 Seismic Evaluation
7438 - LML William T. Doyle Research Building

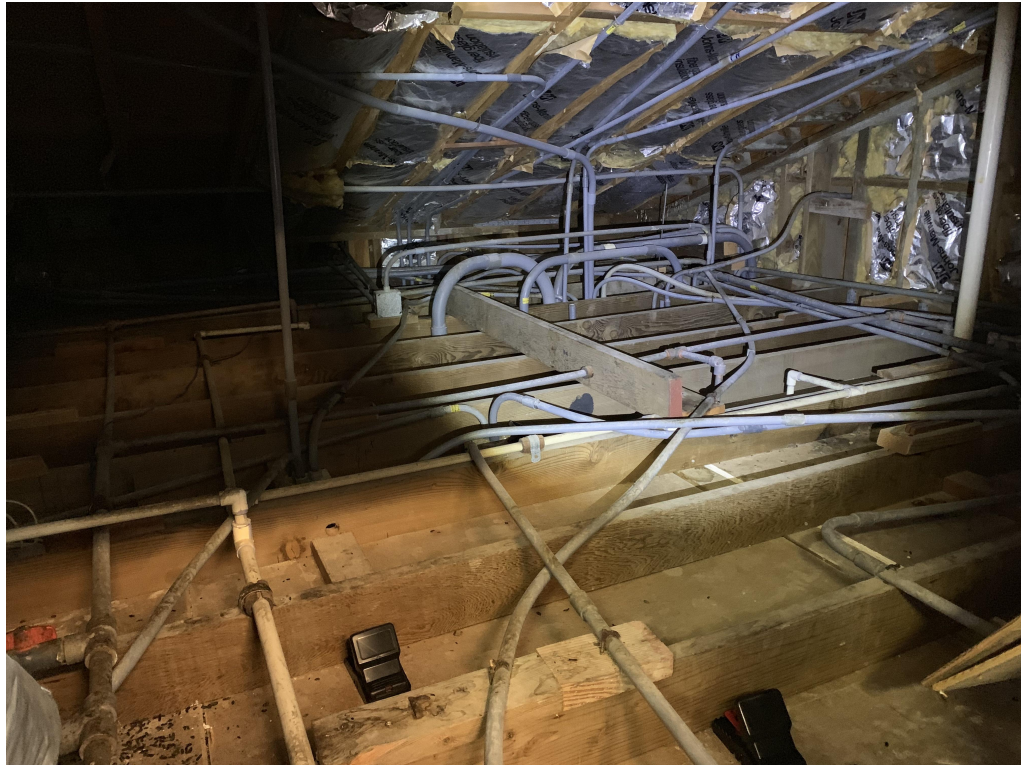
Roof diaphragm framing

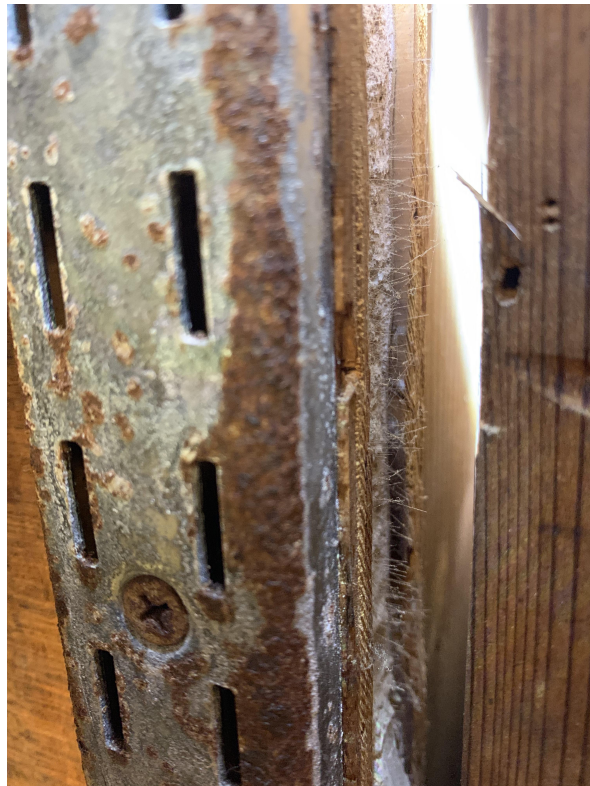
The building is divided into multiple storage and lab spaces. Many of these lab spaces use redwood plywood sheets as the wall siding. These sheets of plywood are not considered shear walls.

Plywood shear wall behind redwood wall cover

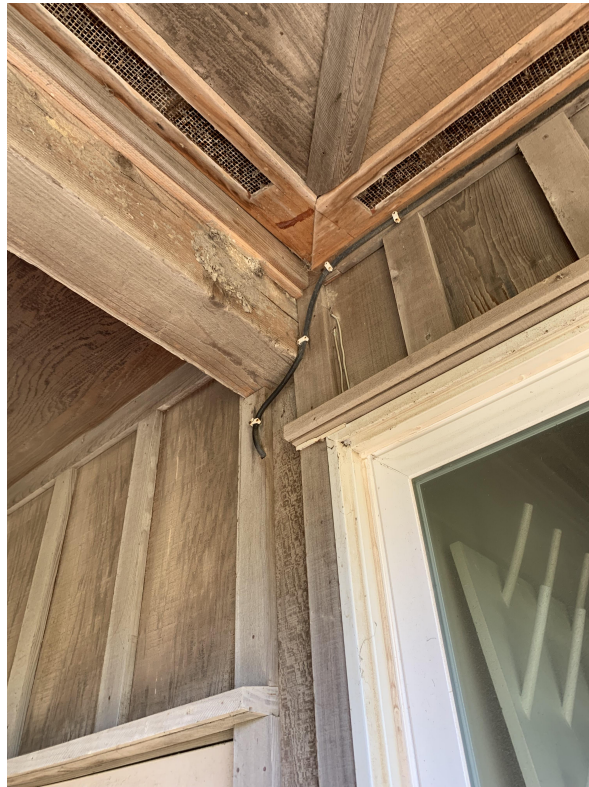
The walls of the main building have enough capacity according to the quick checks. The addition and storage shed are expected to perform sufficiently because of the metal straps in the storage shed and the gypsum in the addition. The connection of the addition roof is expected to separate from the main structure and the shed. This connection should be inspected and reinforced if necessary.

The building meets the requirements of the Tier 1 checklist and was given a IV rating. A priority B was given so further inspect and strengthening of the addition's roof girder connection to the existing roof framing could happen at the next permit application.

Addition roof connection to original structure

The connection between the addition roof and the original roofs should be inspected to confirm the as-builts. The connection should be strengthened to sufficiently tie the roofs together to prevent separation during an earthquake.

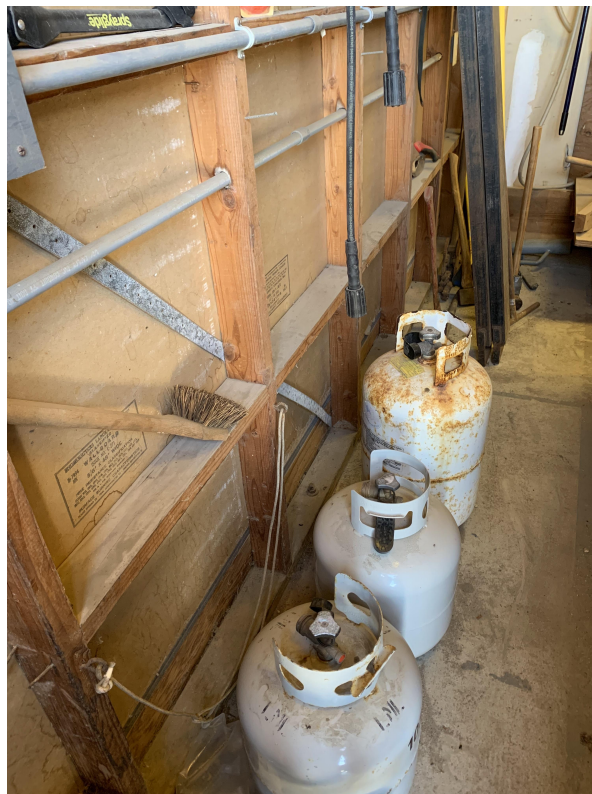
Storage shed metal straps

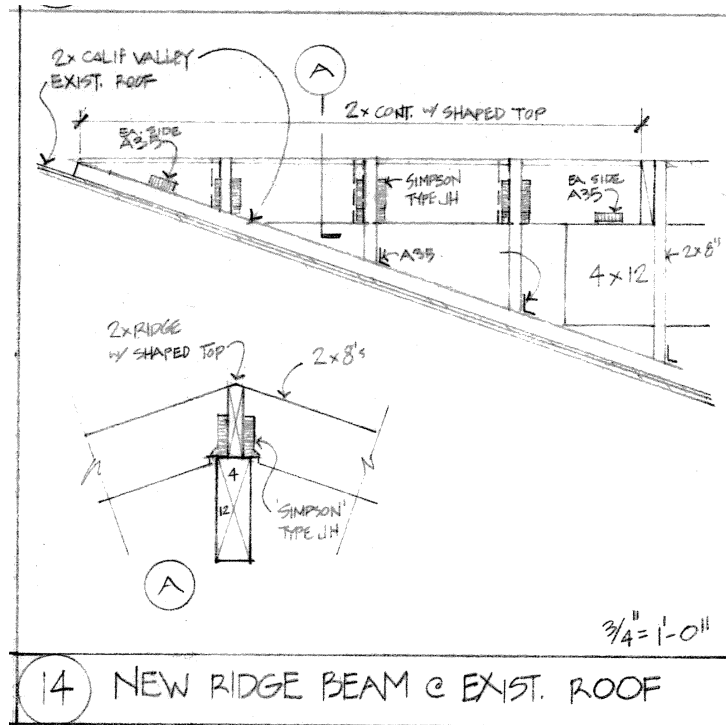
14 NEW RIDGE BEAM @ EXIST. ROOF

Addition roof to original roof detail

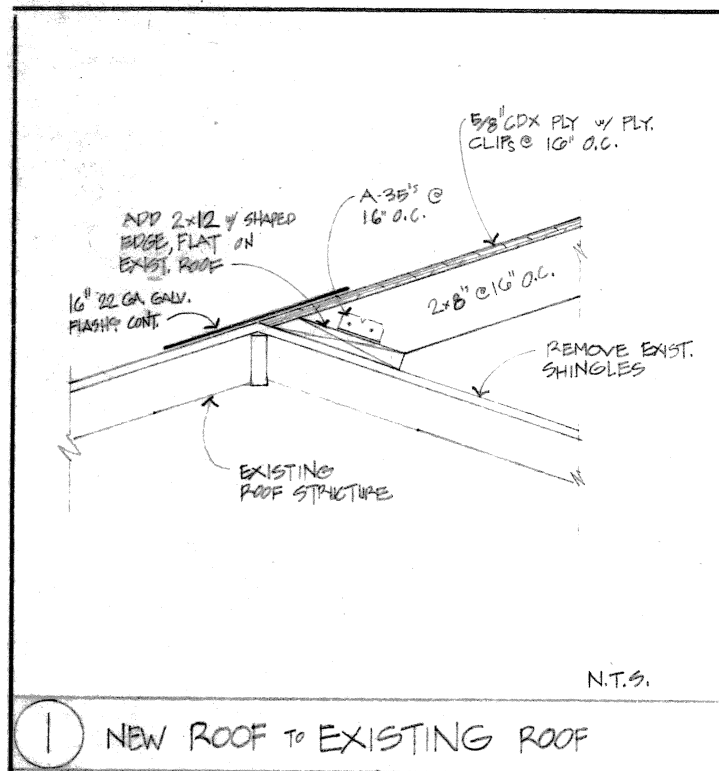
1 NEW ROOF TO EXISTING ROOF

Addition roof to shed roof detail
