DATE: 2019-06-28

UC Santa Cruz building seismic ratings

Visual Arts Facilities-Building A

CAAN #7493

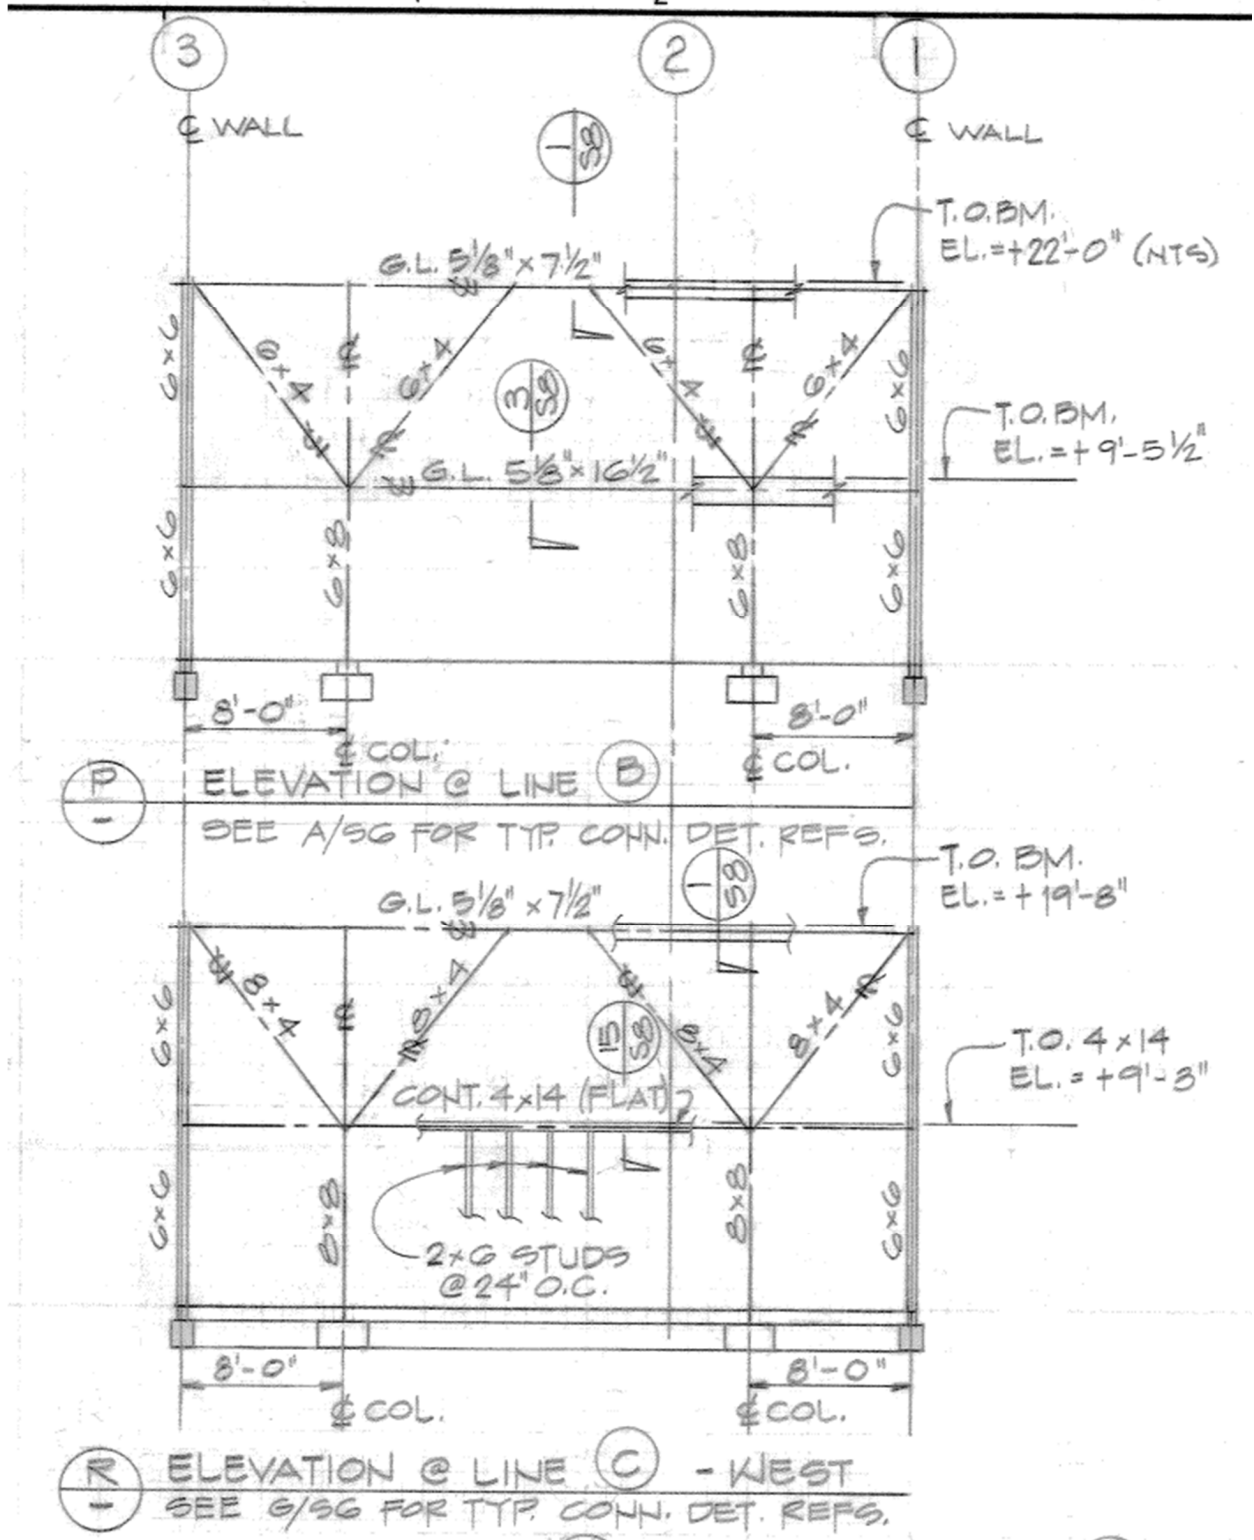
Example Braced Frame Elevations

- The braced frames rely on a complicated set of force transfer details that include bolts in shear in the wood. These details have reduced end distances (4D rather than 7D) and limited ductility compared to a plywood shear wall that dissipates energy through nails in bending, and they are ultimately likely to lead to longitudinal splitting of the wood. This is an unusual structural system not covered by the wood frame Tier 1 checklists of ASCE 41-17. A Tier 2 deficiency-based analysis of the frames, their internal connections, and their connections to the shear walls is needed to understand better the capacity and performance of this lateral force-resisting system.

We recommend that the campus perform a Tier 2 evaluation to review the lateral force-resisting capacity of the wood braced frame members, internal connections, and connections to the plywood shear wall. While ductility is low, it may be that there is sufficient capacity due to low demands. If the braced frames were found to be inadequate, connections could be strengthened, or supplemental lateral resistance could be added such as steel moment frames to help continue to preserve the clerestory light. We assign the building to Priority Category B, as the retrofit of the building should be done when there are any plans for modifying or change of occupancy.

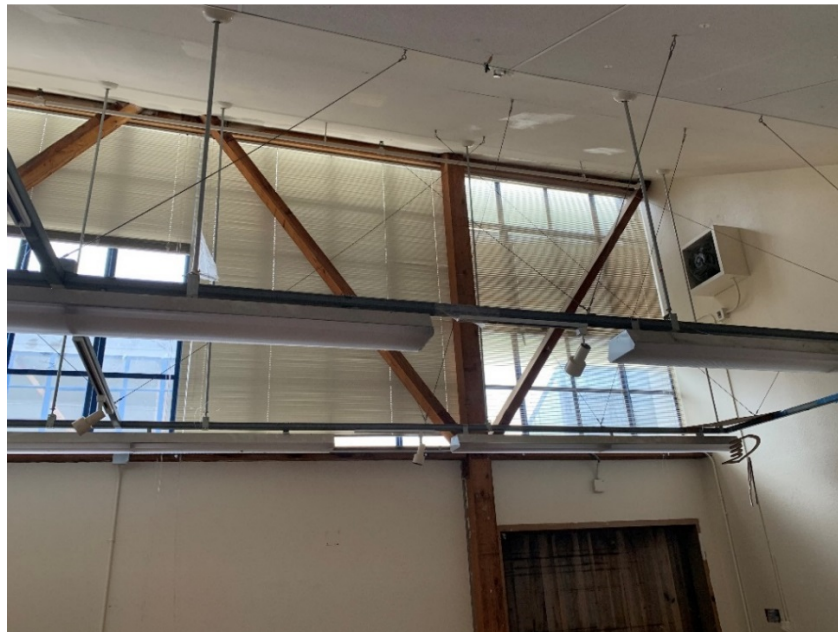
Elevation of Clerestory Window and Braces
at Line C (Looking Southwest)

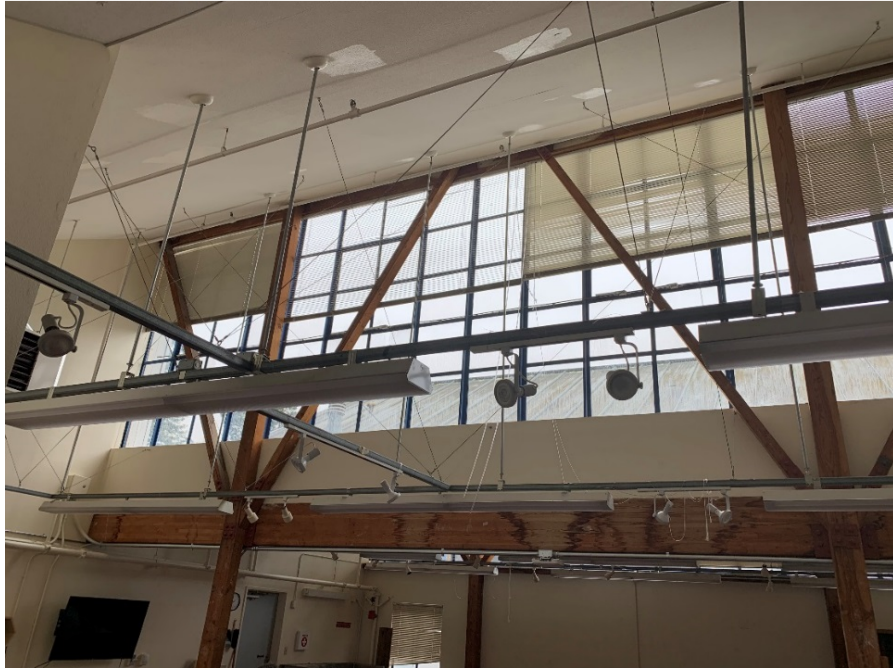
Elevation of Clerestory Window and Braces
at Line B (Looking Southeast)

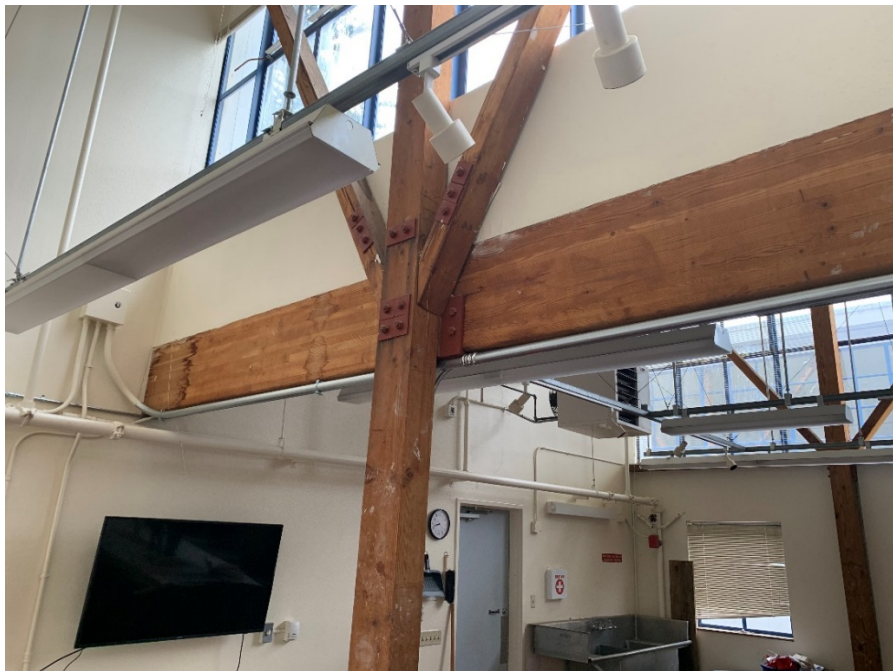
Interior Wood Braced Frame Connection to Glulam Beam at Line B

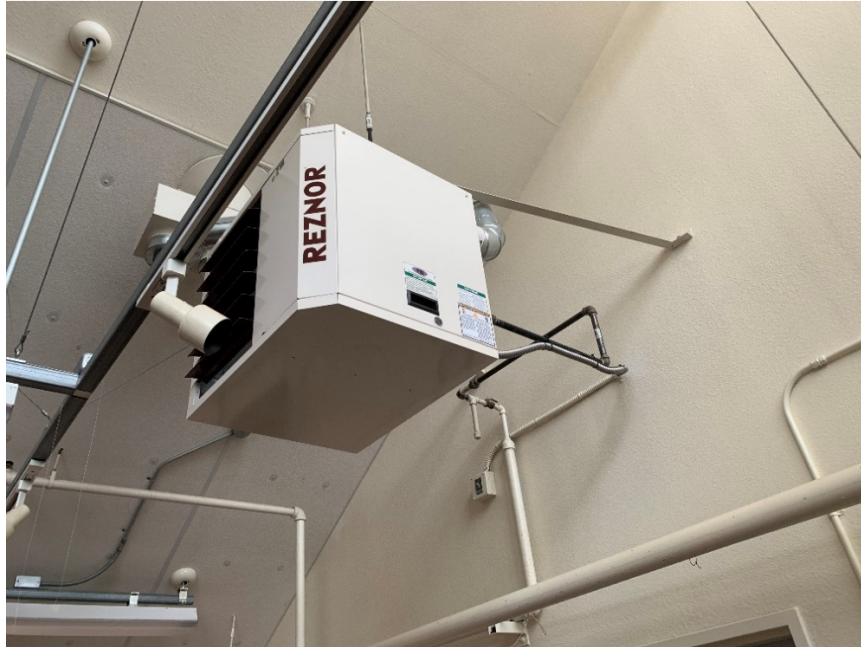
Close-up of Braced Heater

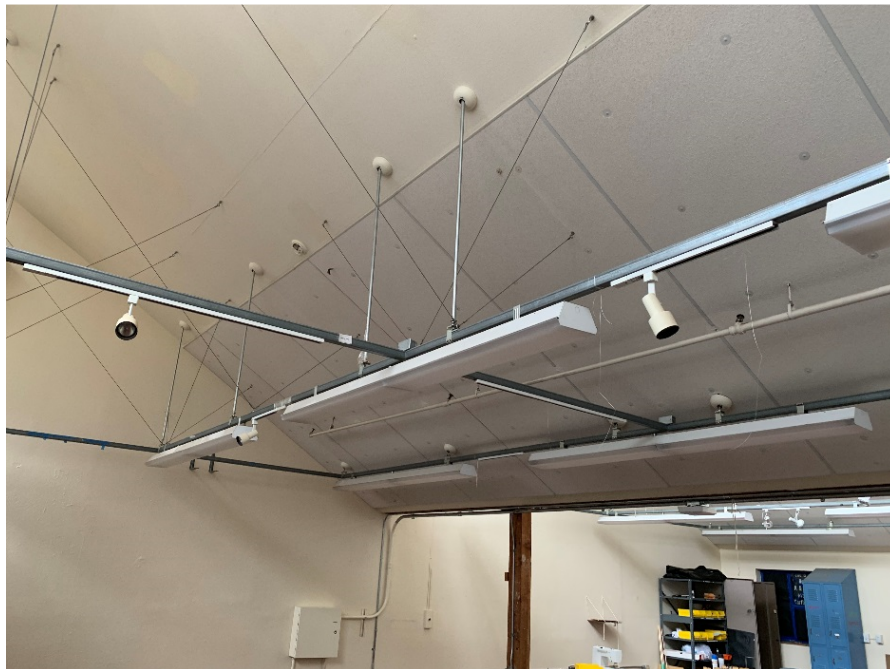
Close up of Braced Light Fixtures
