UC Santa Cruz building seismic ratings
EBASK Building D

CAAN #7496

433 Baskin Arts Service Road, Santa Cruz, CA 95064

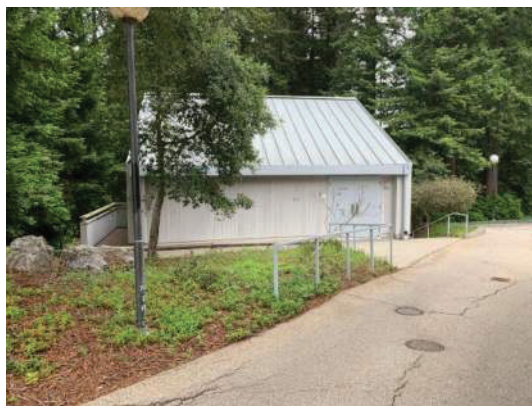
Southwest Elevation (Looking Northeast)

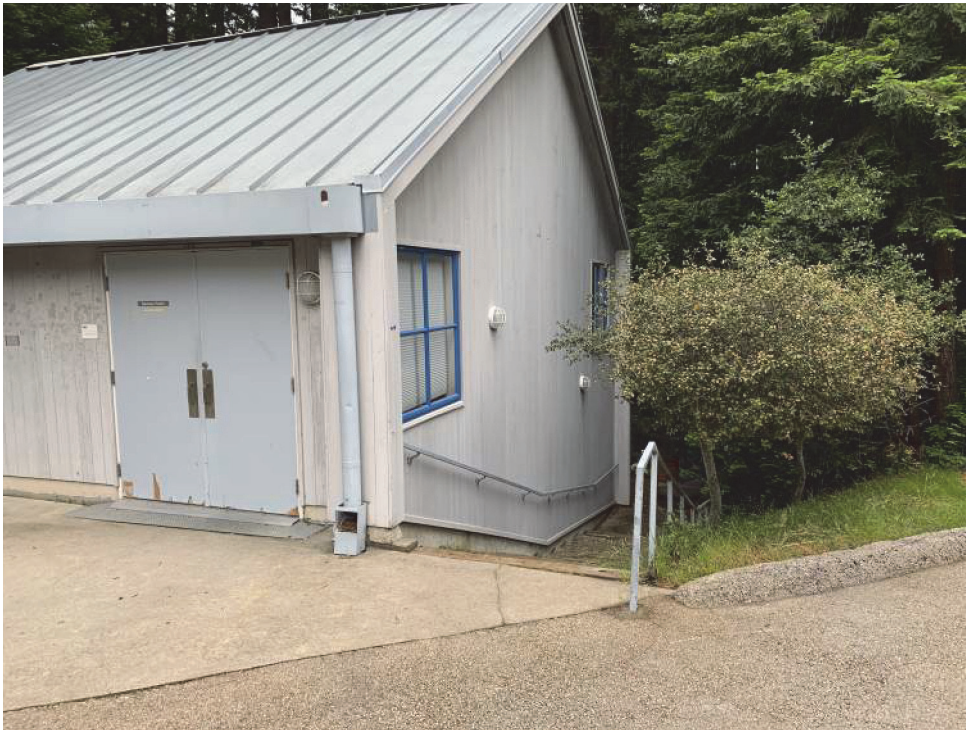
- The structure location meets the definition of a hillside site/sloping site. The one-story above grade walls are stiffer than the two-story tall wall located on the site downslope. However, the extent of wall on the downslope side is considered sufficient for the relatively small size of the building.

Sloping site to the northeast (looking north)

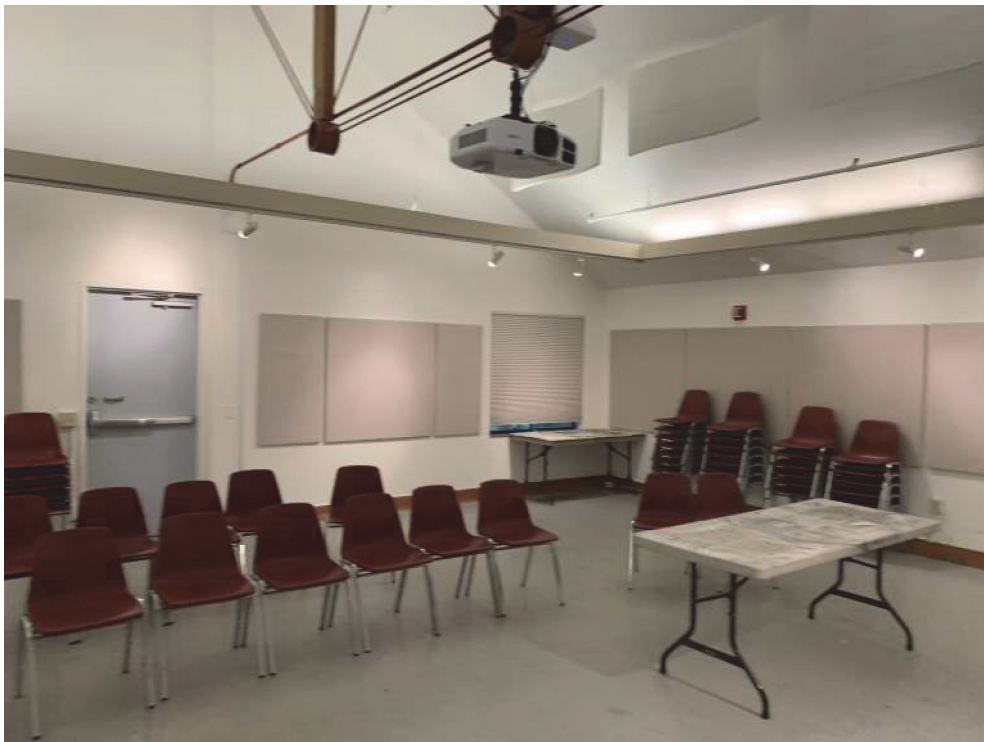
Classroom in upper floor (looking north)

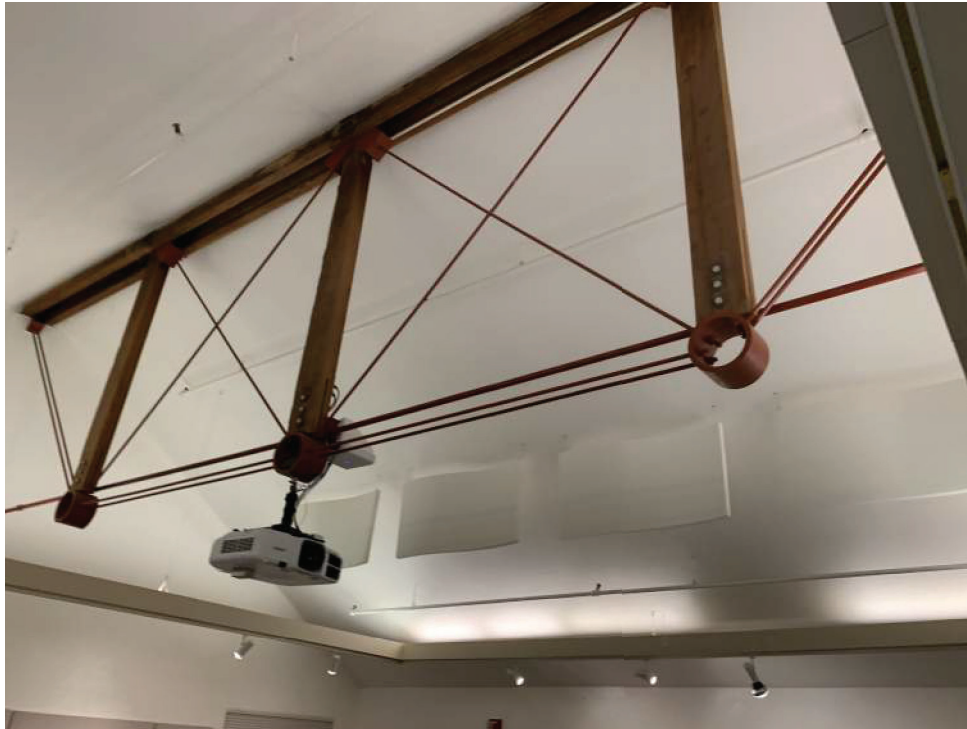
Wood and steel truss below roof

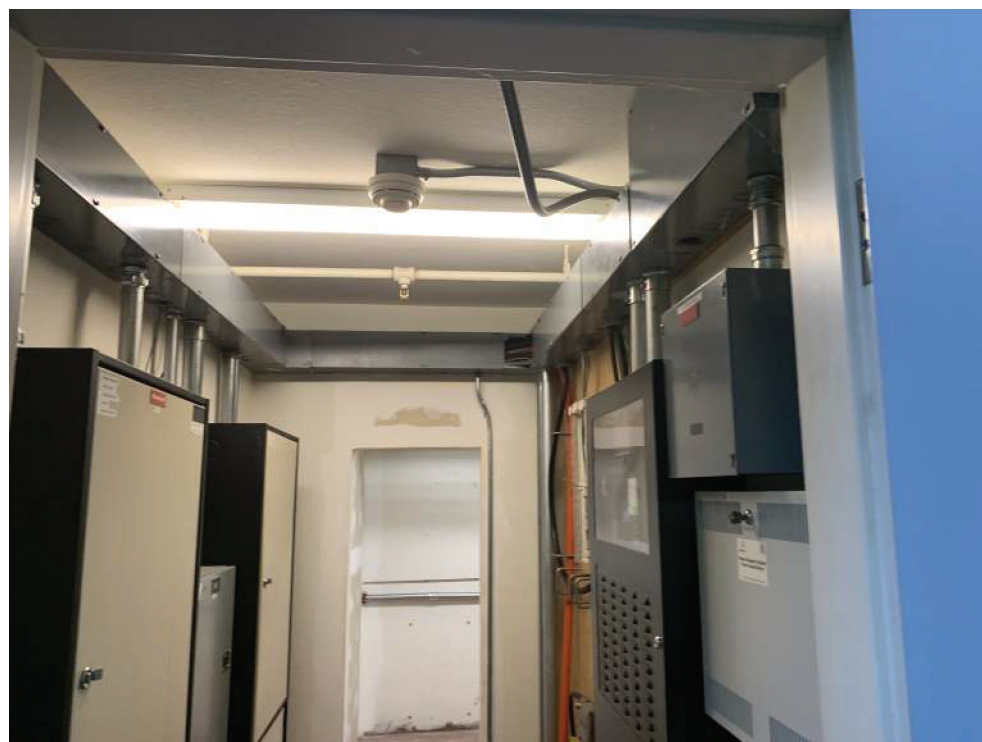
Mechanical equipment at lower floor
