UC Santa Cruz building seismic ratings
Visual Arts Facilities-Building F

CAAN #7498

Elena Baskin Visual Arts, Santa Cruz, CA 95064

Rating summary	Entry	Notes
UC Seismic Performance Level (rating)	V (Poor)	
Rating basis	Tier 1	ASCE 41-17 ¹
Date of rating	2019	
Recommended list assignment (UC Santa Cruz category for retrofit)	Priority B	Priority A=Retrofit ASAP Priority B=Retrofit at next permit application
Ballpark total construction cost to retrofit to IV rating ²	Medium (\$50-200/sf)	See recommendations on further evaluation and retrofit.
Is 2018-2019 rating required by UCOP?	Yes	Building was not previously rated
Further evaluation recommended?	Yes	Focused on analysis of current wood braced frame connections and possible improvement to the seismic resistance of the building in general

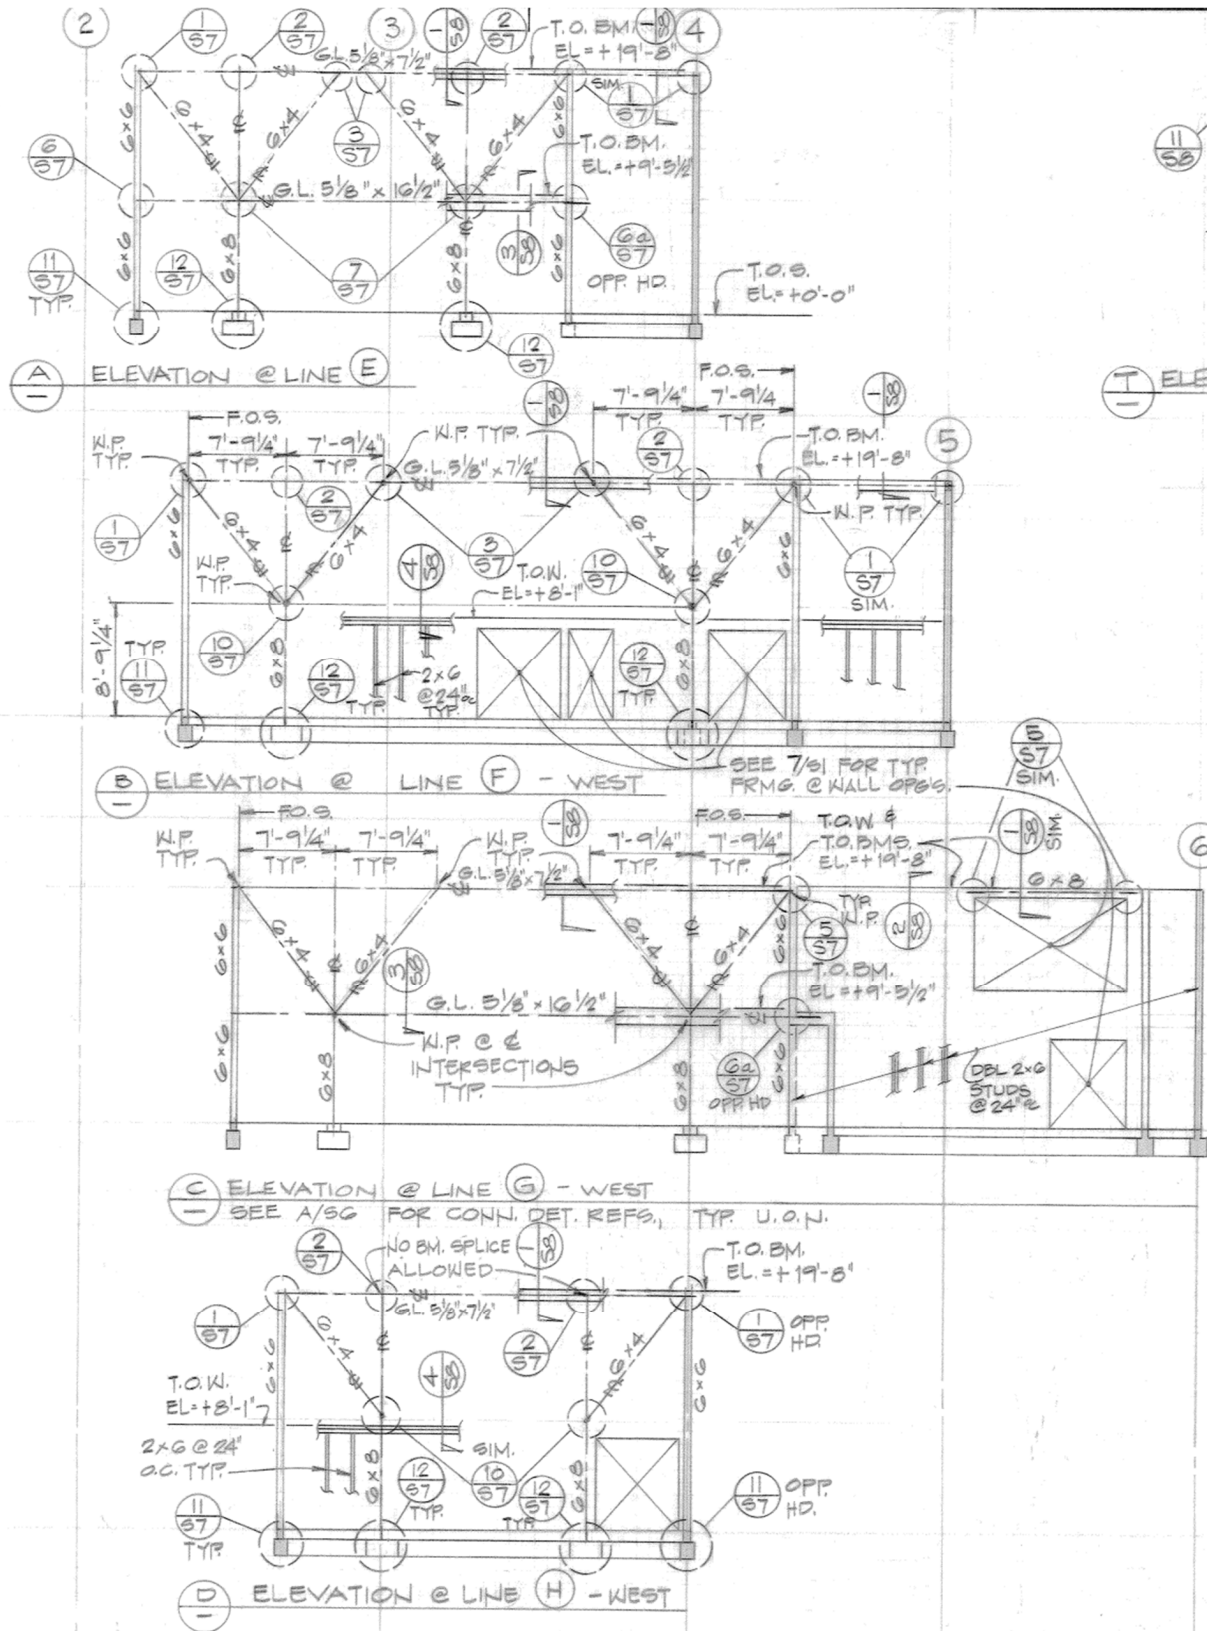
Example Braced Frame Elevations

- The braced frames rely on a complicated set of force transfer details that include bolts in shear in the wood. These details have reduced end distances (4D rather than 7D) and limited ductility compared to a plywood shear wall that dissipates energy through nails in bending, and they are ultimately likely to lead to longitudinal splitting of the wood. This is an unusual structural system not covered by the wood frame Tier 1 checklists of ASCE 41-17. A Tier 2 deficiency-based analysis of the frames, their internal connections, and their connections to the shear walls is needed to understand better the capacity and performance of this lateral force-resisting system.

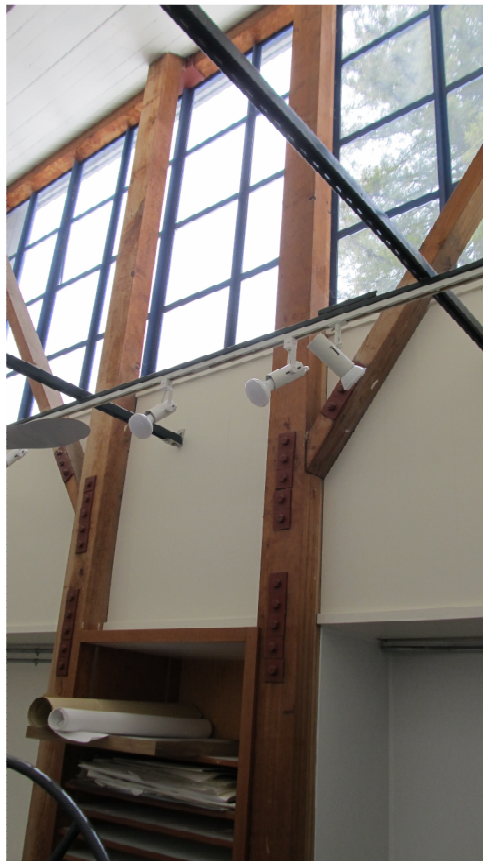
Wood Brace Frame in Enclosed Print Room
(Looking Northwest; Detail K on Sheet S6)

We recommend that the campus perform a Tier 2 evaluation to review the lateral force-resisting capacity of the wood braced frame members, internal connections, and connections to the plywood shear wall. While ductility is low, it may be that there is sufficient capacity due to low demands. If the braced frames were found to be inadequate, connections could be strengthened or supplemental lateral resistance could be added, such as steel moment frames to help continue to preserve the clerestory light. Retrofits would also include positive anchorage at the canopy to perimeter stud walls to prevent cross-grain bending. We assign the building to Priority Category B, as the retrofit of the building should be done when there are any plans for renovation or change of occupancy. Falling hazards reduction, such as the storage mezzanines, should be addressed.
