UC Santa Cruz building seismic ratings
Visual Arts Facilities-Building G

CAAN #7499

Elena Baskin Visual Arts, Santa Cruz, CA 95064

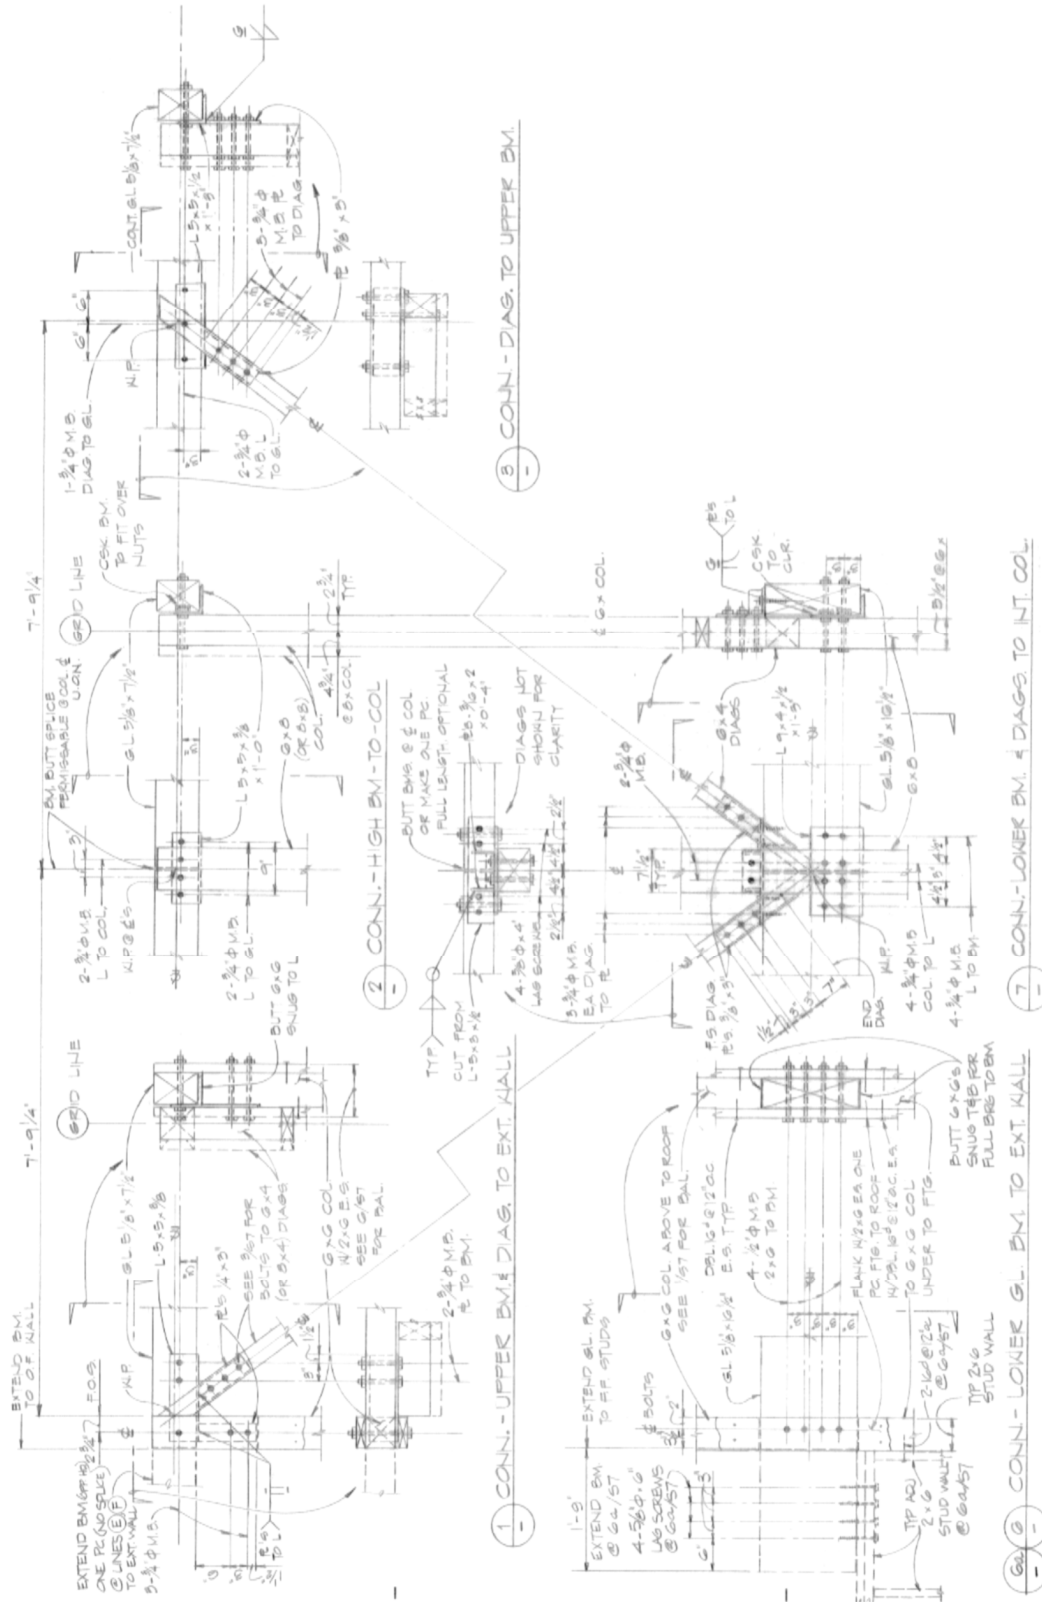
Connection Detail between Main Elements of the Wood Diagonal Braced Frames

- The braced frames rely on a complicated set of force transfer details that include bolts in shear in the wood. These details have reduced end distances (4D rather than 7D) and limited ductility compared to a plywood shear wall that dissipates energy through nails in bending, and they are ultimately likely to lead to longitudinal splitting of the wood. This is an unusual structural system not covered by the wood frame Tier 1 checklists of ASCE 41-17. A Tier 2 deficiency-based analysis of the frames, their internal connections, and their connections to the shear walls is needed to understand better the capacity and performance of this lateral force-resisting system.

We recommend that the campus perform a Tier 2 evaluation to review the lateral force-resisting capacity of the wood braced frame members, internal connections, and connections to the plywood shear wall. While ductility is low, it may be that there is sufficient capacity due to low demands. If the braced frames were found to be inadequate, connections could be strengthened or supplemental lateral resistance could be added, such steel moment frames to help continue to preserve the clerestory light. Retrofits would also include positive anchorage at the canopy to perimeter stud walls to prevent cross-grain bending. We assign the building to Priority Category B, as the retrofit of the building should be done when there are any plans for renovation or change of occupancy. Falling hazards reduction, such as the storage mezzanines, should be addressed.

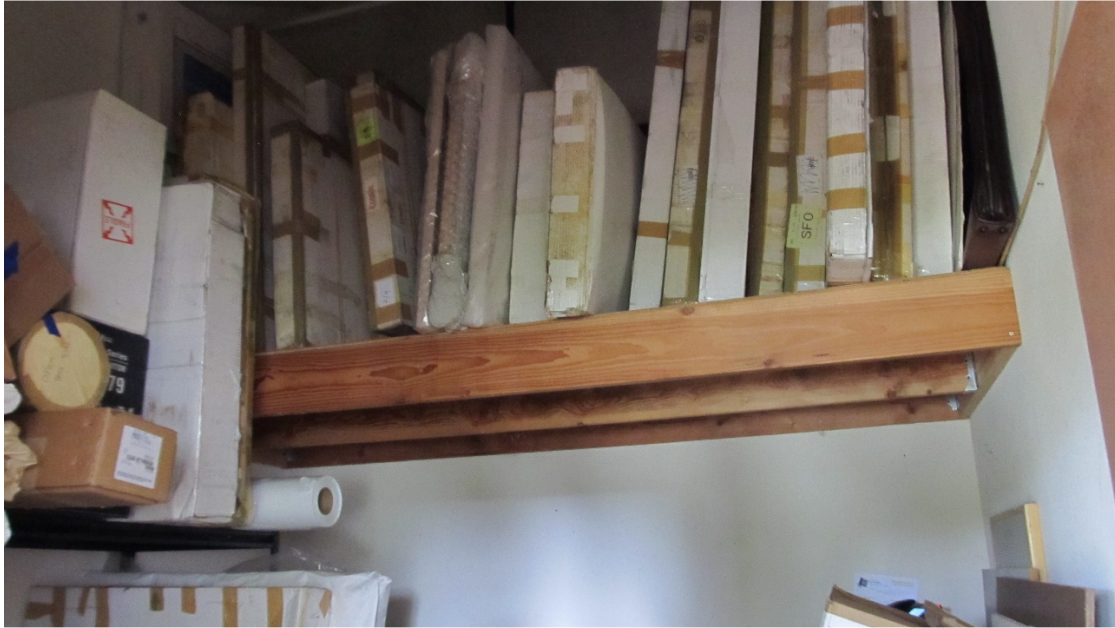
Storage Mezzanine in Offices

Light storage mezzanines inside office spaces were discovered during the brief site visit performed on 16 May 2019. Items stored on those are considered as falling hazard during an earthquake event. Lockers in the corridor should be properly braced from tipping over.
