DATE: 2019-06-30

UC Santa Cruz building seismic ratings
Cowell College Faculty Office Addition, Cowell College

CAAN #7566

University of California, Santa Cruz
ASCE 41-17 Tier 1 Seismic Evaluation
7566 - Cowell College Faculty Office Addition

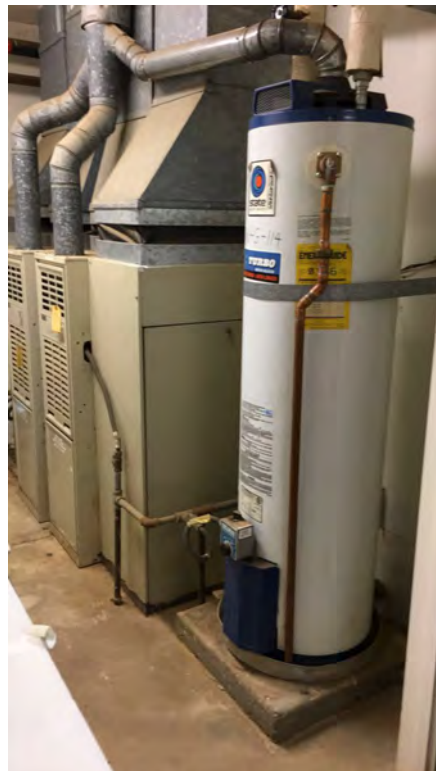
Boiler at the basement level not apparently anchored at base. The boiler is near a door in one of the lower level rooms. Tall MEP equipment that is not anchored may topple over during a seismic event and block exits or doorways. However, this is a moderate falling hazard since the boiler is at a lower level and did not seem too heavy.

Figure 2 - MEP Equipment not anchored at base

1. Anchorage of tall MEP equipment such as the boiler encountered will ensure that exits remain clear for evacuating the building.
