DATE: 2019-06-28

**UC Santa Cruz Building Seismic Ratings**

**P.E. Facilities**

CAAN #7743

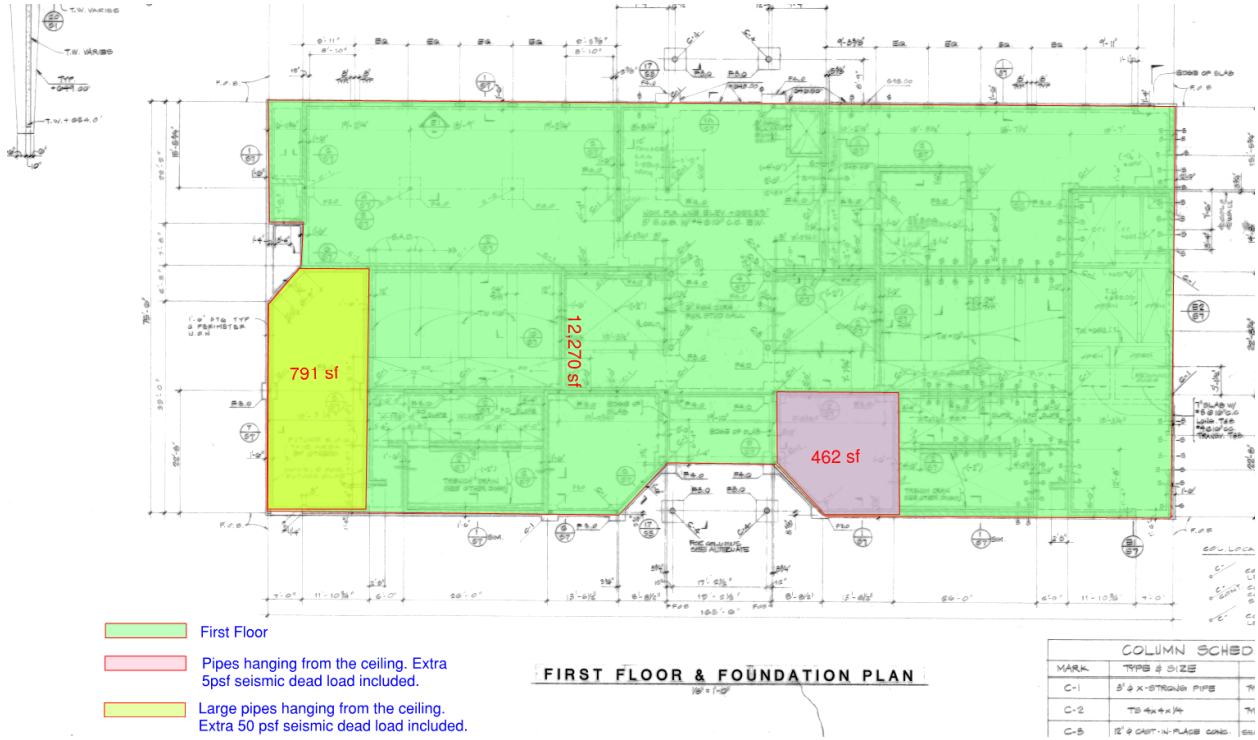
**First Floor (Ground) Plan**

- First Floor
- Pipes hanging from the ceiling. Extra 5psf seismic dead load included.
- Large pipes hanging from the ceiling. Extra 50 psf seismic dead load included.

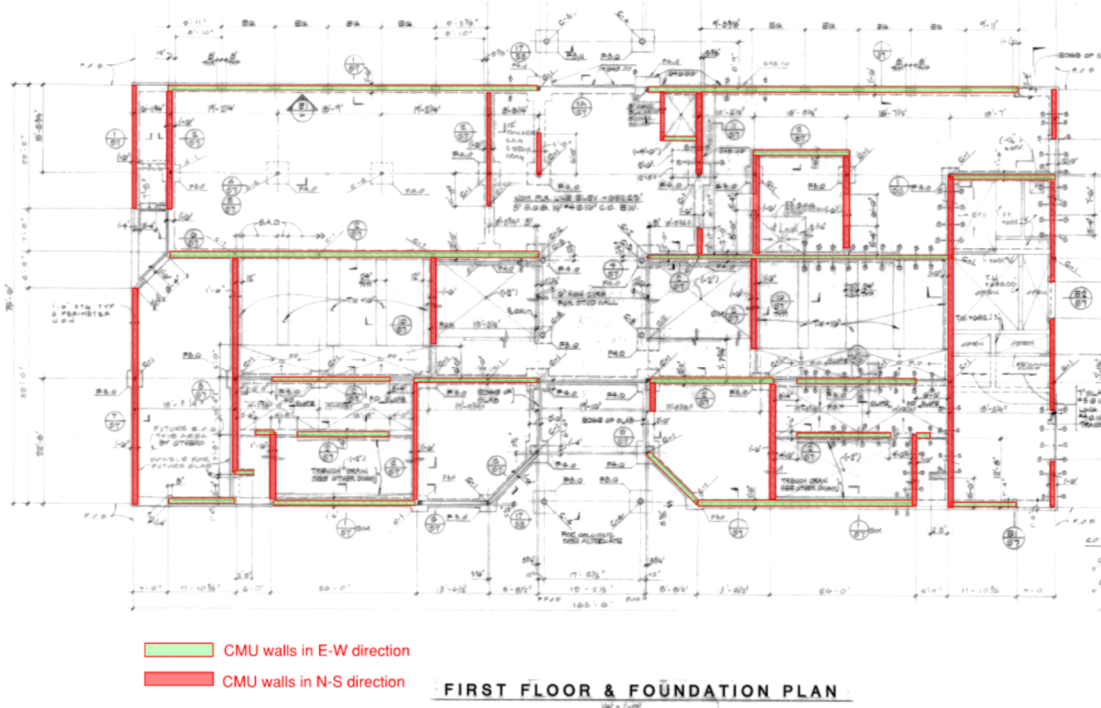
Annotated CMU walls at first floor

- The amounts of vertical and horizontal reinforcement provided in the CMU walls comply with ASCE 41-17 Tier 1 Quick Check. Well detailed diaphragm-wall connections will allow to transfer the loads from the second floor diaphragm and second story wood shear walls to the CMU walls. The calculated average shear stress in the CMU walls is well below the ASCE 41-17 limit, since the building has ample walls in both directions, with a demand-to-capacity ratio (D/C) = 0.16 in the N-S direction and D/C=0.18 in the E-W direction. At the north façade, there are a series of short CMU piers between clerestory windows along a large portion of the building length. The wall line has a D/C=0.55 using a tributary area assumption. The demand-to-capacity ratios at the second story plywood walls, while compliant with the Tier 1 Quick Check, are substantially higher than those of the CMU walls. The average D/C ratio is 0.99 for the N-S direction and 0.59 for the E-W direction.

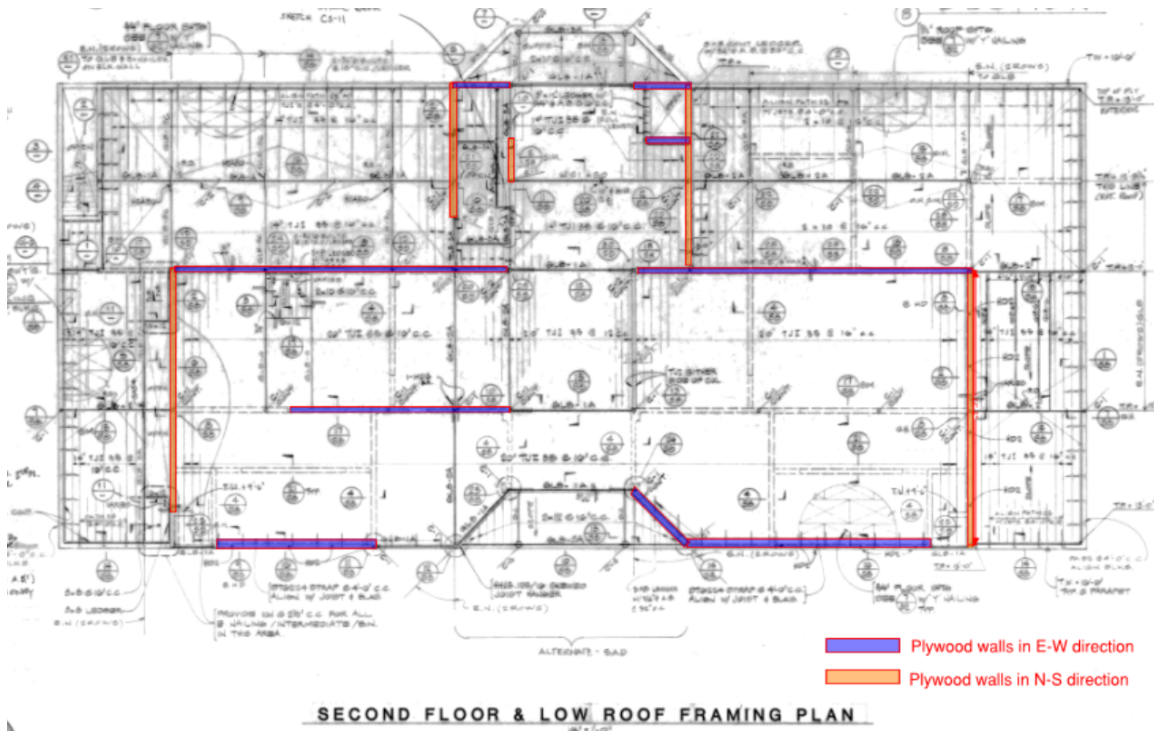
Annotated Plywood Walls at Second Floor

- Given the relative D/C ratios, the nonlinear behavior of the structure is expected to be concentrated on inelastic response of wood-framed walls at the second story, with the potential for concentrated inelastic action at the piers next to clerestory windows on the north façade.

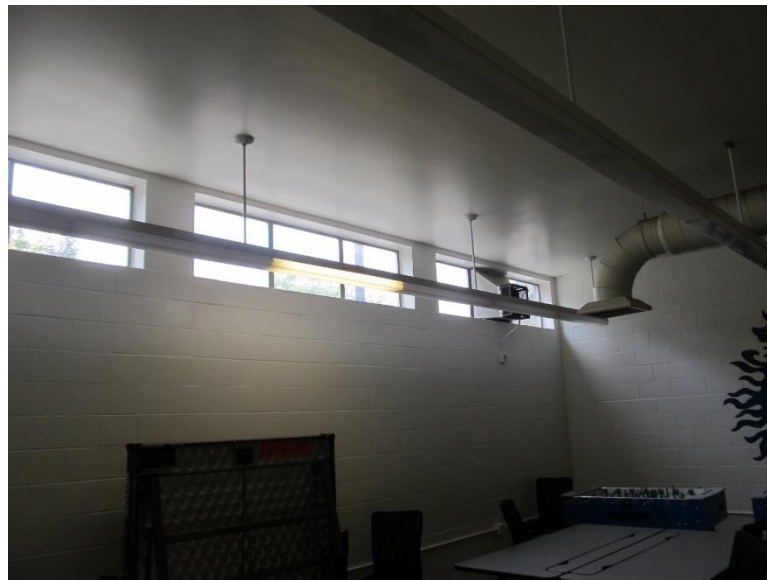
CMU wall at first story

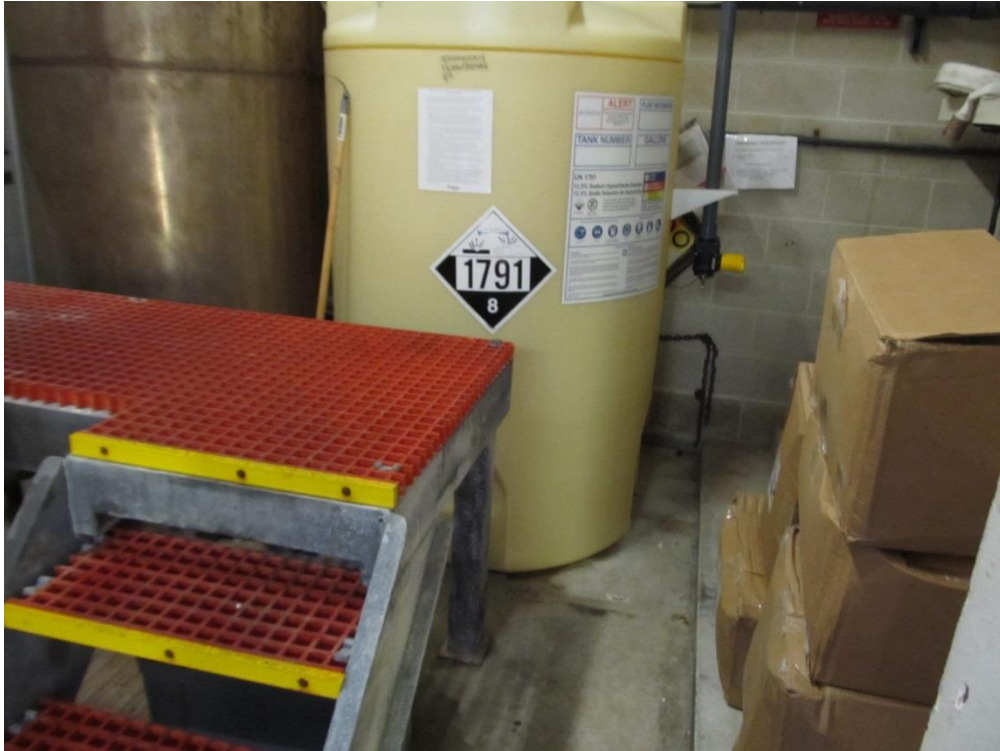
- In Rooms 118 and 119, there are tanks holding pool filtration chemicals that are unrestrained. We recommend properly restraining any hazardous materials as that can be done independently of any structural or architectural work and has a high return in terms of risk reduction vs dollars spent.

Unrestrained tank of filtration chemicals

<input checked="" type="checkbox"/>	<input type="checkbox"/>	<b>Comments:</b> Chemicals stored in rooms 118 and 119 are used in the pool filtration system; existing drawings do not specify if those chemicals are classified as hazardous. A cursory review of those rooms identified that tanks storing those chemicals are not restrained. Facilities personnel indicated that this room is scheduled to undergo remodeling. If that occurs, we recommend that all containers holding hazardous materials are identified and restrained to current provisions.
P	N/A	Masonry chimneys
<input type="checkbox"/>	<input checked="" type="checkbox"/>	<b>Comments:</b> There are no masonry chimneys.
P	N/A	Unrestrained natural gas-fueled equipment such as water heaters, boilers, emergency generators, etc.
<input type="checkbox"/>	<input checked="" type="checkbox"/>	<b>Comments:</b> Visual observation of equipment in Room 134 showed that most (if not all) feature anchors to the floor. Switchgear equipment and other electrical panels are anchored to a CMU wall.

Unrestrained Hazardous Materials Risk: Moderate-High.

From a structural standpoint, we do not recommend any further evaluations or retrofit. From a nonstructural standpoint, we recommend restraining of tanks in Rooms 118 and 119, and a more focused evaluation of utility bracing in Room 134.

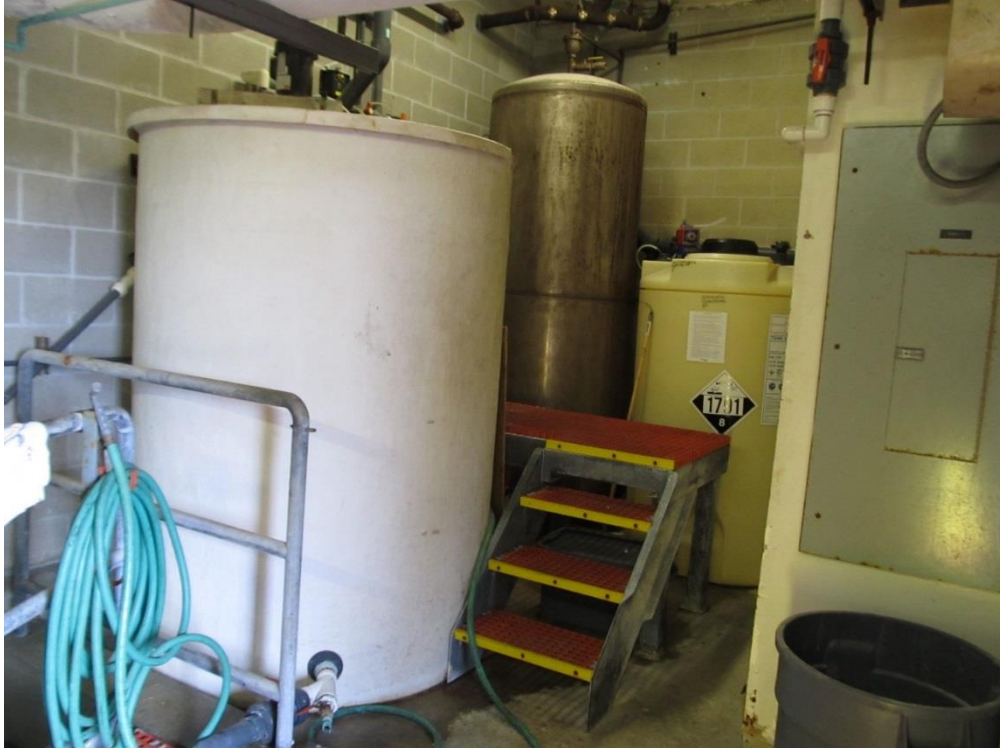
Unrestrained tanks of filtration chemicals

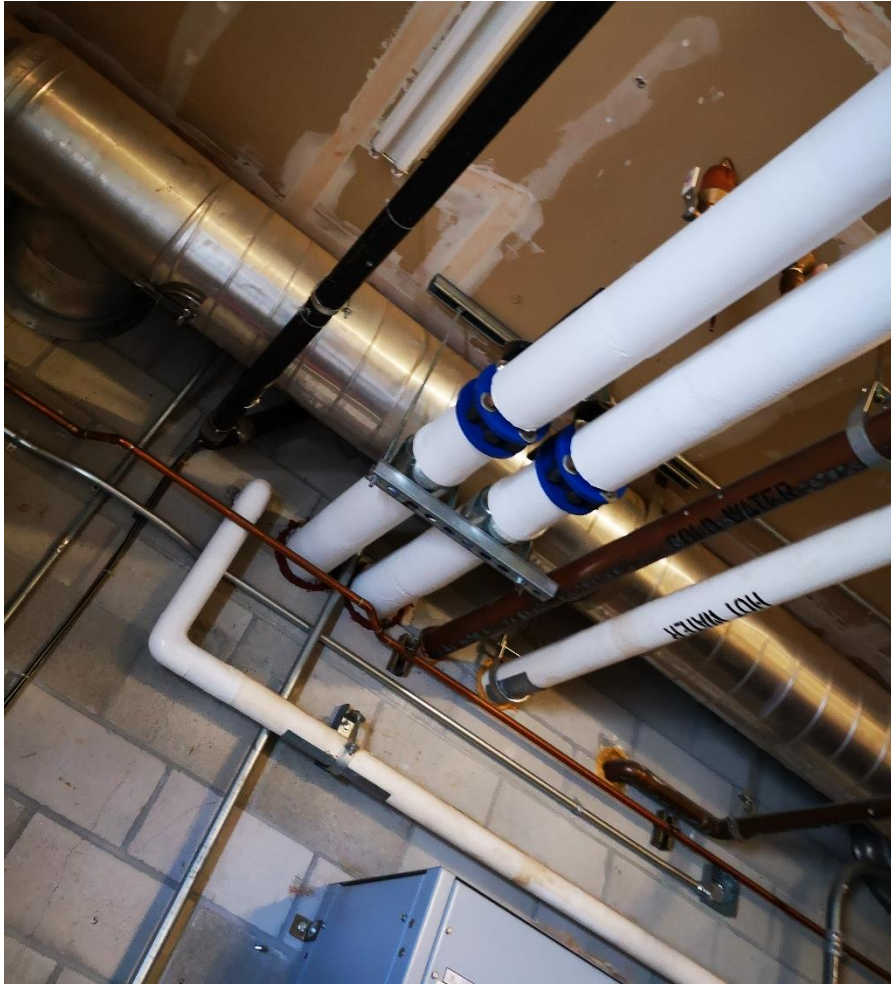
- Unbraced piping was observed in Room 134, the cogeneration room. It is acknowledged that the presence of unbraced piping is not an indication of non-compliance with current provisions. For that reason, we recommend that further evaluation of the utility bracing in Room 134 be conducted to properly assess any risk that may exist and suggest ways of mitigating said risk.

Pipes in Room 134 (cogeneration room)

P	N/A	Other: Unbraced Piping in Room 134
<input checked="" type="checkbox"/>	<input type="checkbox"/>	<b>Comments:</b> Room 134 is the cogen room, and as such it contains substantial equipment, associated piping, and conduit. It appears that some piping was not restrained as would be required under current provisions. There are many exceptions under which the piping/conduit is exempt from provisions depending on its size, its service, distance to adjacent obstacles, distance to support above, etc. A cursory Tier 1 evaluation can only identify the possibility of a deficiency. A more focused, detailed MEP distribution system evaluation of the cogen room would be necessary to rule out the presence of a deficiency and its associated life-safety hazard.

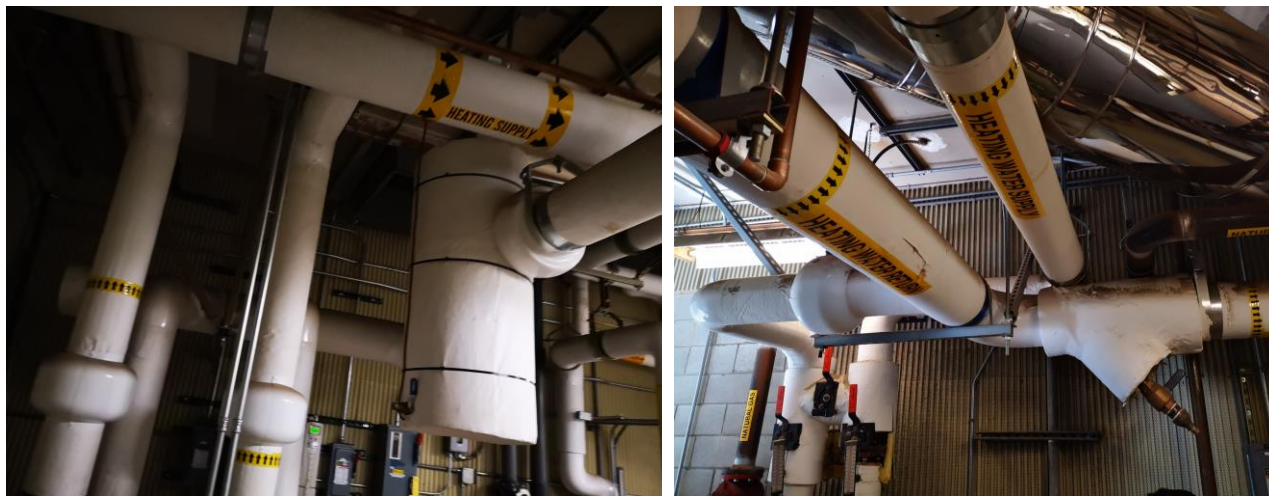
Pipes in Room 134 (cogeneration room)
