## UC Santa Cruz building seismic ratings

### Elena Baskin Visual Arts Building J (Painting Studio)

CAAN #7822

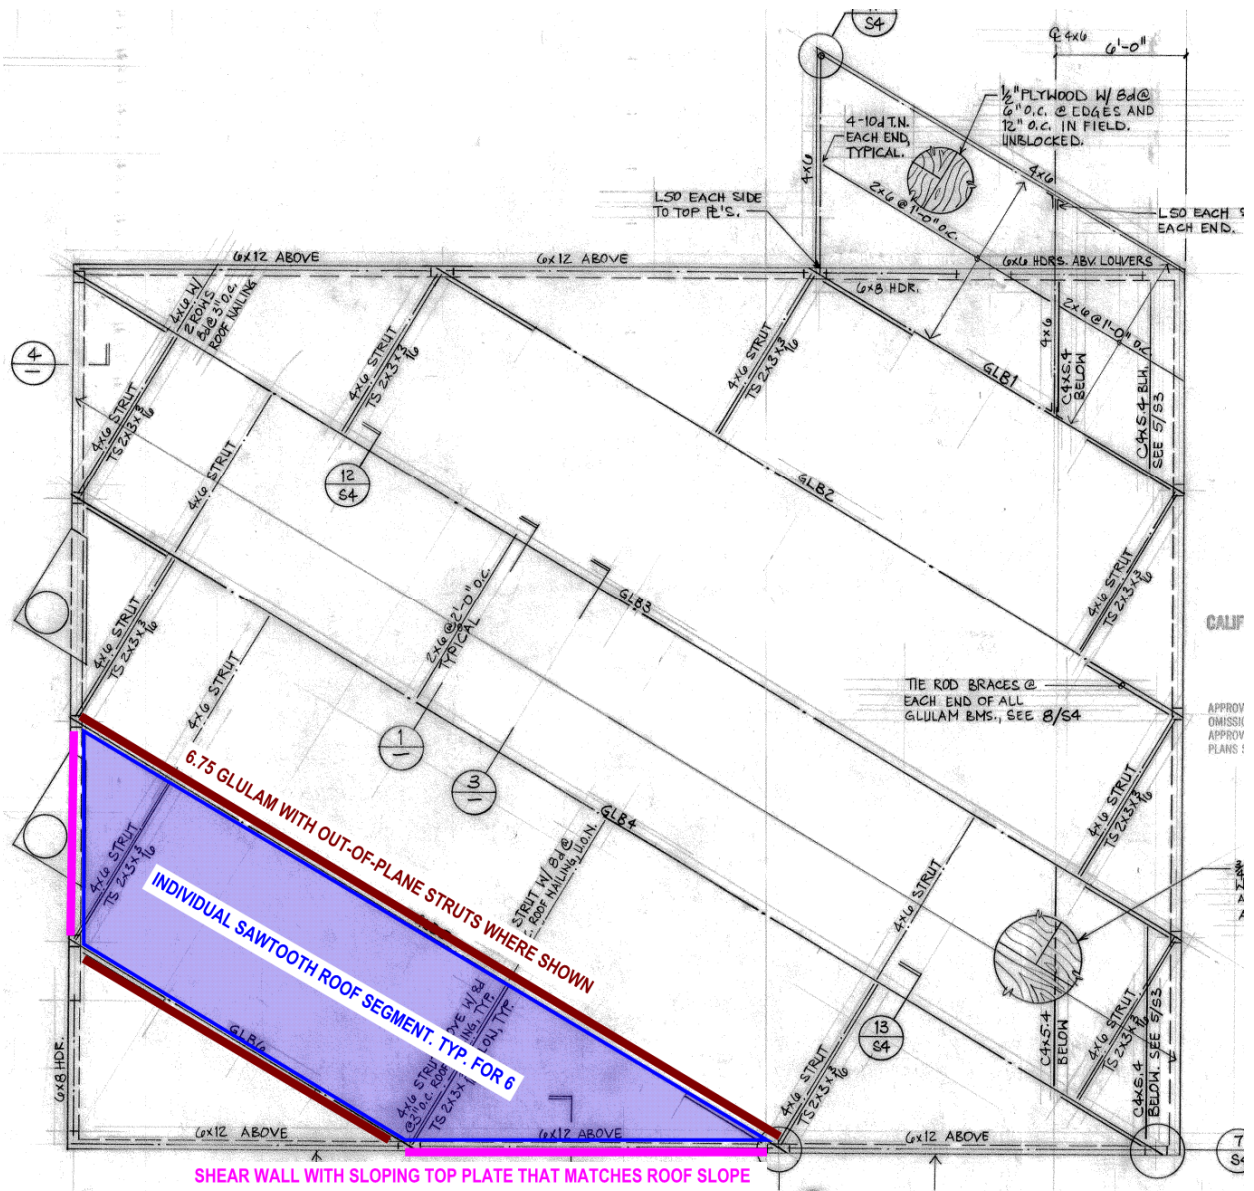
### Roof framing and description of typical sawtooth segment

The key architectural feature of the building are the sawtooth roofs which create large clerestory windows and interrupt the roof diaphragm and are oriented diagonally in plan with the perimeter walls. The structural approach taken to address this is unusual.

Lateral loads in the NE-SW direction will span through each monoslope plywood diaphragm roof segment to its ends on the NW and SE sides where the perimeter plywood walls are located. The aspect ratio of the roof segments is poor (ranging from about 3:1 to 6.5:1), but there are a set of struts parallel to the rafters (running NE-SW) made of a 4x6 in the plane of the sloped roof and a TS3x2x3/16 at the glulam level which will help link each roof segment together. The struts do not always align on each side of the glulam so the glulam will act in weak way bending.

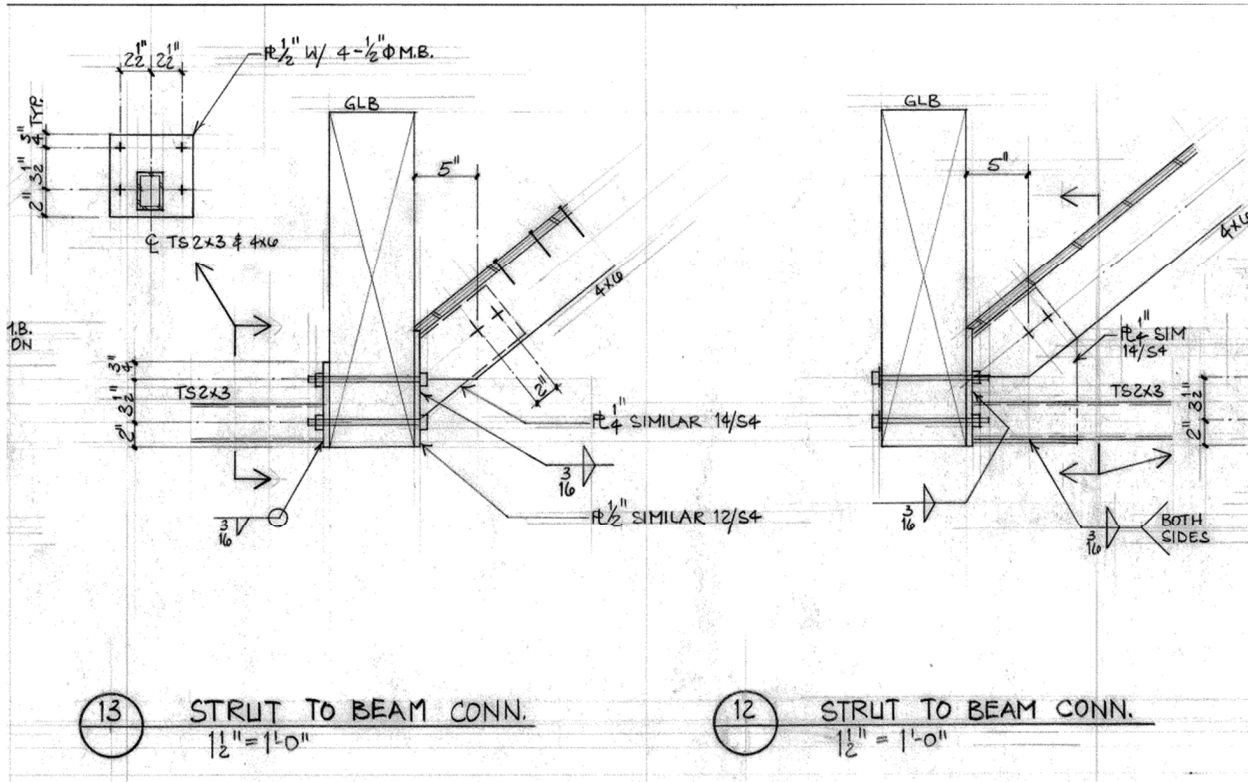
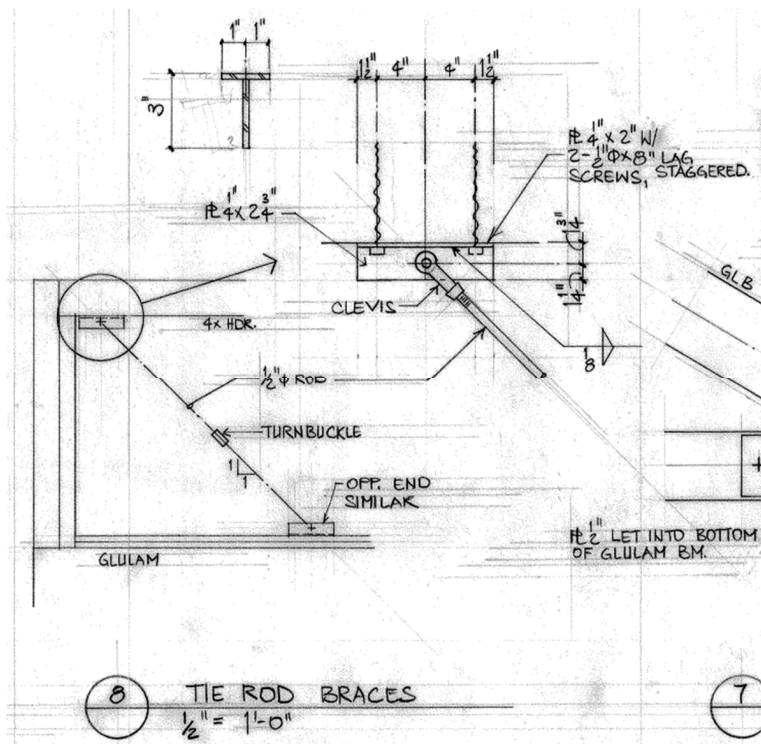
Details for the roof struts and tie rods

Lateral loads in the NW-SW direction have a series of nominally connected roof segments because of the clerestory window. At each end of the glulam, there is a ½" diameter tie rod in Detail 8/S4 which vertically connects the 4x10 header at the top of the clerestory window down to the glulam at the bottom of the window. Internal load transfer within the diaphragm through the tie rods will be small, but the tie rods are also relatively small. The combined plywood and tie-rod bracing diaphragm connects to the perimeter walls and transfers loads into the walls and down to the foundation.

- The only deficiency is that of the roof diaphragm discontinuity created by the sawtooth roof segments. In the NE-SW direction, this creates high diaphragm aspect ratios. In the NW-SE direction, the unusual combination of plywood and tension rods in the windows limits diaphragm capacity in the load path and increases diaphragm flexibility.

We assign a Seismic Performance Level rating of V to this building. The walls have relatively low demands, but the sawtooth roof diaphragm has limited capacity to adequately resist loads, particularly in the NW-SE direction. A more

detailed analysis beyond the scope of the Tier 1 evaluation is needed to evaluate the adequacy of the system, including the tie rods, their connections, and the struts

We recommend that at Tier 2 evaluation be performed to investigate in detail the adequacy of the segmented roof diaphragm including the tie rods, their connections, the struts, and weak way bending of the wood members. If these are found to be adequate, this could lead to an improvement in the rating from level V to Level IV.

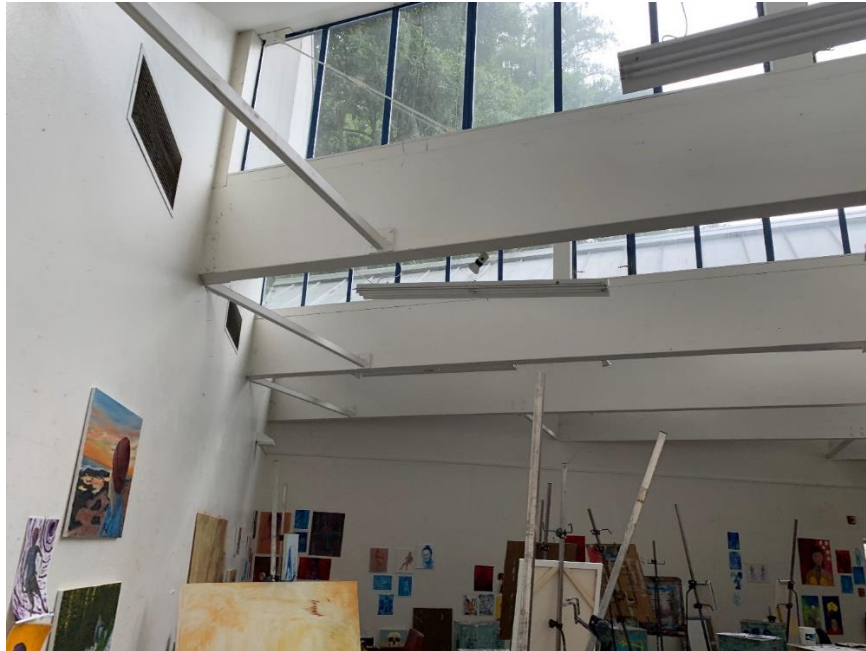
Glulam beams supporting clerestory windows.

Note the tie rod in the upper left corner running from the bottom of 4x10 header over the windows to the top of the 6-3/4" x 27" glulam at the bottom chord. The TX3x2x3/16 struts are also visible at the bottom chord level.
