Text in **green** is to be part of UC Santa Cruz building database and may be part of UCOP database**UC Santa Cruz building seismic ratings****Music Center – Recital Hall**

CAAN #7922.1

DATE: 2019-06-24

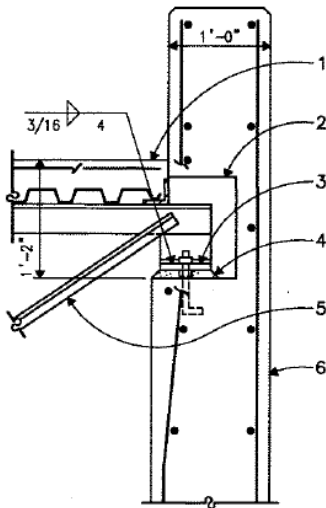
330 19

- The connection of the concrete fill over metal deck roof diaphragm to the north and south walls is inadequate for lateral support of the top of the concrete wall.
- The connection of the concrete fill over metal deck roof diaphragm is significantly inadequate to transfer the diaphragm seismic forces to the perimeter concrete walls.

The connection of the concrete fill over metal deck roof diaphragm to the wall in the east-west direction is inadequate for lateral support of the concrete wall, and significantly inadequate (DCR = 0.6) to transfer the diaphragm seismic forces to the perimeter concrete walls. A rating of V reflects this major deficiency.

Joist connection at roof diaphragm to concrete wall, used at east and west walls only

While the concrete walls are adequately sized to resist a BSE-C level seismic event and possibly larger, the connection of the concrete fill over metal deck roof to the concrete walls, which relies on the joists underlying the roof and running east to west consists of two 3/4" diameter anchor bolts at each joist in addition to spot welds to a ledger angle along the perimeter of the walls. The capacity of this connection is significantly inadequate to transmit the diaphragm seismic force to the concrete walls and should be evaluated further for the purpose of retrofit.

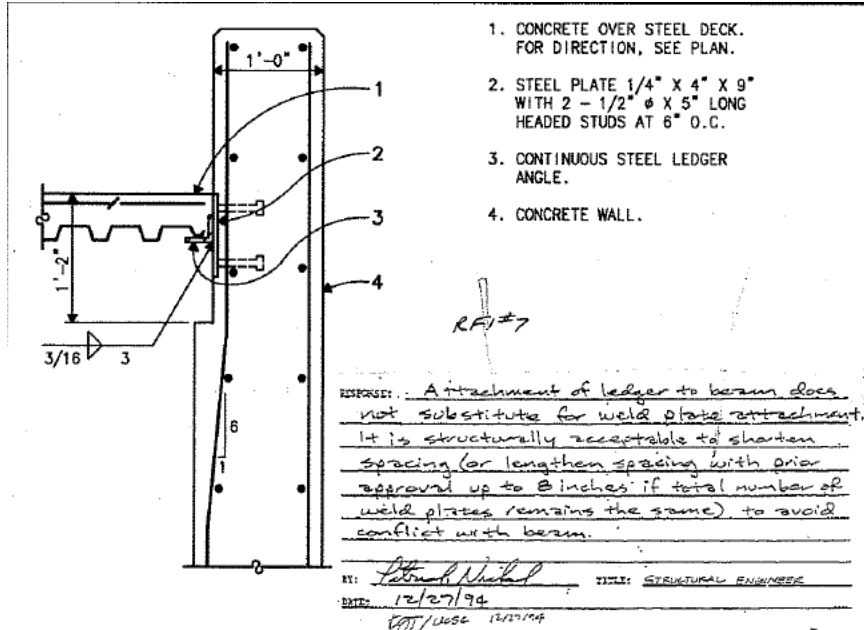
331 19

- The concrete fill over metal deck roof diaphragm is connected to the exterior walls with ledger angles anchored to the concrete walls and attached to the metal deck with puddle welds. Current research suggests that welded connections of metal deck to supporting steel provide less ductility than other connection types such as fasteners.

Ledger angle connection at roof diaphragm to concrete wall, used around entire building perimeter

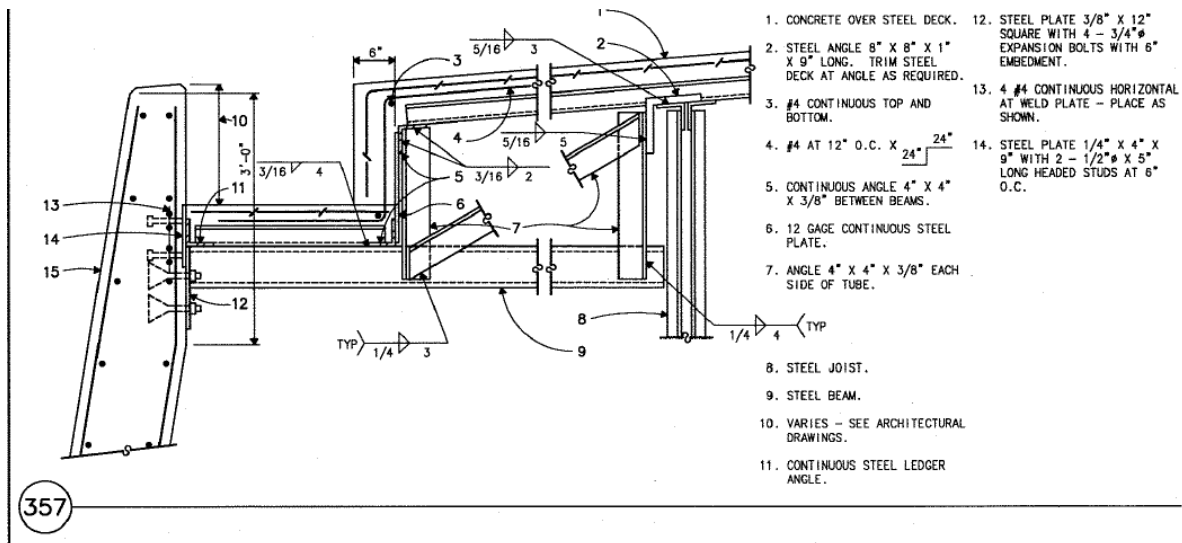
357

- The roof diaphragm is discontinuous at the south end of the building, with a step at the connection of the diaphragm to the wall. Further evaluation is required to determine whether the step details are adequate for in-plane and out-of-plane diaphragm demands.

Connection at roof diaphragm to concrete wall, at diaphragm step at the south wall

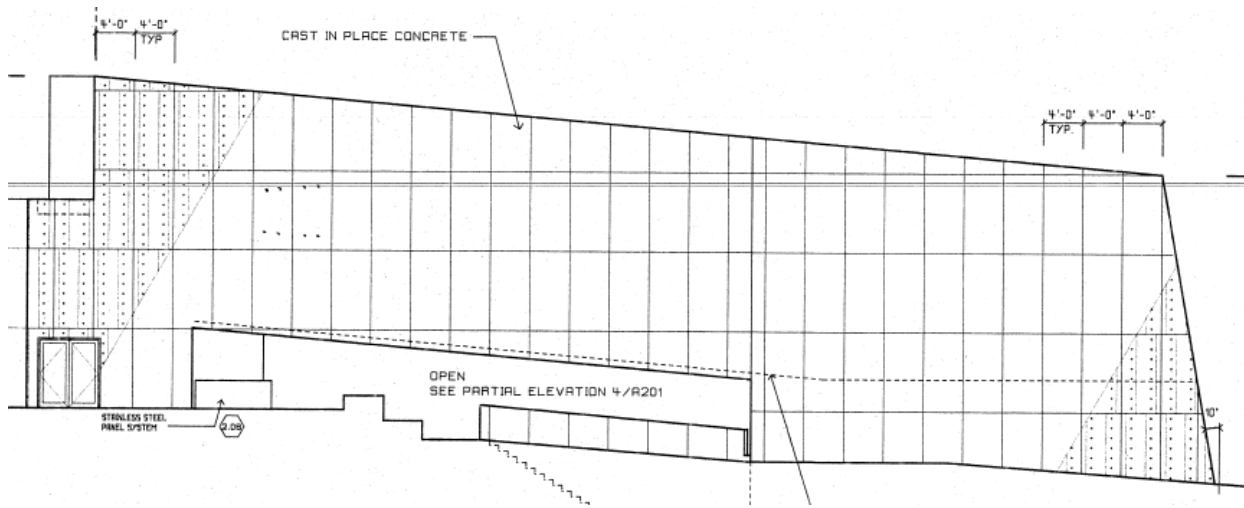
- The west wall of the building is discontinuous for over 80% of its length. Because wall shear stresses are low and the wall bears on solid wall at each end, it is not anticipated that this affects the building rating.

West Elevation of Recital Hall showing discontinuous wall at west wall

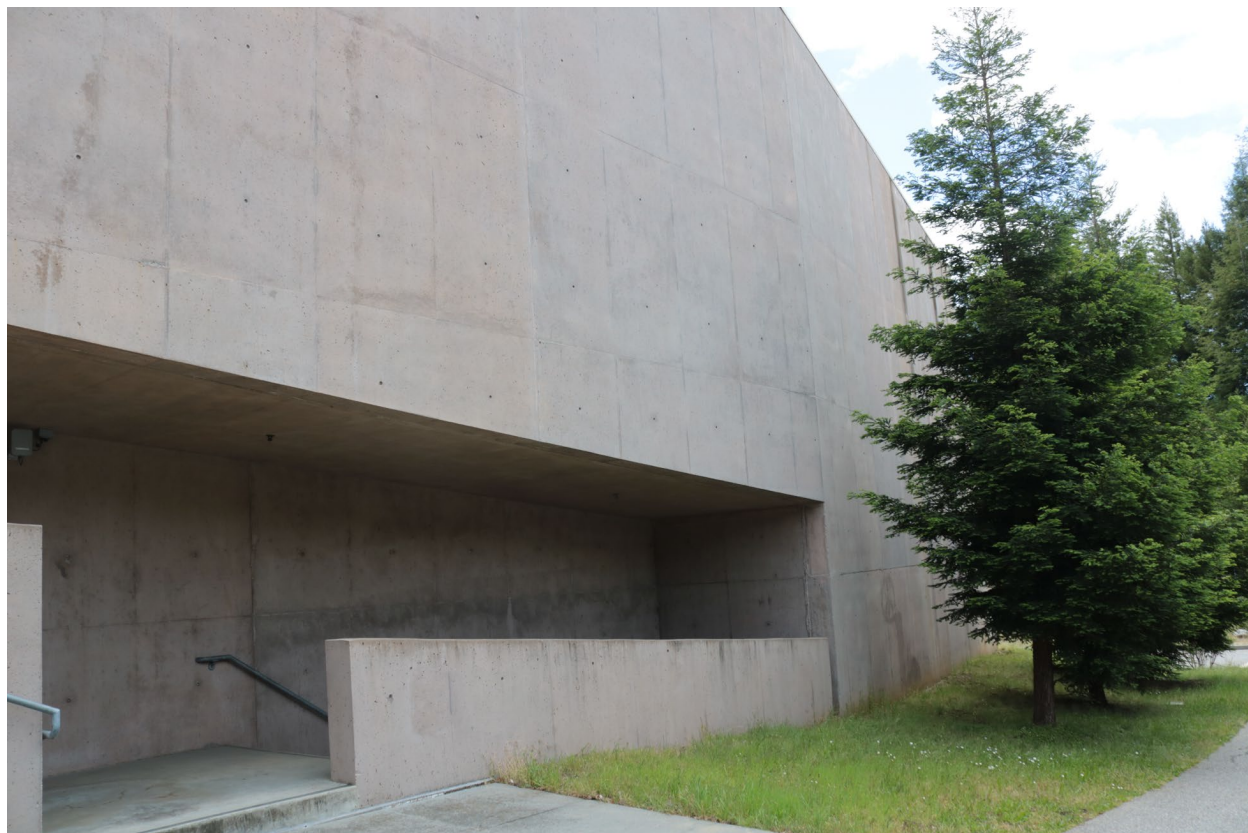
Discontinuous wall at west elevation of Recital Hall (looking north)
