Text in *green* is to be part of UC Santa Cruz building database and may be part of UCOP database**UC Santa Cruz building seismic ratings**  
**Music Center – Ensemble Rehearsal Wing**

CAAN #7922.2

DATE: 2019-06-24

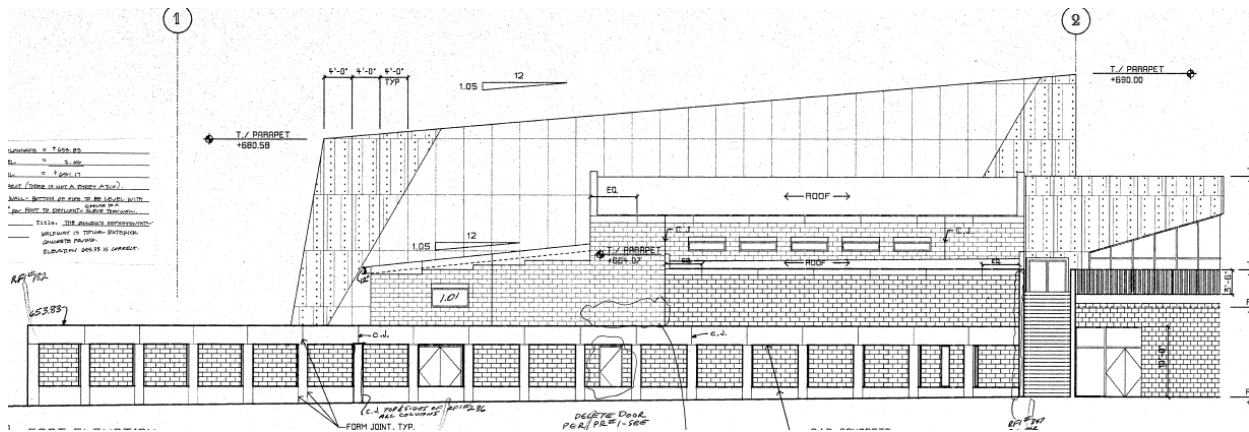
- The expansion joint between the Ensemble Rehearsal Wing and the adjacent Recital Hall (CAAN 7922.1) is 1" wide. It is likely that the gap is too small and that pounding might occur between the buildings in the case of a significant seismic event. Because the floors of the adjacent buildings do not align, the second floor and roof of the Ensemble Rehearsal Building would pound on the east concrete wall of the Recital Hall which has no floors at these elevations, and at roof level is at a higher elevation than that of the Ensemble Rehearsal building.

East Elevation of Ensemble Rehearsal Wing with Recital Hall (CAAN 7922.1) behind

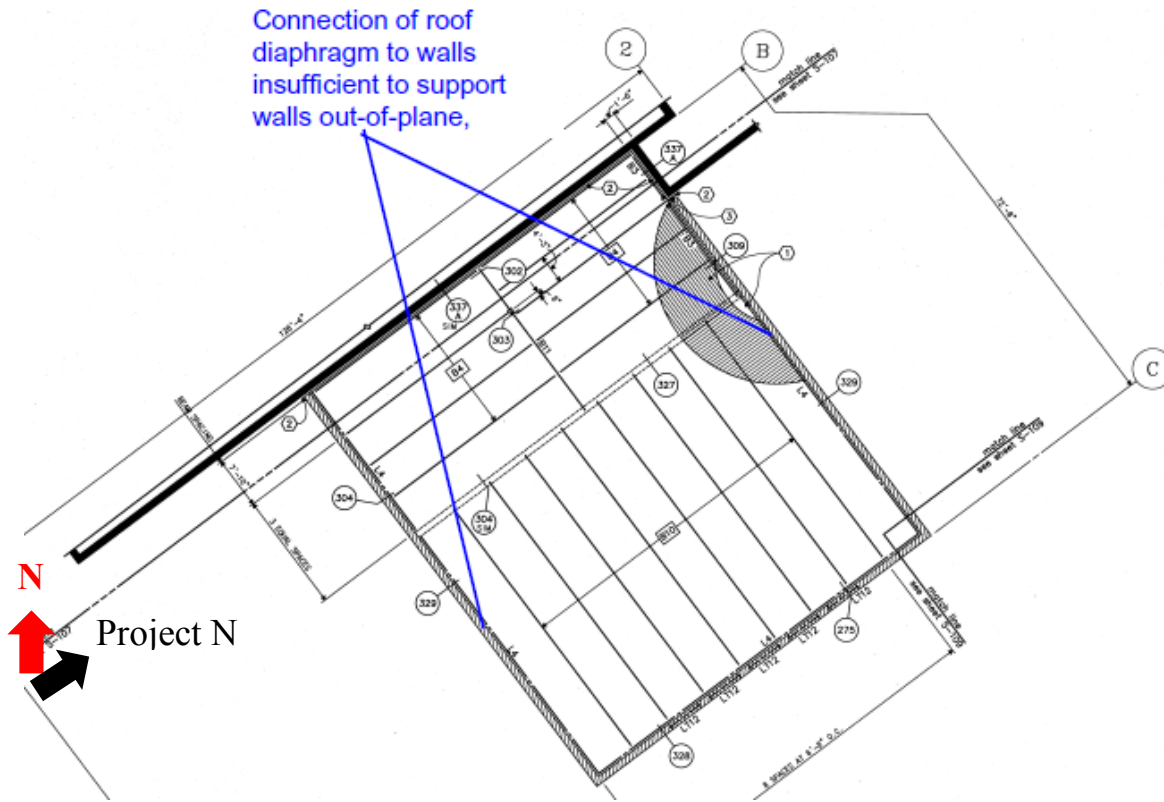
Roof Plan of Ensemble Rehearsal Hall

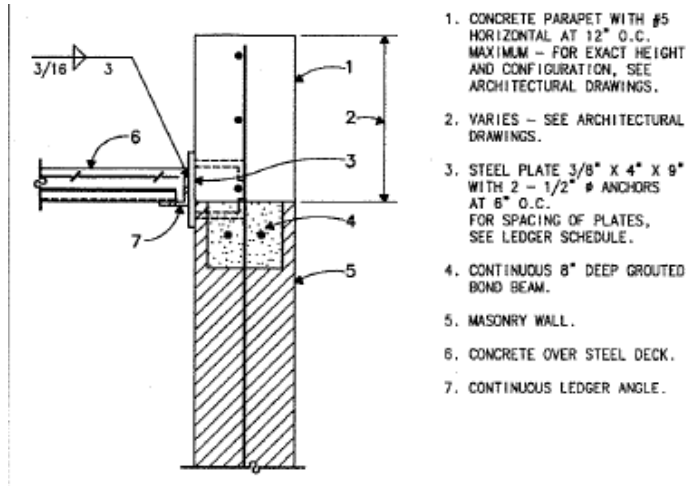
329 05

- The connection of the concrete fill over metal deck roof diaphragm to the north and south walls of the Ensemble Rehearsal Hall relies on spot welds to a ledger angle running along the walls. The capacity of the welds is inadequate for lateral support of the top of the CMU wall.

The connection of the concrete fill over metal deck roof diaphragm to the north and south walls of the Ensemble Rehearsal Hall is inadequate for lateral support of the CMU walls. A rating of V reflects this deficiency, in addition to other connection vulnerabilities as described above.

Ledger angle connection at roof diaphragm to CMU wall, used around entire building perimeter

While the CMU walls are adequately sized to resist a BSE-C level seismic event and possibly larger, the connection of the concrete fill over metal deck roof diaphragm to the north and south walls of the Ensemble Rehearsal Hall is inadequate for lateral support of the CMU walls. Further evaluation is also needed for the connection of roof to wall, which consists of two 3/4" diameter anchor bolts at each W-beam in addition to spot welds to a ledger angle along the perimeter of the walls. The capacity of these connections approaches the diaphragm seismic force transfer demands to the CMU walls and should be evaluated further for the purpose of retrofit.
