UC Santa Cruz building seismic ratings
Music Center – Addition

CAAN #7922.3
 402 McHenry Road, Santa Cruz, CA 95064
 UCSC Campus: Main Campus

DATE: 2019-06-24

This report is for the Music Center Addition (CAAN 7922.3).

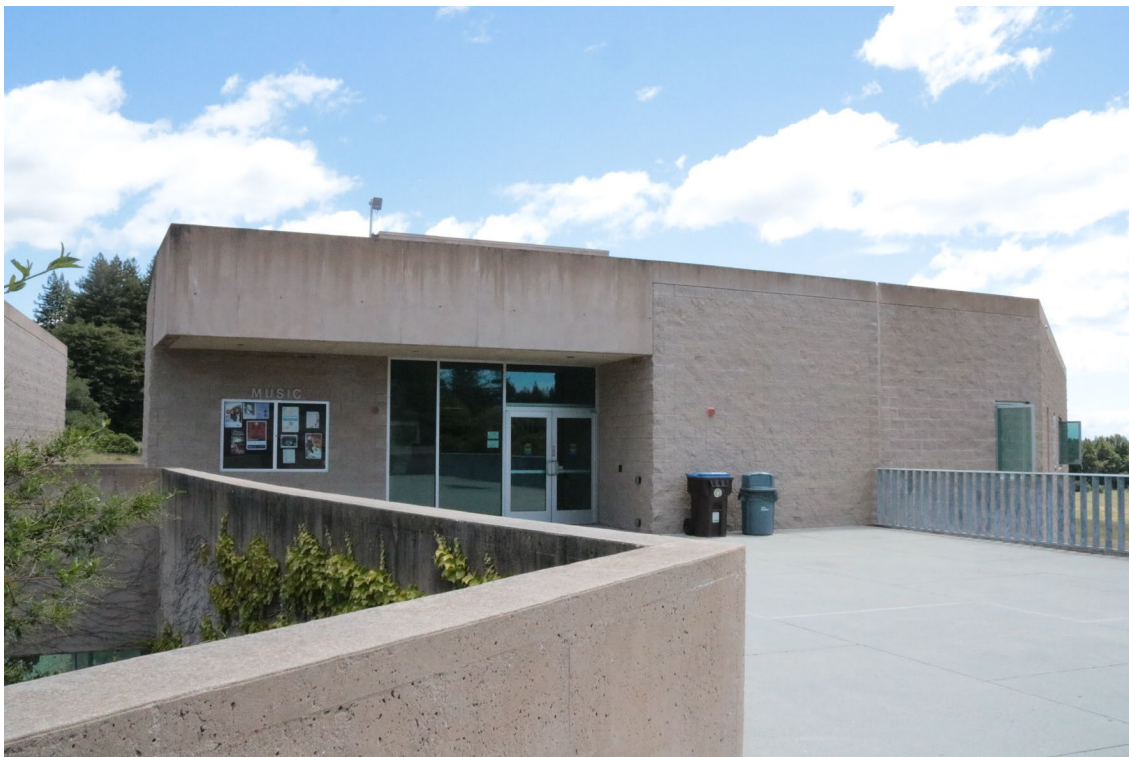
Transition from CAAN 7922 to Building 3W at Level 2 entrance, looking east

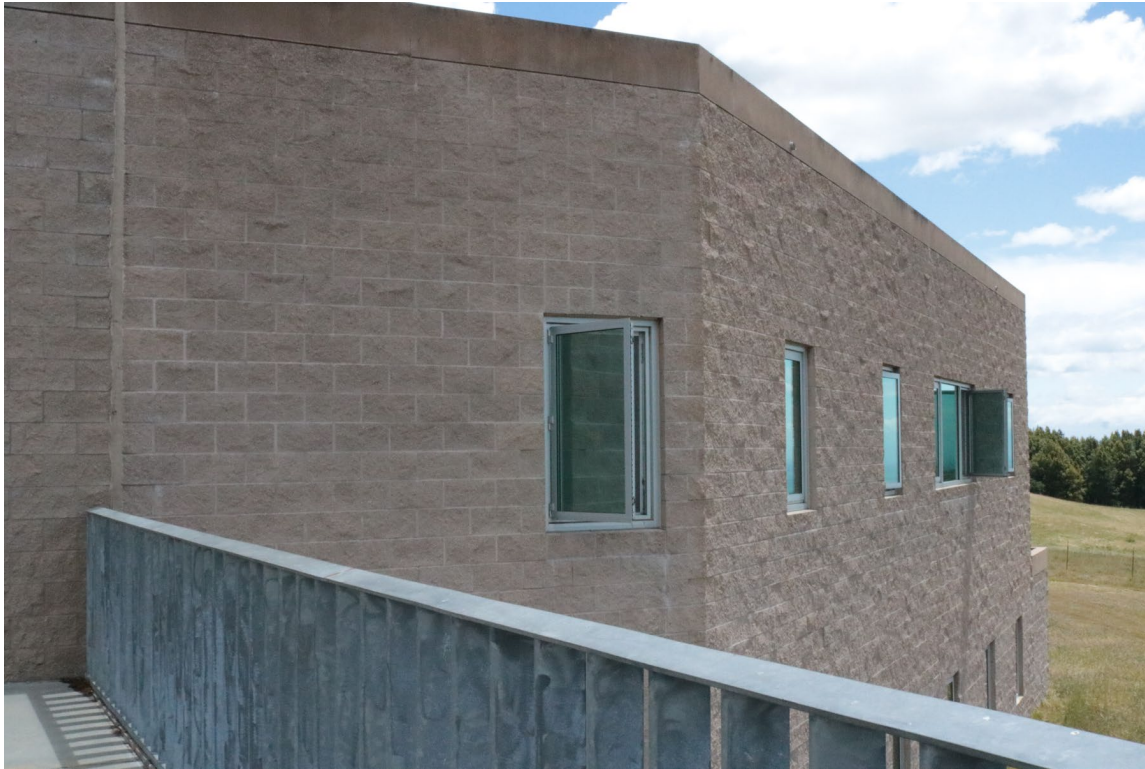
- The seismic isolation gap between buildings 3E and 3W on one side and the adjacent Lab Studios (CAAN 7922) building is 2" wide. It is likely that the seismic gap is too small and that pounding might occur between the buildings in the case of a significant seismic event. Since the floor levels align on each side of the joint, this is not anticipated to affect the rating.
- The concrete fill over metal deck roof diaphragm is connected to the perimeter supporting walls by puddle welds to steel ledgers anchored to the walls. Current research suggests that welded connections of metal deck to supporting steel provide less ductility than other connection types such as fasteners.

Expansion joint at Building 3W, looking south

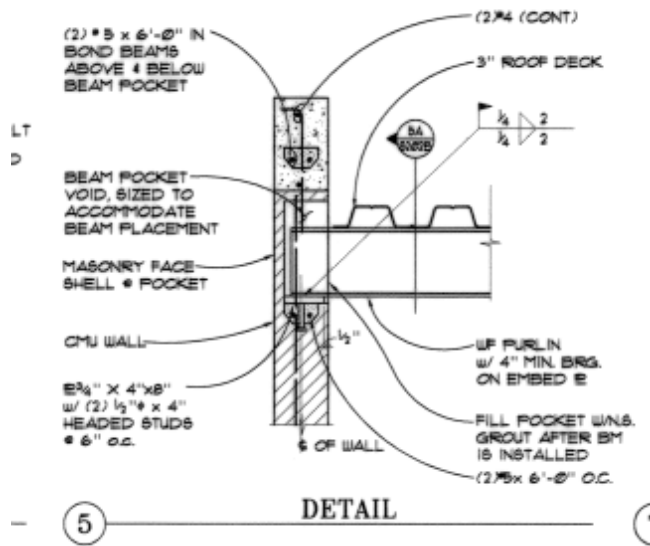
W-beam connection at roof diaphragm to CMU wall, used at east and west walls only

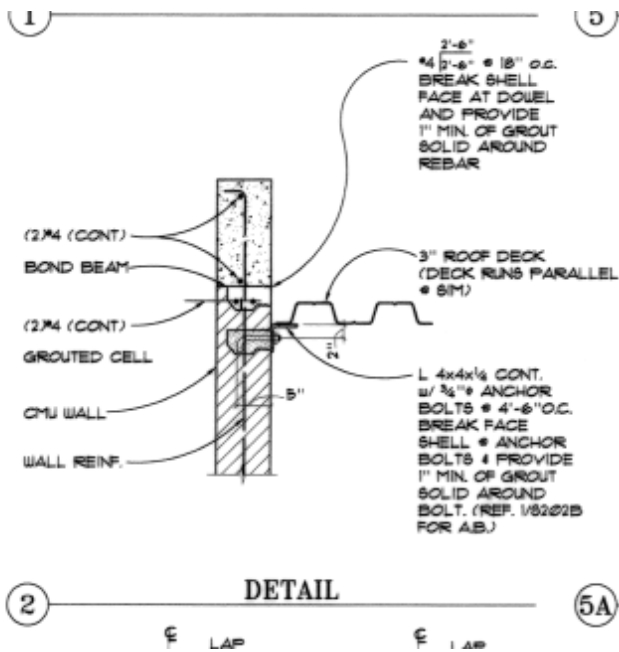
Ledger angle connection at roof diaphragm to CMU wall, used around entire building perimeter
