Text in *green* is to be part of UC Santa Cruz building database and may be part of UCOP database**UC Santa Cruz building seismic ratings****Music Center – Practice Studios and Class Lab**

CAAN #7922

402 McHenry Road, Santa Cruz, CA 95064

DATE: 2019-06-30

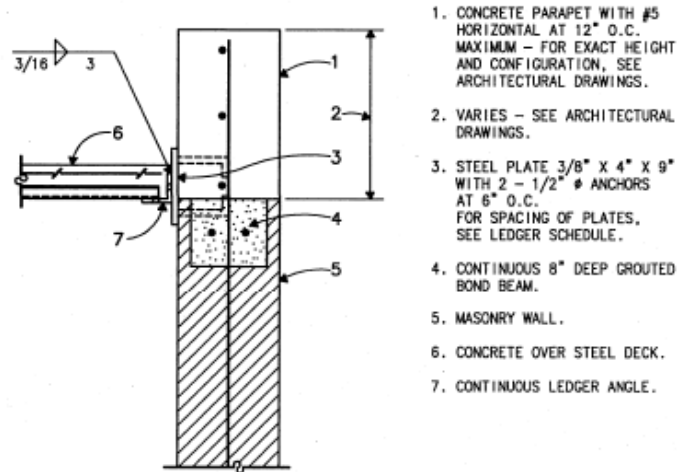
329 05

- For the South Building, the concrete fill over metal deck roof diaphragm is connected to the exterior walls with ledger angles anchored to the CMU walls and attached to the metal deck with puddle welds. Current research suggests that welded connections of metal deck to supporting steel provide less ductility than other connection types such as fasteners. In addition, the margin of safety for lateral support of the east and west walls is small and warrants further evaluation.

Ledger angle connection at roof diaphragm to CMU wall, used around entire building perimeter

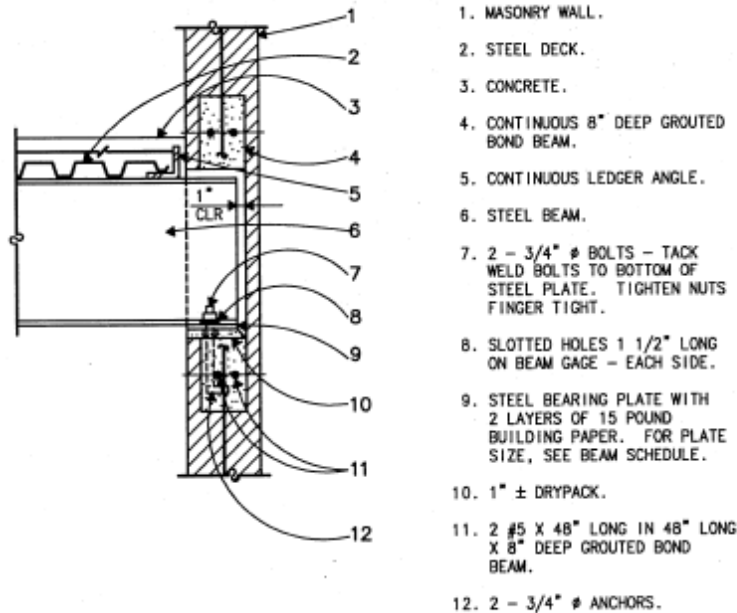
304 STEEL BEAM BEARING ON MASONRY WALL  
417-03

Joist connection at roof diaphragm to CMU wall, used at north and south walls only
