## UC Santa Cruz building seismic ratings

### Visual Arts Facilities-Building P

CAAN #7929

Elena Baskin Visual Arts, Santa Cruz, CA 95064

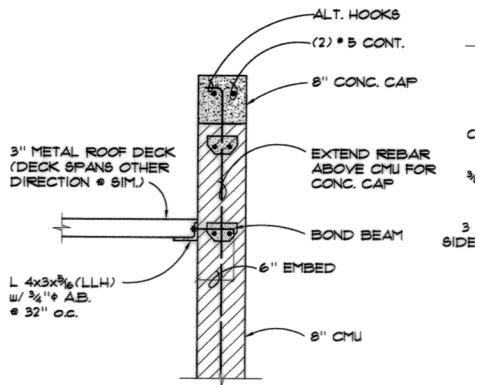
**7** TYP. LEDGER  
CONN. TO CMU WALL  
1"=1'-0" S122

- Roof-to-wall tie: The typical roof-to-wall tie per Detail 7/S3.01 at the west and east walls relies on puddle welds from the deck to the top of an L4x3x3/8" ledger which are connected with 3/4" diameter bolt at 32" o.c. to a bond beam in the CMU wall. In addition, between CMU walls, there are two concentrated tube-to-wall connections along the wall length per Detail 9/S3.03 that use a similar approach as Detail 7/S3.01, but with four anchor bolts centered about the tube. At the north and south CMU perimeter walls, the deck flutes are parallel to the wall, so the only out-of-plane tie is from the open web joists to a pocket in the wall per Detail 9/S3.01. At the pocket, the top chord of the joist bears on a base plate which has two 3/4" anchor bolts into the CMU wall which resist loads in shear. Information showing how the top chord of the joists is connected to the base plate is missing. A

We recommend the Campus to perform a more detailed review of the anchorage used to transfer the load from the diaphragm to the walls in both orthogonal directions.

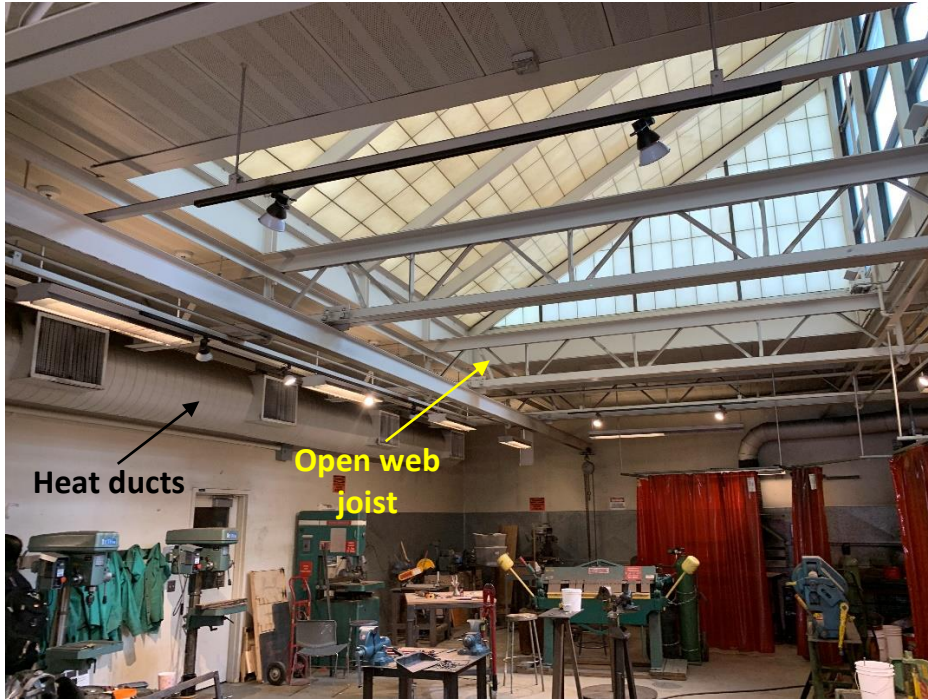
Heat ducts

Open web joist

Metal workshop (looking west)

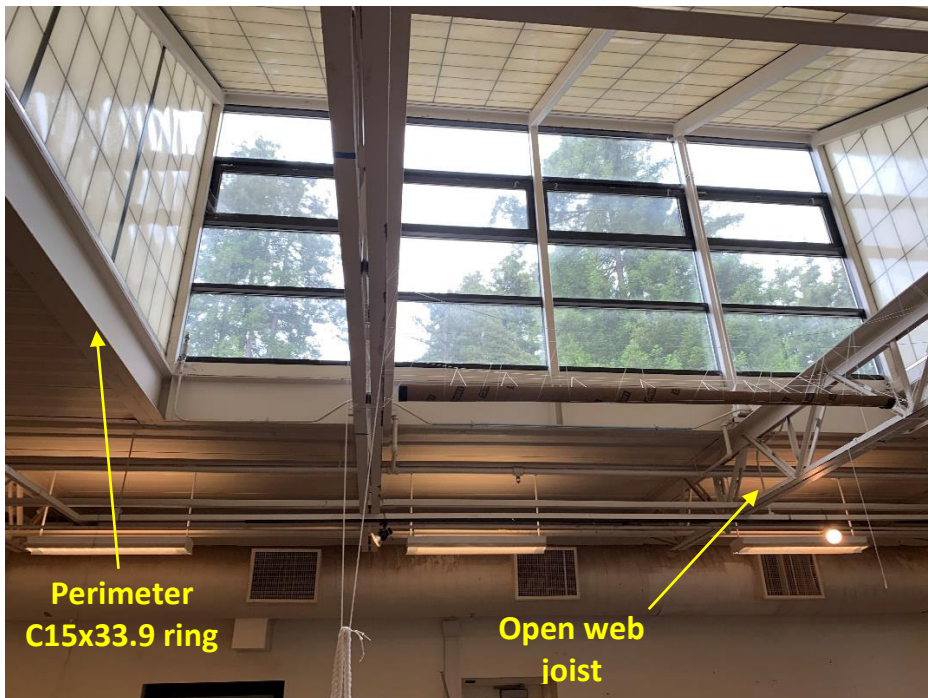
Perimeter C15x33.9 ring

Open web joist

Skylight (looking north)

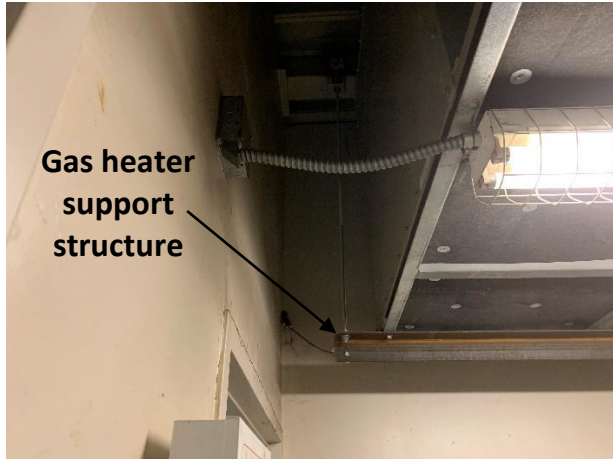
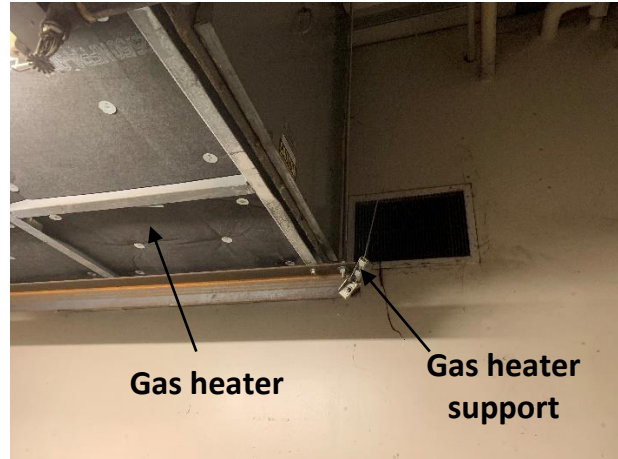
Gas heater support

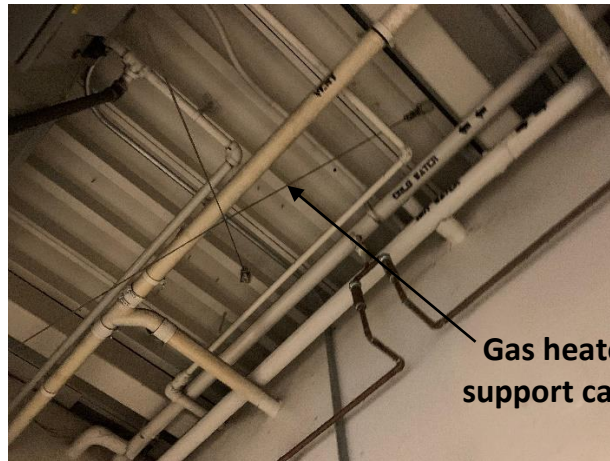
Gas heater support to metal deck
