UC Santa Cruz building seismic ratings
Long Marine Lab Younger Research Building, UCSC

CAAN #7437

University of California, Santa Cruz
ASCE 41-17 Tier 1 Seismic Evaluation
7437 - Long Marine Lab Younger Research Building

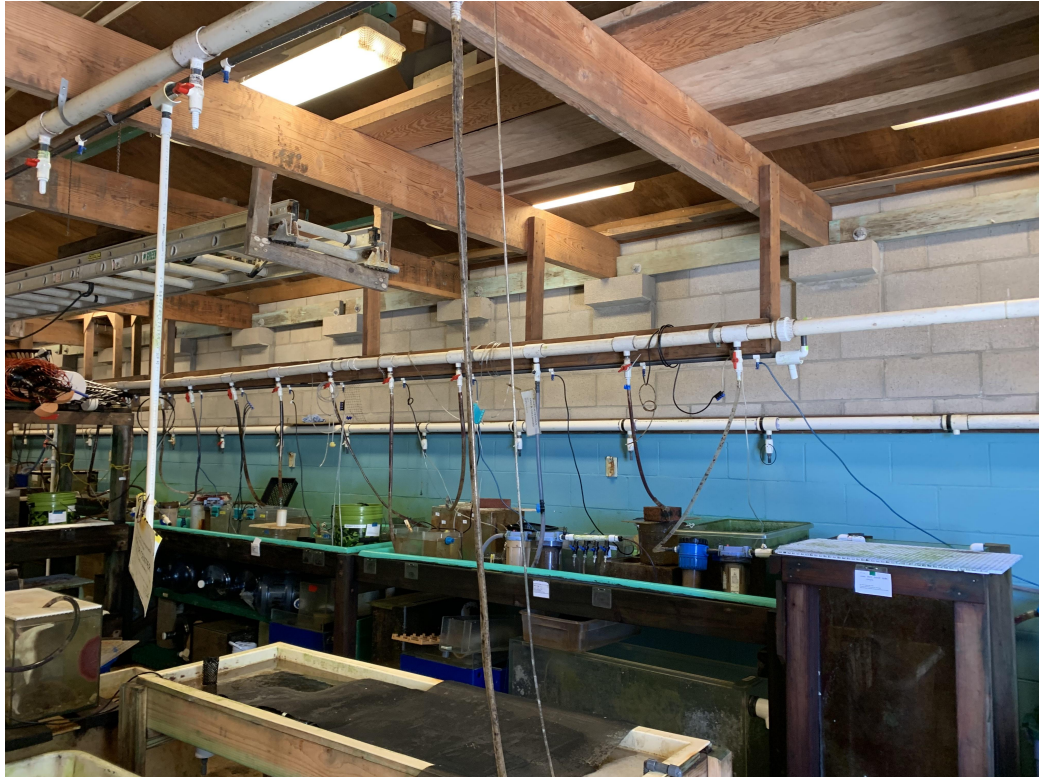
Western Interior View

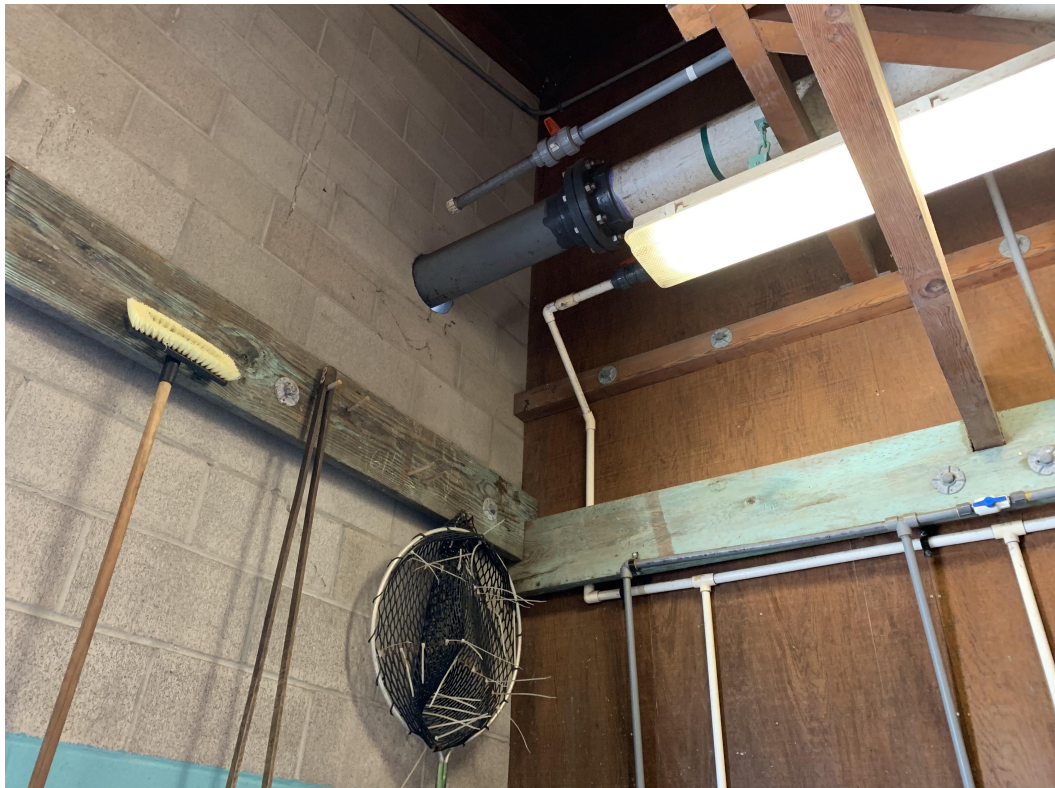
Northern Interior View

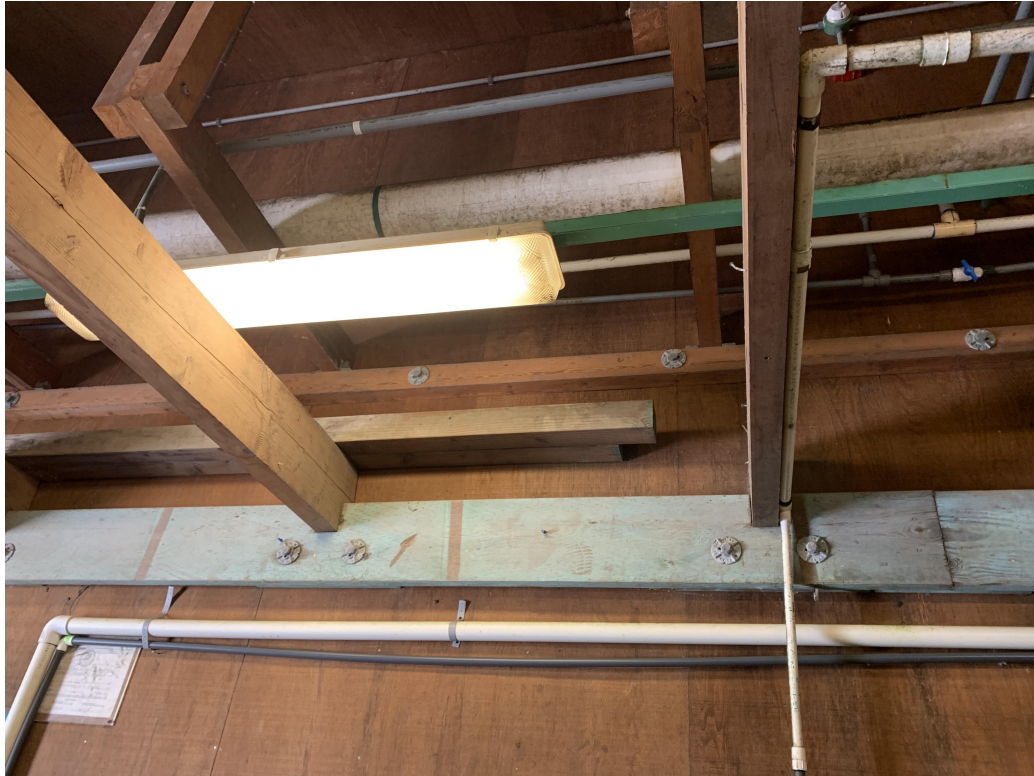
Interior Wall and Removable Joist

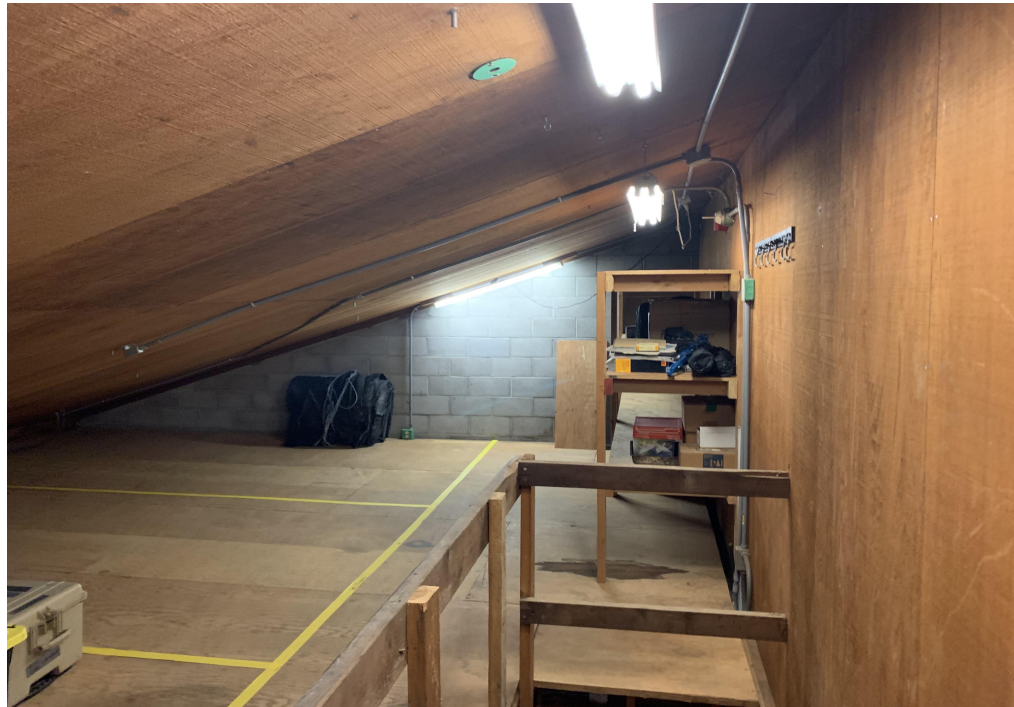
Identification of levels: Ground level with an attic storage space on the south end of the building (Ground Floor).

Southern Attic View

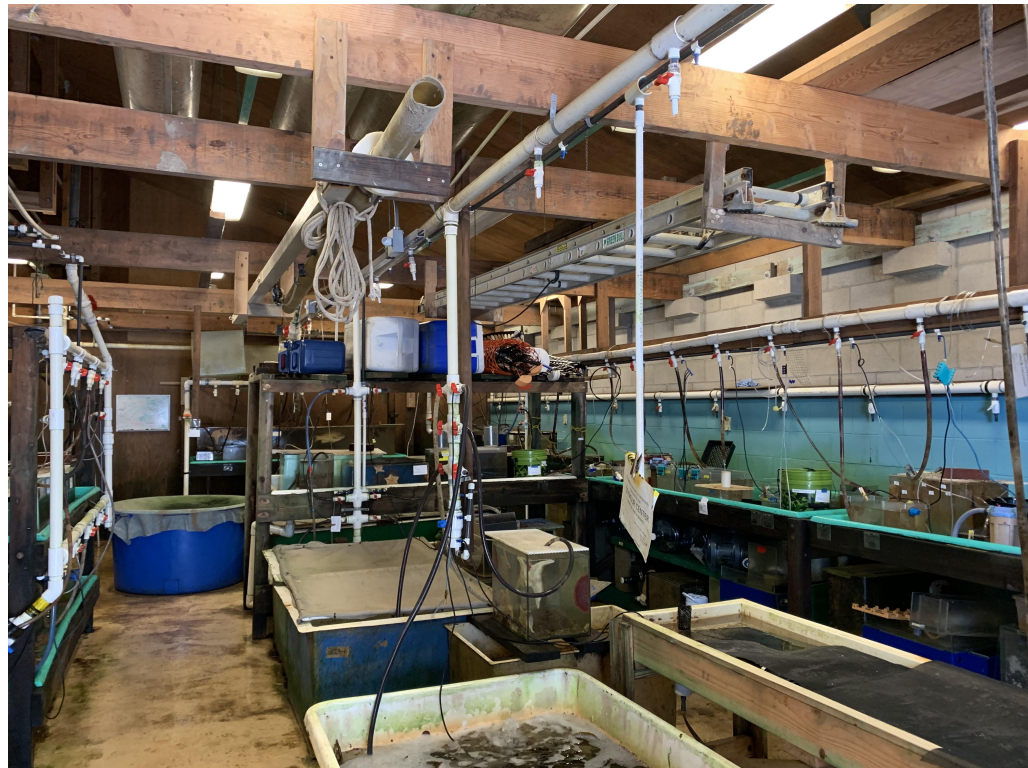
Overhead lab storage and equipment hanging

Unrestrained items stored overhead in Lab space could become dislodged during an earthquake. Injury of lab occupants or blocking of exit routes is possible. Future investigation should look at how these items are anchored when stored.

Equipment Storage Falling Hazards
