DATE: 2019-06-28

**UC Santa Cruz building seismic ratings****MT Hamilton Main Building**

CAAN #7240

UCSC Campus: **Mt Hamilton Campus**

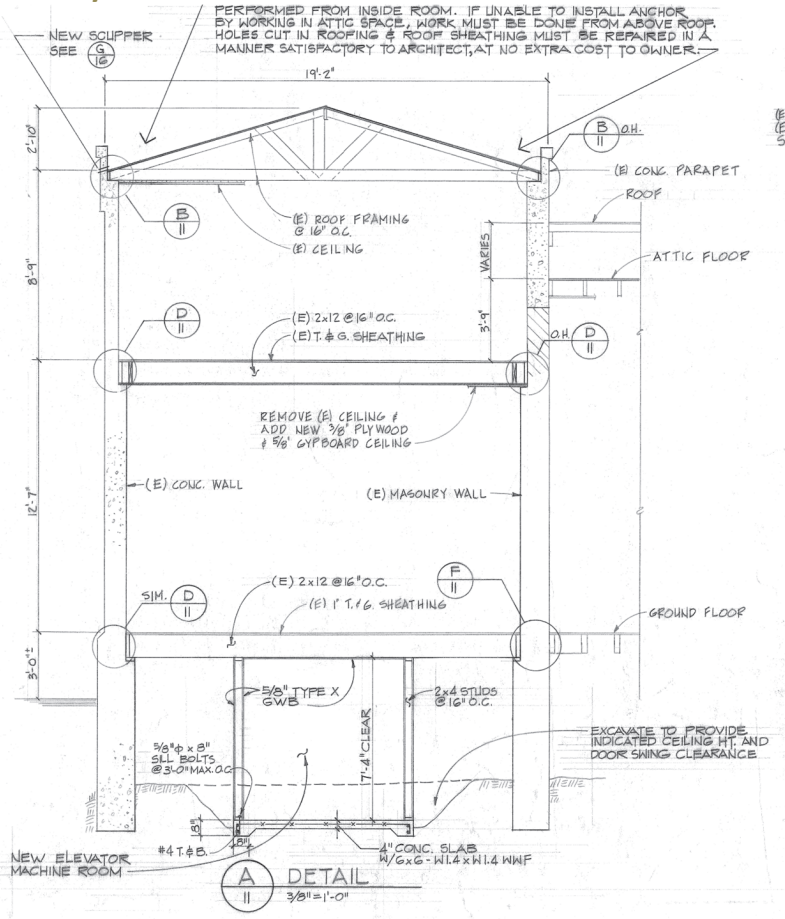
### North Foyer

The building was seismically retrofitted in 1989. Per the 1988 retrofit drawings, the 1985 *Uniform Code for Building Conservation* (UCBC) Appendix Chapter 1 was used with an allowable design base shear of  $V = 0.10W$ . The retrofit included removal of the outer wythe of the exterior brick walls in the rectangular section and replacement with 4" of shotcrete, leaving 16" of brick. 12" wide x 12" deep vertical ribs were installed at a maximum of 8'0" o.c. The shotcrete was connected to the brick with drilled dowels at 4'0" o.c. at the ribs and at the edge of openings. A similar approach was used at the North Dome. At the larger South Dome, the shotcrete replacement is 20-1/2" thick, leaving 8-1/2" of brick. Stucco was used to cover the exterior shotcrete. Interior brick walls were braced against out-of-plane loading with 6x6 wood posts doweled to the brick, but not strengthened with shotcrete for in-plane loads. Plywood was added to the top of the attic floor which aligns with the top of the walls, and out-of-plane and in-plane ties were installed to connect the attic diaphragm and walls. Roof-to-wall and attic floor ties were added at the Central Foyer as well.

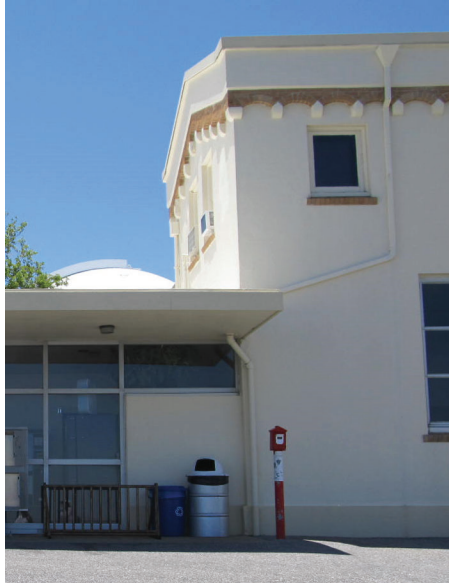
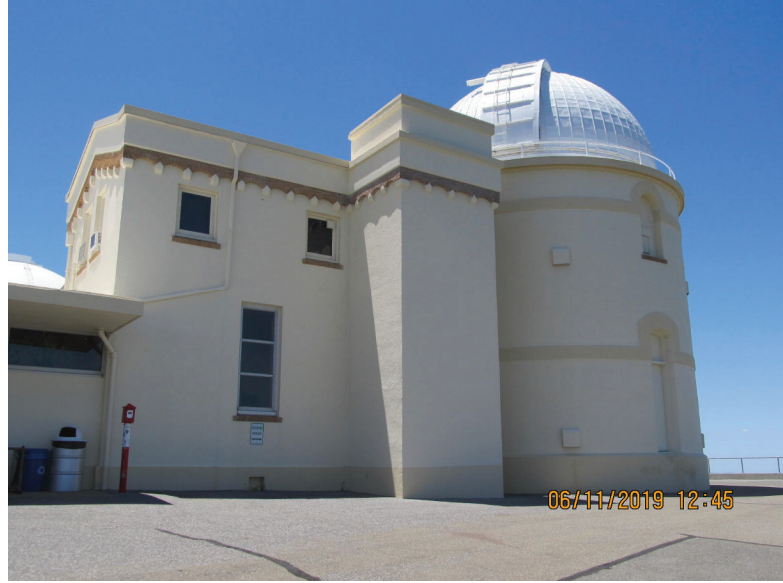
North Elevation (Looking Southwest)  
(Lab and Measurement Building to the Left and the North Dome to the Right)

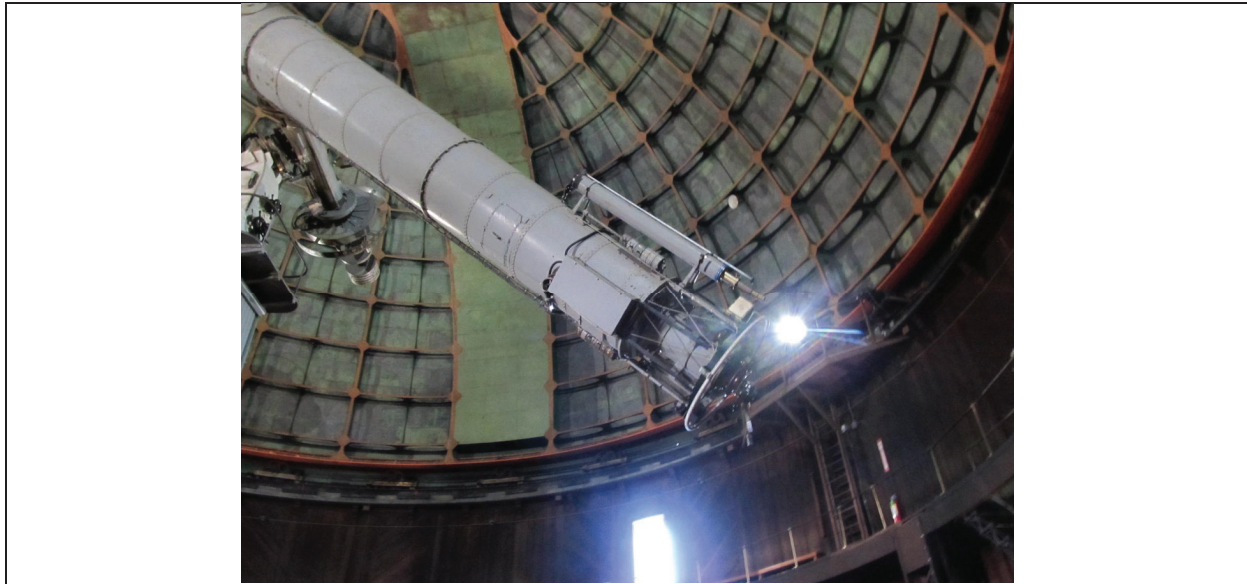
Telescope in South Dome

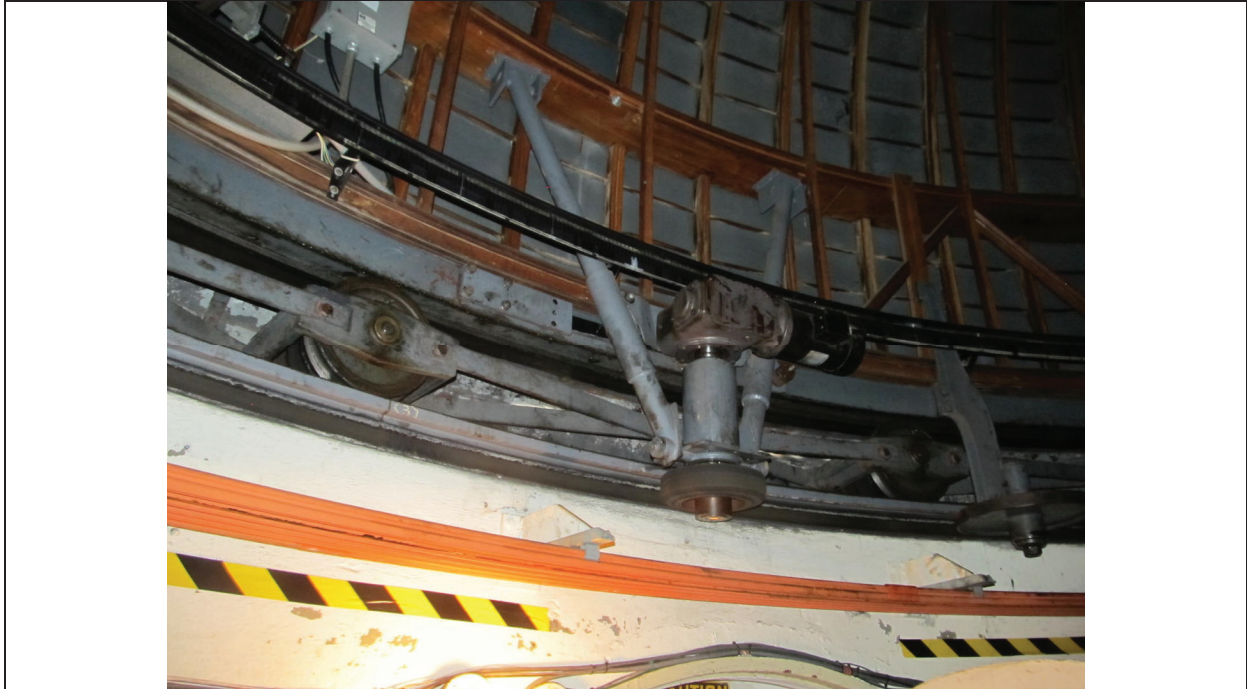
- The ability of the steel dome to act as a diaphragm at the top of the circular walls is questionable.
- There is a 2" cavity shown inside the North Dome URM wall between the inner and the outer wythes. The retrofit provided anchors only every 8'0" o.c. at ribs to cross this joint. Height-to-thickness ratios are high, and because of the cavity, even though the outer wythes are reinforced with shotcrete, the inner wythes may act independently and be damaged or fall from out-of-plane and in-plane forces.

Roller Trucks Supporting the North Dome

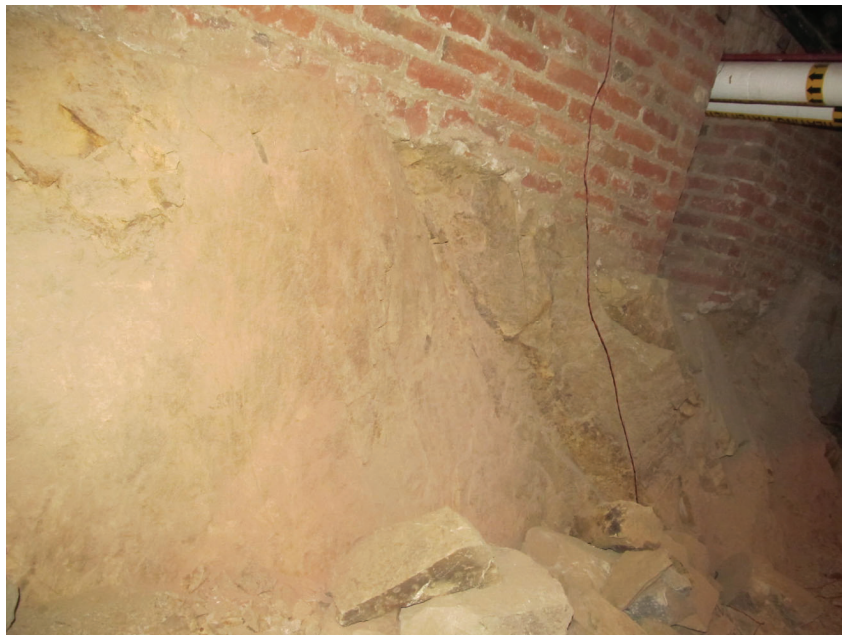
Foundation system: All walls extend down to grade as continuous footings, typically 22" in the halls and 38" at the domes. The rocky site at the top the mountain was reportedly leveled using dynamite. Exposed areas of rock can be seen in the crawl space, and the walls bear directly on the rock. 9x9 brick piers are provided as intermediate support for the first floor framing in the halls; they are spaced typically at 5'-10" in the corridors and 10'-0" to 15'-0" in the offices.

Rock Substrate Directly Under Brick Footings

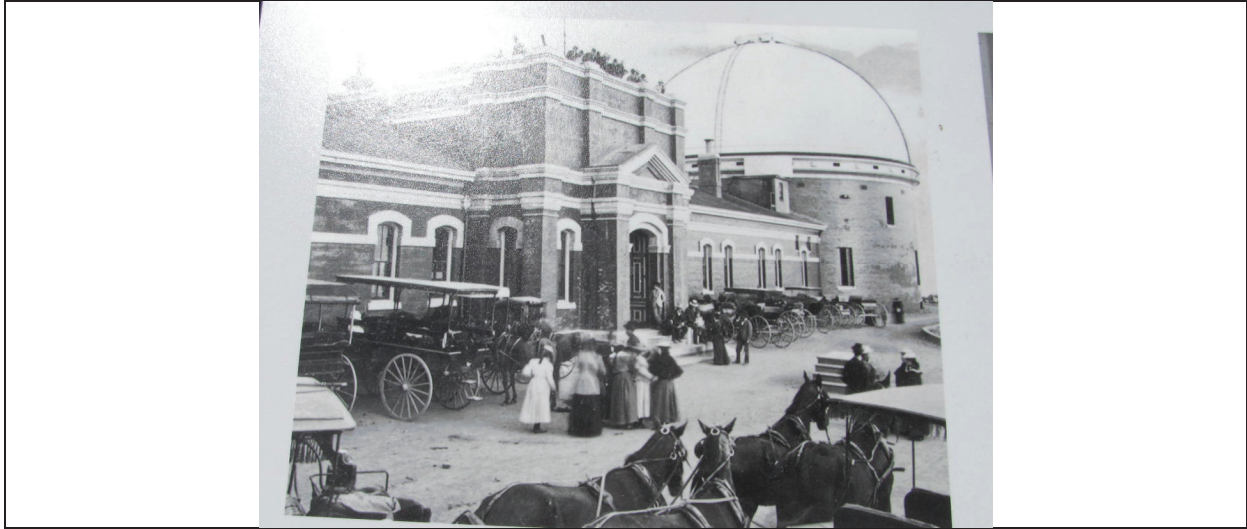
Vintage Photo of the Building (Well) Before Retrofitting Showing Exposed Brick
