**UC Santa Cruz building seismic ratings**  
**Oakes College Residence B11-15**

CAAN #7414  
 230 Oakes Road, Santa Cruz, CA 95064  
 UCSC Campus: Main Campus

DATE: 2019-06-30

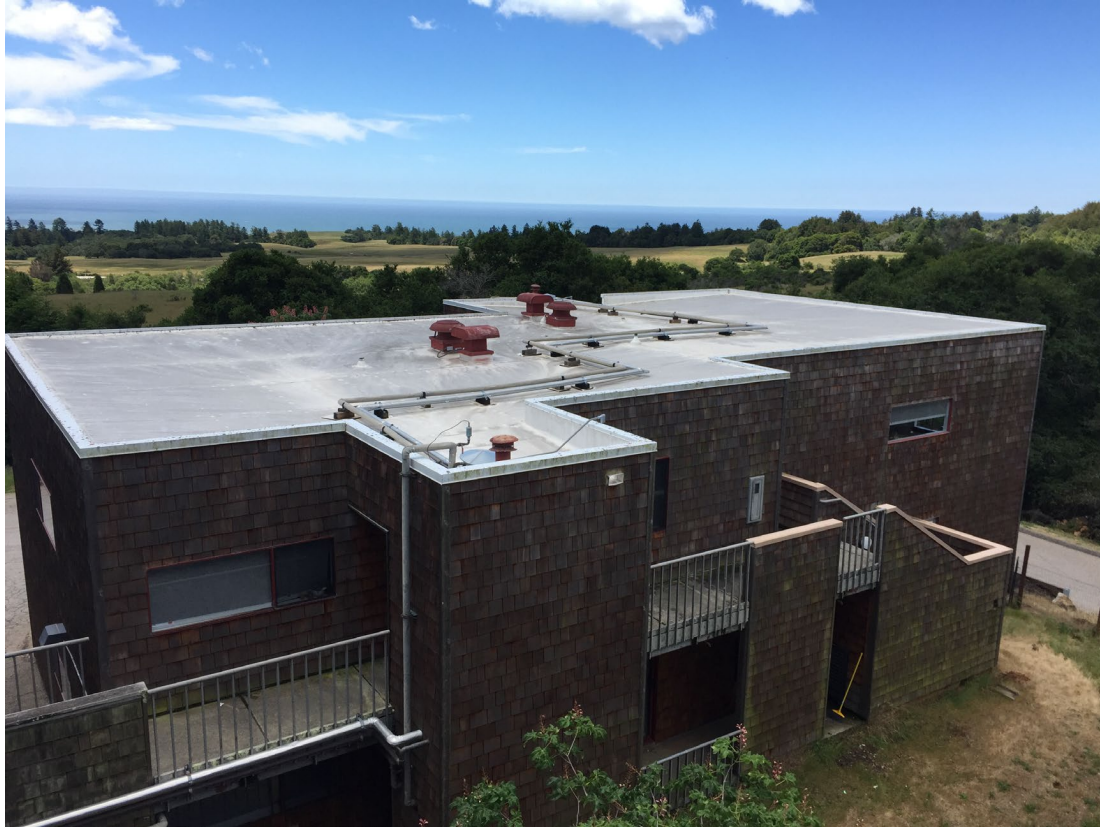
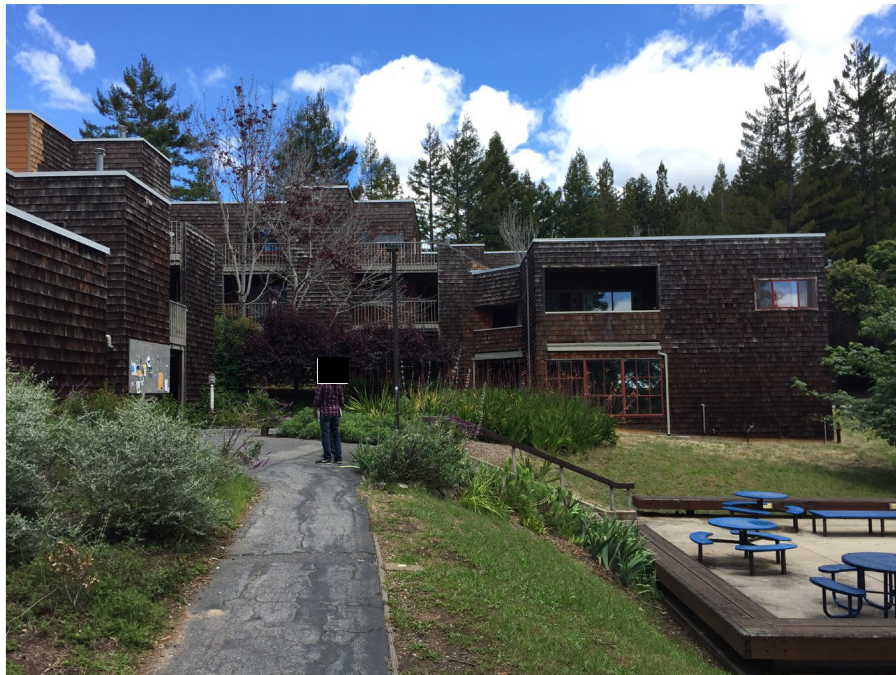
We observed no clear concerns. The stair connections at the exterior walkway is rigid at both ends and may present drift compatibility issues in a seismic event.

Photos of walkway and stairs
