UC Santa Cruz building seismic ratings
Oakes College Residence D14-16

CAAN #7423

243 Oakes Field Service Road, Santa Cruz, CA 95064

DATE: 2019-06-30

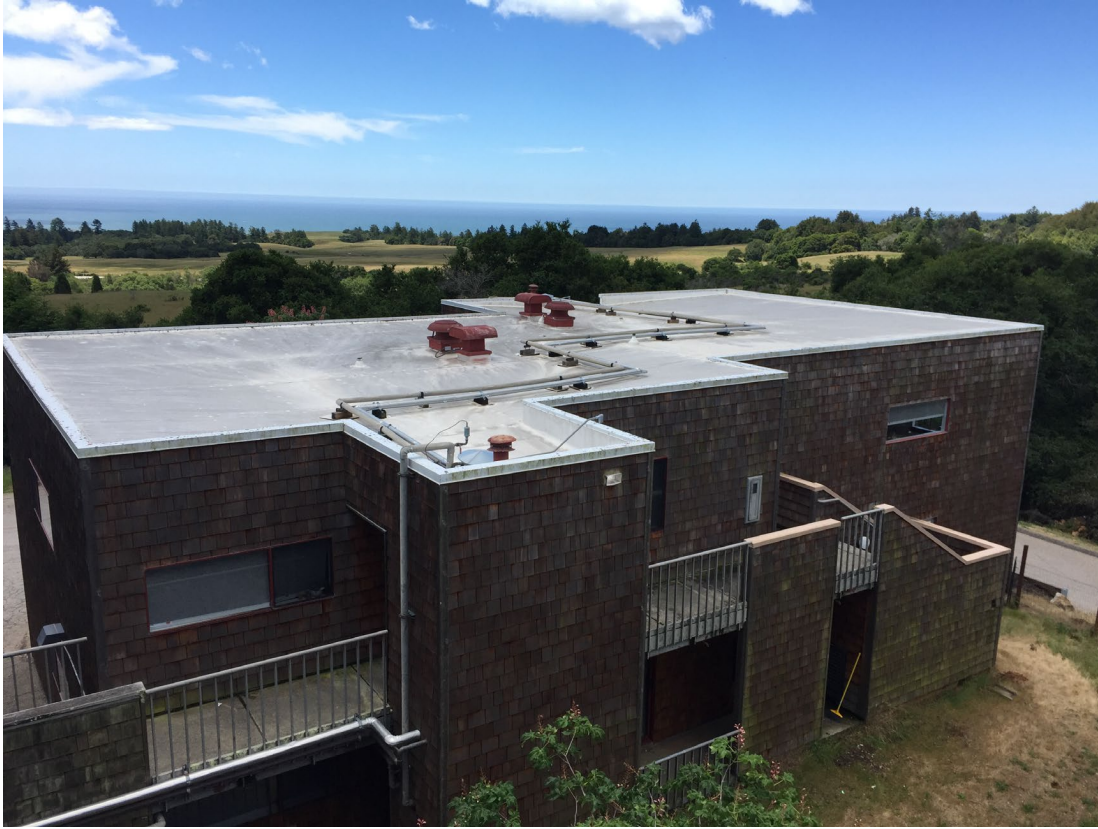
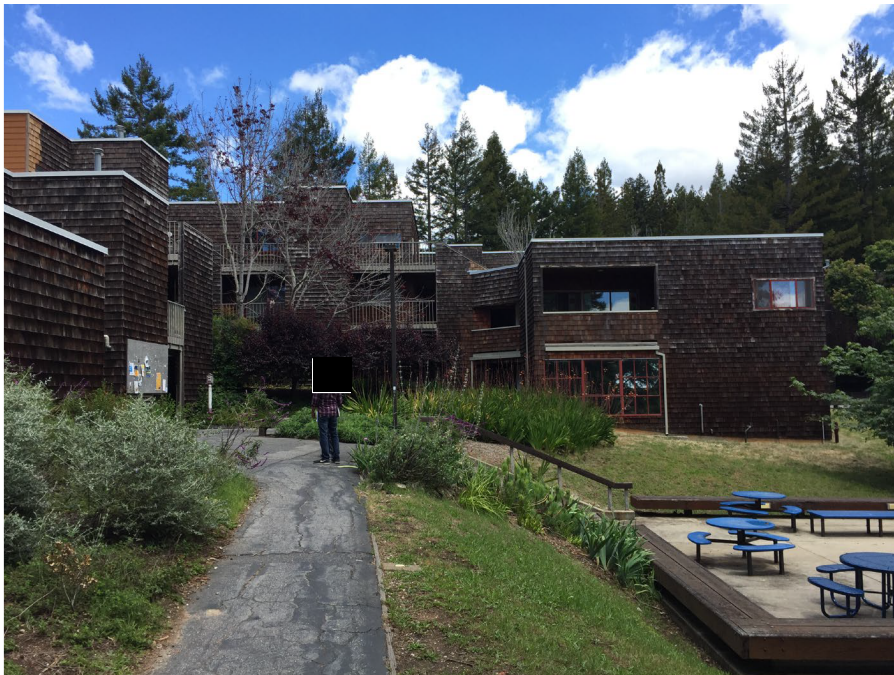
We observed no clear concerns. The stair connections at the exterior walkway is rigid at both ends and may present drift compatibility issues in a seismic event.

Photos of walkway and stairs

Although we rate the building as IV (Fair), we recommend that the Campus perform a more detailed review of stair connections, for both a condition assessment and adequacy of the connections for a seismic event. We put the building on Priority Category B, as the above items should be done if there are any plans for modifying the building.
