## UC Santa Cruz building seismic ratings

### Elena Baskin Visual Arts Building J (Painting Studio)

CAAN #7822

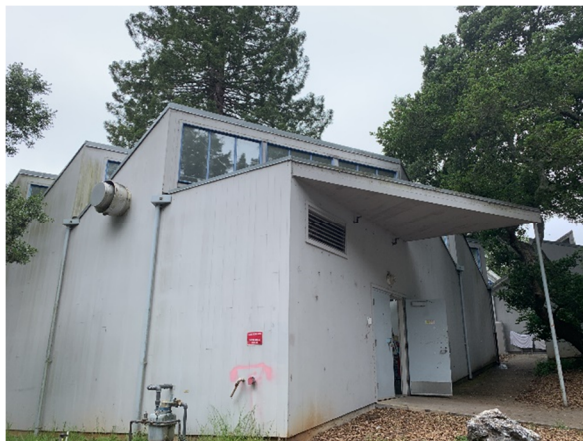
Northeast Corner (Looking Southwest)

Building condition: in general, the building is in good structural condition. No significant damage in the structural system was observed during the site visit.

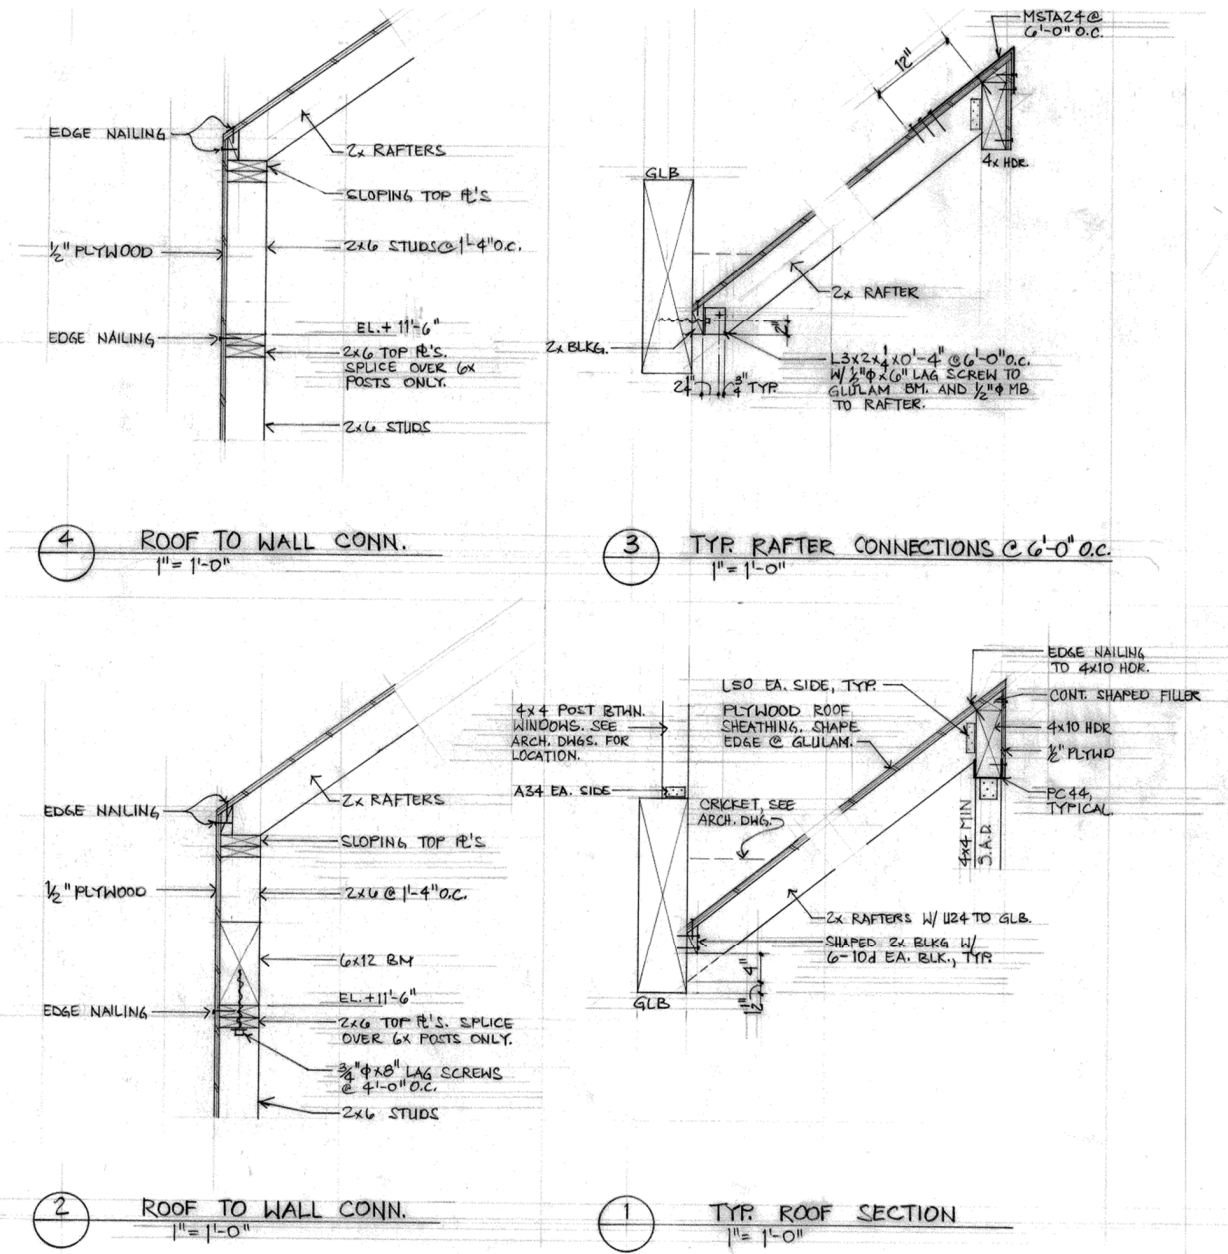
Typical roof details

Lateral loads in the NW-SW direction have a series of nominally connected roof segments because of the clerestory window. At each end of the glulam, there is a ½" diameter tie rod in Detail 8/S4 which vertically connects the 4x10 header at the top of the clerestory window down to the glulam at the bottom of the window. Internal load transfer within the diaphragm through the tie rods will be small, but the tie rods are also relatively small. The combined plywood and tie-rod bracing diaphragm connects to the perimeter walls and transfers loads into the walls and down to the foundation.

- The only deficiency is that of the roof diaphragm discontinuity created by the sawtooth roof segments. In the NE-SW direction, this creates high diaphragm aspect ratios. In the NW-SE direction, the unusual combination of plywood and tension rods in the windows limits diaphragm capacity in the load path and increases diaphragm flexibility.

We recommend that at Tier 2 evaluation be performed to investigate in detail the adequacy of the segmented roof diaphragm including the tie rods, their connections, the struts, and weak way bending of the wood members. If these are found to be adequate, this could lead to an improvement in the rating from level V to Level IV.
