Text in **green** is to be part of UC Santa Cruz building database and may be part of UCOP database**UC Santa Cruz building seismic ratings****Music Center – Recital Hall**

CAAN #7922.1

DATE: 2019-06-24

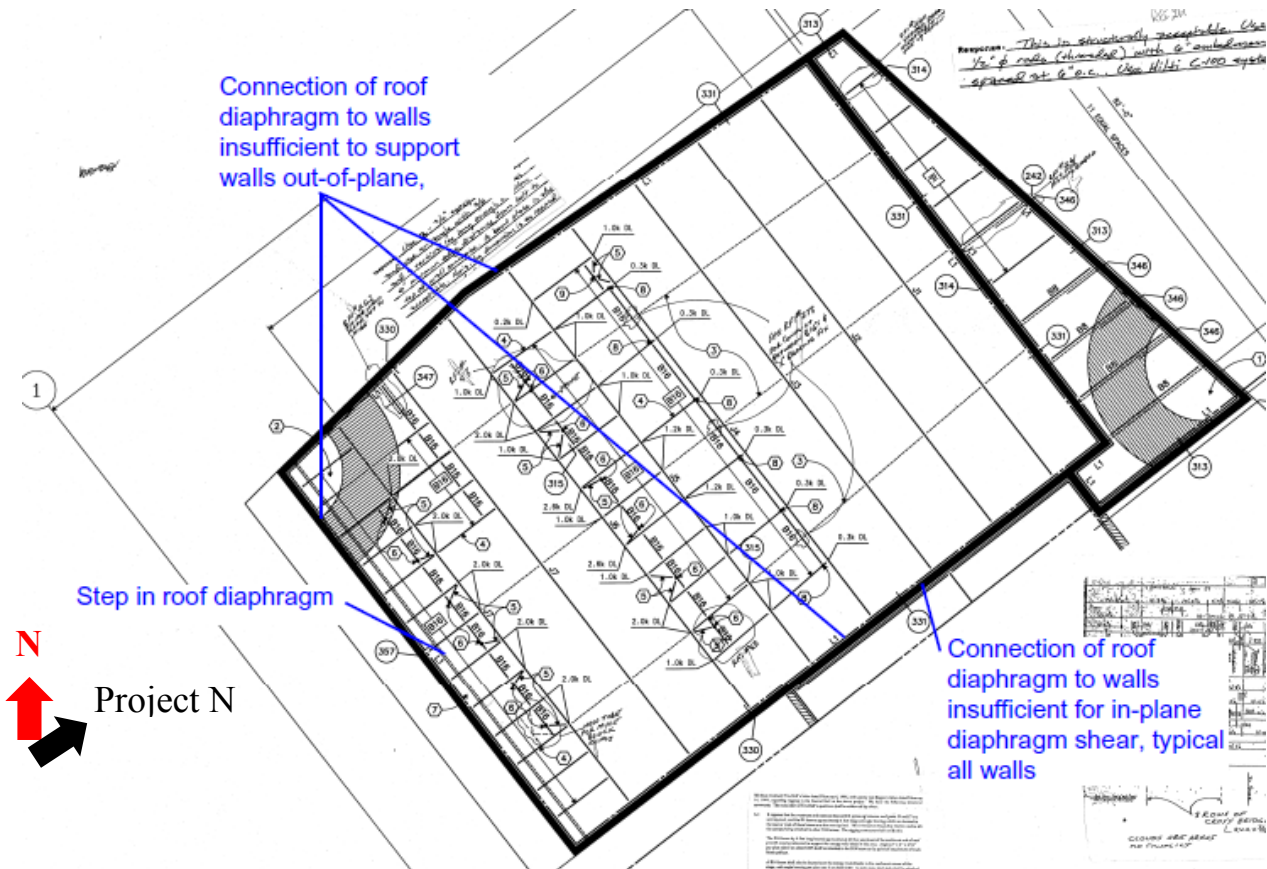
Roof Plan of Recital Hall

The connection of the concrete fill over metal deck roof diaphragm to the wall in the east-west direction is inadequate for lateral support of the concrete wall, and significantly inadequate (DCR = 0.6) to transfer the diaphragm seismic forces to the perimeter concrete walls. A rating of V reflects this major deficiency.

While the concrete walls are adequately sized to resist a BSE-C level seismic event and possibly larger, the connection of the concrete fill over metal deck roof to the concrete walls, which relies on the joists underlying the roof and running east to west consists of two 3/4" diameter anchor bolts at each joist in addition to spot welds to a ledger angle along the perimeter of the walls. The capacity of this connection is significantly inadequate to transmit the diaphragm seismic force to the concrete walls and should be evaluated further for the purpose of retrofit.
