Text in *green* is to be part of UC Santa Cruz building database and may be part of UCOP database**UC Santa Cruz building seismic ratings**  
**Music Center – Ensemble Rehearsal Wing**

CAAN #7922.2

DATE: 2019-06-24

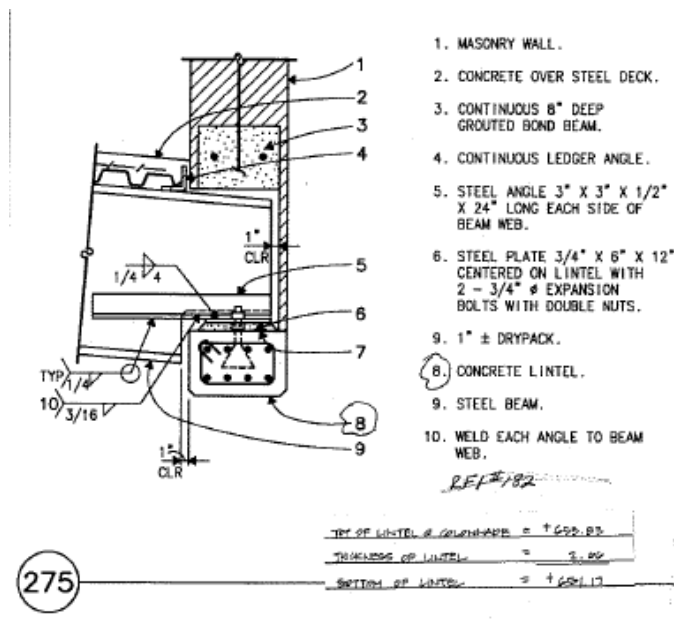
- The connection of the concrete fill over metal deck roof diaphragm to the north and south walls of the Ensemble Rehearsal Hall relies on spot welds to a ledger angle running along the walls. The capacity of the welds is inadequate for lateral support of the top of the CMU wall.

While the CMU walls are adequately sized to resist a BSE-C level seismic event and possibly larger, the connection of the concrete fill over metal deck roof diaphragm to the north and south walls of the Ensemble Rehearsal Hall is inadequate for lateral support of the CMU walls. Further evaluation is also needed for the connection of roof to wall, which consists of two 3/4" diameter anchor bolts at each W-beam in addition to spot welds to a ledger angle along the perimeter of the walls. The capacity of these connections approaches the diaphragm seismic force transfer demands to the CMU walls and should be evaluated further for the purpose of retrofit.
