Text in *green* is to be part of UC Santa Cruz building database and may be part of UCOP database**UC Santa Cruz building seismic ratings****Music Center – Practice Studios and Class Lab**

CAAN #7922

402 McHenry Road, Santa Cruz, CA 95064

DATE: 2019-06-30

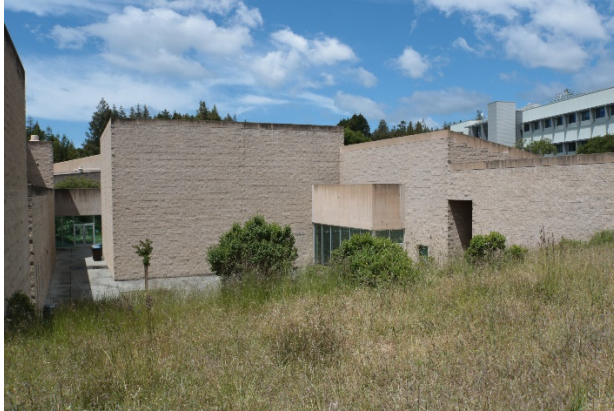
East View of Practice Studios and Class Lab

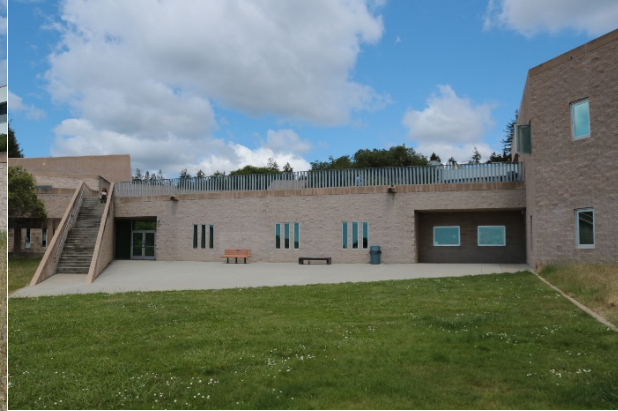
South View of Practice Studios and Class Lab
